POWER SYSTEM OPERATING INCIDENT REPORT – SIMULTANEOUS TRIP AND AUTO-RECLOSE OF TARONG BLACKWALL 875 AND TARONG BLACKWALL 827 275 KV TRANSMISSION LINES ON 21 MARCH 2013

PREPARED BY: System Performance & Commercial

DATE: 14 May 2013

FINAL

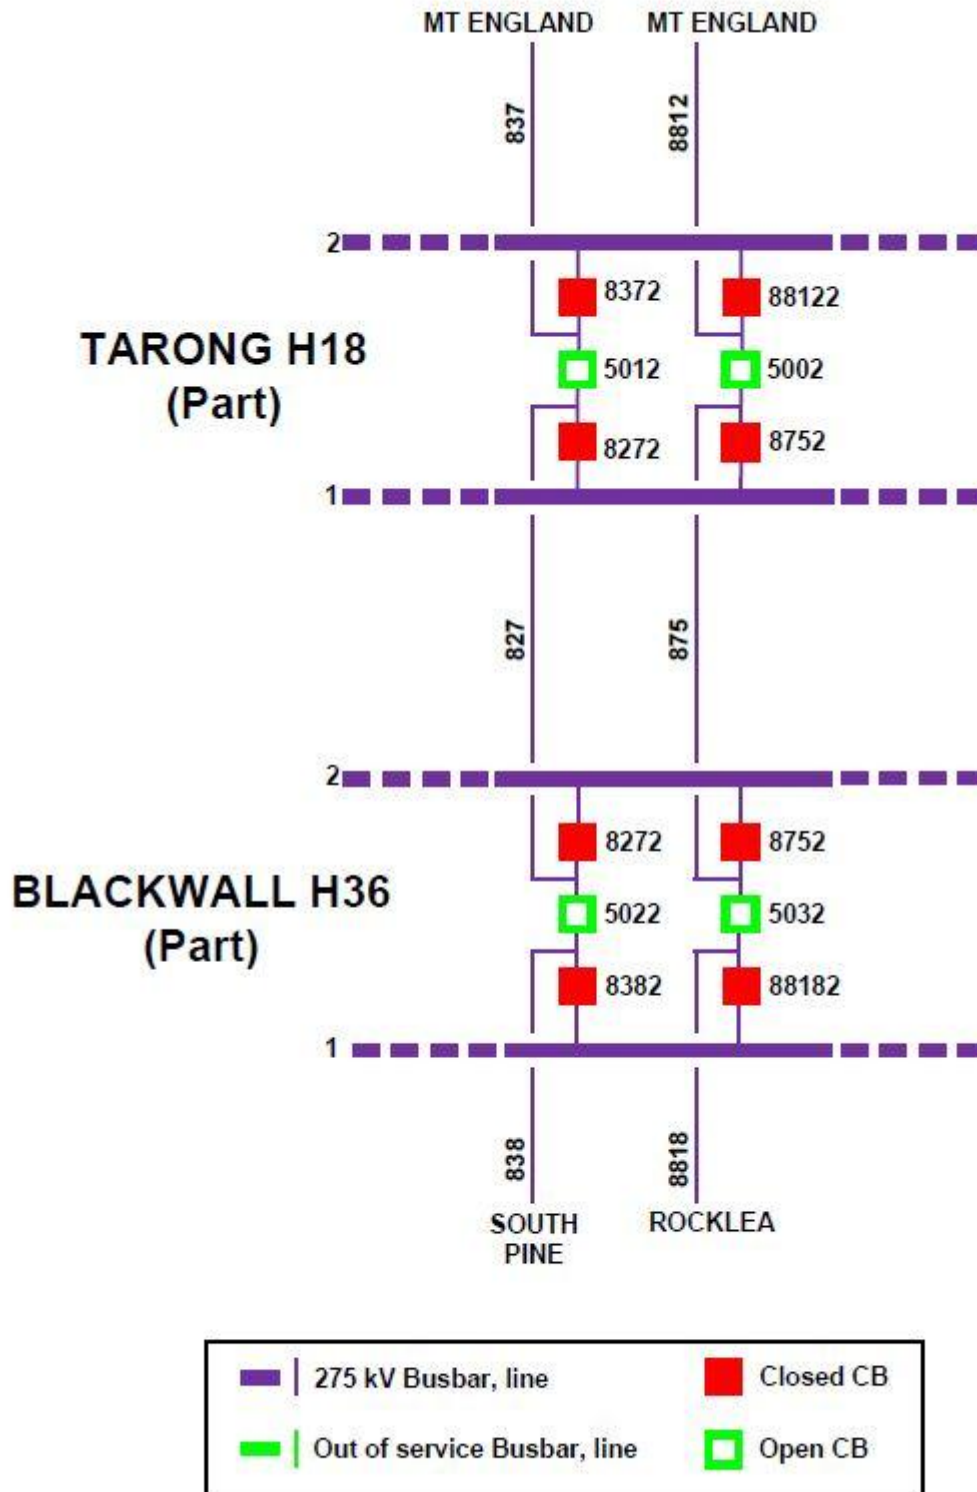
Figure 2 - Status of the power system after the incident

Time	Events
21/03/2013 09:08:27 hrs	Tarong – Blackwall 875 275 kV Transmission Line tripped.
21/03/2013 09:08:32 hrs	Tarong – Blackwall 875 275 kV Transmission Line auto reclosed. CB 5002 and CB 5032 remained OPEN after auto reclose operation. ²
21/03/2013 09:15:38 hrs	Tarong – Blackwall 875 275 kV Transmission Line tripped.
21/03/2013 09:15:43 hrs	Tarong – Blackwall 875 275 kV Transmission Line auto reclosed. CB 5002 and CB 5032 remained OPEN after auto reclose operation.
21/03/2013 09:17:58 hrs – 09:18:13 hrs	Tarong – Blackwall 875 and 827 275 kV Transmission Lines simultaneously tripped and auto reclosed. For a six second period from 09:18:03 hrs – 09:18:09 hrs, both Tarong – Blackwall 875 and 827 275 kV Transmission Lines out of service. CB 5002, CB 5032, CB 5012 and CB 5022 remained OPEN after auto reclose operation.
21/03/2013 09:28:29 hrs	Tarong – Blackwall 875 275 kV Transmission Line tripped.

21/03/2013 09:28:39 hrs	Tarong – Blackwall 875 275 kV Transmission auto reclosed. CB 5002, CB 5032, CB 5012 and CB 5022 remained OPEN after auto reclose operation.
21/03/2013 1000 hrs	AEMO issued the Electricity Market Notice No.41956 advising the market of a non-credible contingency.

The status of the power system after the incident is shown in Figure 2.
