POWER SYSTEM OPERATING INCIDENT REPORT – TRIP OF TARONG NO. 2 275KV BUSBAR ON 8 JANUARY 2013

PREPARED BY: System Performance & Commercial

DATE: 28 February 2013

FINAL

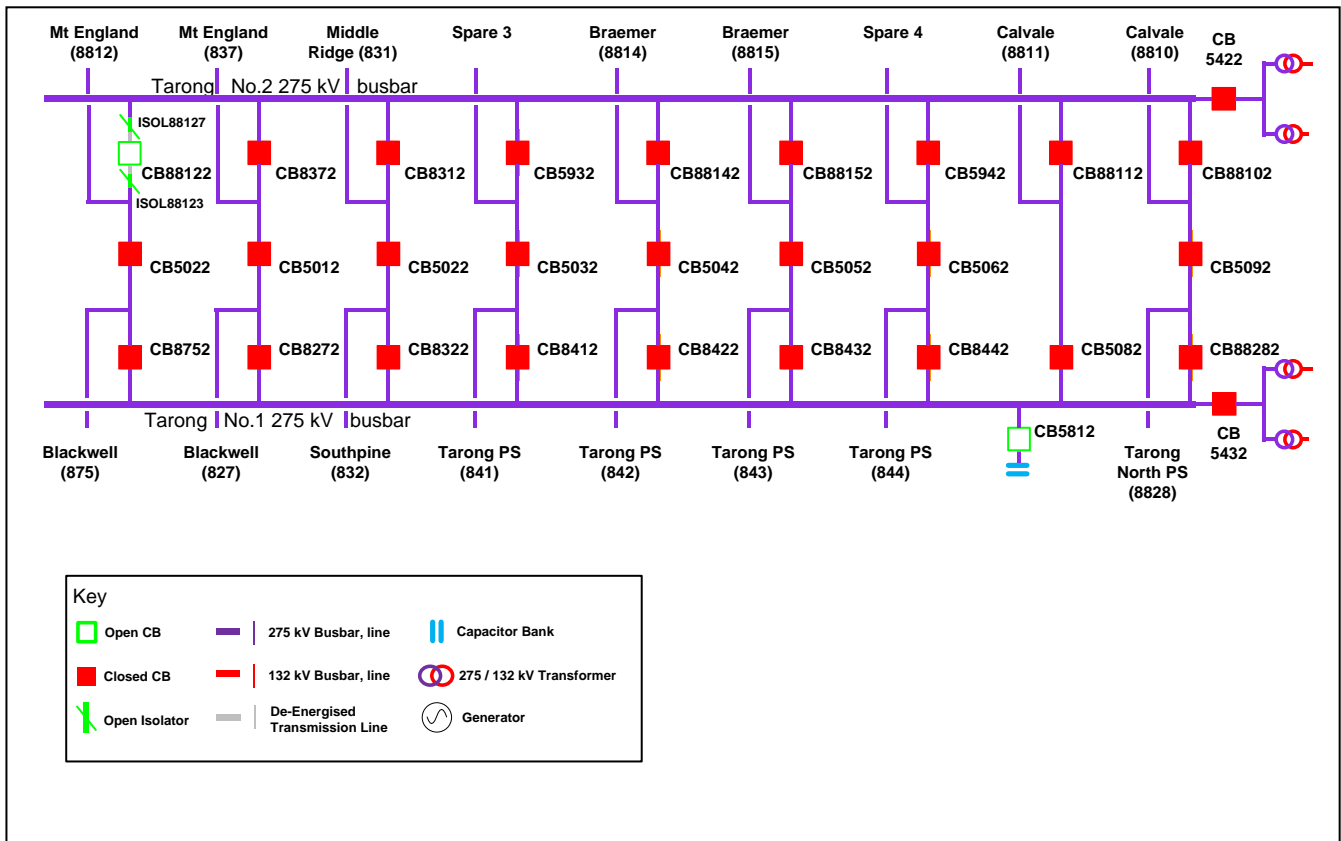
Figure 1 - Status of the power system prior to the incident

H18 Tarong Substation has two 275 kV busbars that connect the Tarong North and Tarong Power Stations to the transmission network. Prior to the time of the incident both No.1 and No. 2 275 kV busbars at Tarong Substation were in service.

The status of the power system prior to the incident is shown in Figure 1. For clarity, only equipment relevant to this incident has been included in the diagram.

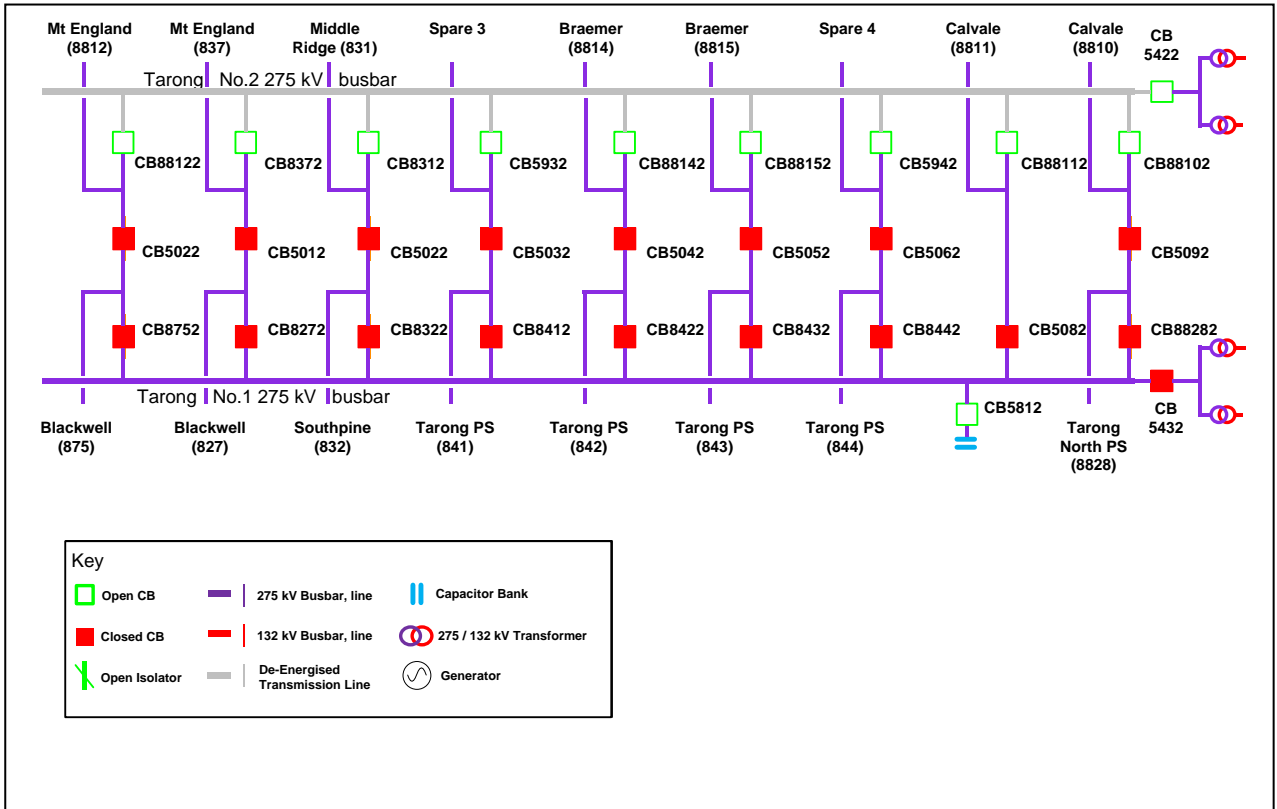
Figure 2 - Status of the power system immediately after the incident

On 8 January 2013, planned maintenance activity was being conducted on the H18 Tarong 275 kV CB 88122. This work required the closure of the CB 88122 as part of a maintenance activity. At 0904 hrs when CB 88122 was closed, an induced current flowed through the CB and the associated current transformer (CT), which were both isolated from the transmission network and

connected to earth potential at the time. The current within the CT was sufficient to trigger the busbar protection scheme and tripped the No. 2 275KV busbar.

The status of the power system immediately after the incident is shown in Figure 2.

The trip of H18 Tarong No. 2 275 kV busbar on 8 January 2013 was caused by a current induced within a current transformer in a section of the substation that had been isolated from the network and had earths applied. The protection system responded to this induced current by operating the busbar protection system.

Powerlink have advised that an investigation has been initiated to review the source of the unexpected current present on the identified plant that caused the protection system to operate. This investigation is expected to be completed by 30 April 2013. Powerlink have also advised that, until a final solution is determined and implemented, planned maintenance activities have been amended to include additional secondary isolation actions.
