POWER SYSTEM OPERATING INCIDENT REPORT – TRIP OF DAVENPORT – NORTHERN POWER STATION No.2 275 KV LINE AND NORTHERN POWER STATION UNITS 1 AND 2 ON 26 FEBRUARY 2013

PREPARED BY: Systems Performance and Commercial

DATE: 16 April 2013

FINAL

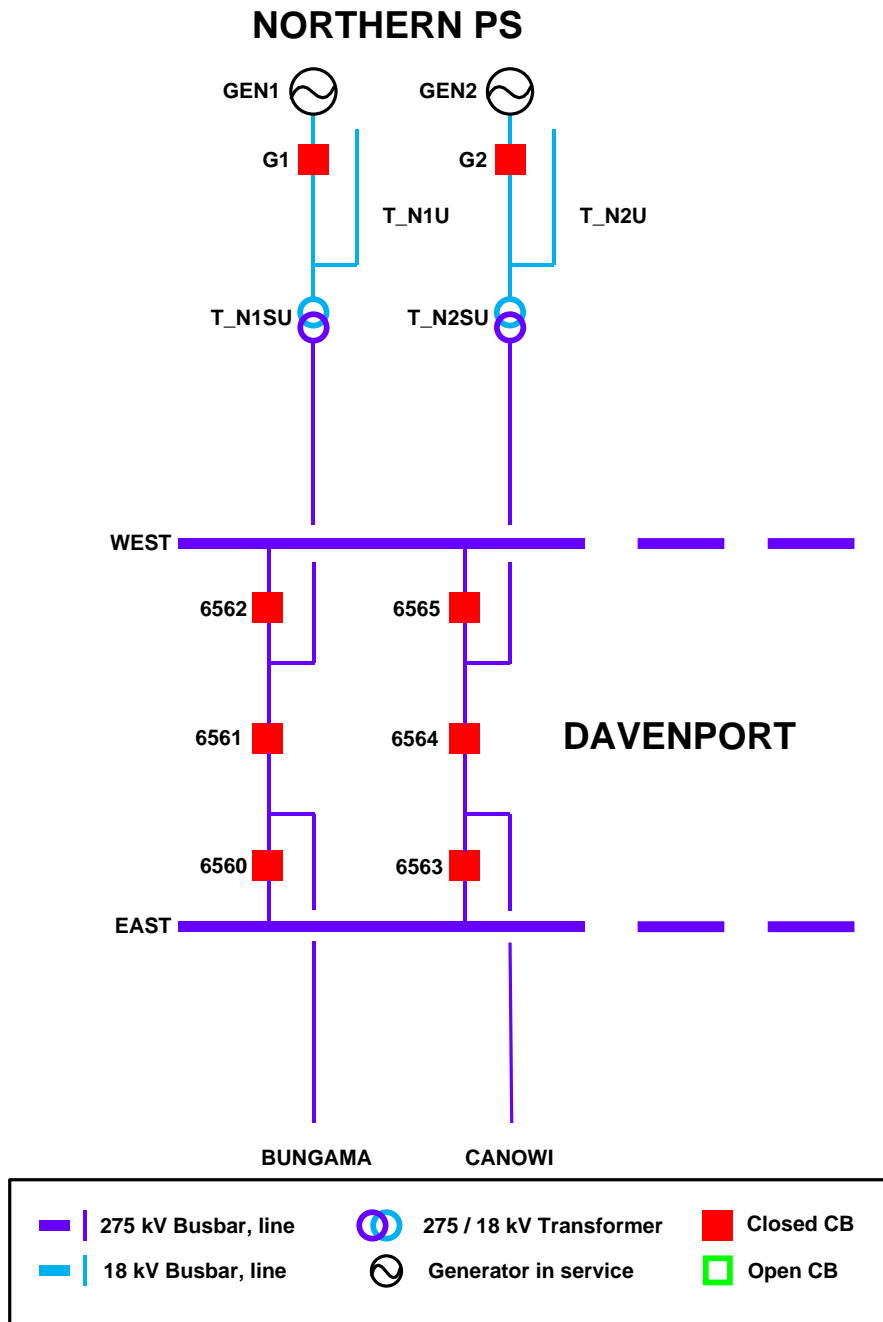
Figure 1 - Status of the power system prior to the incident

Prior to the event the Northern Power Station Unit 1 was generating 236 MW and the Northern Power Station Unit 2 was generating 232 MW.

The status of the power system prior to the incident is shown in Figure 1. For clarity only equipment relevant to this incident has been included in the diagram.

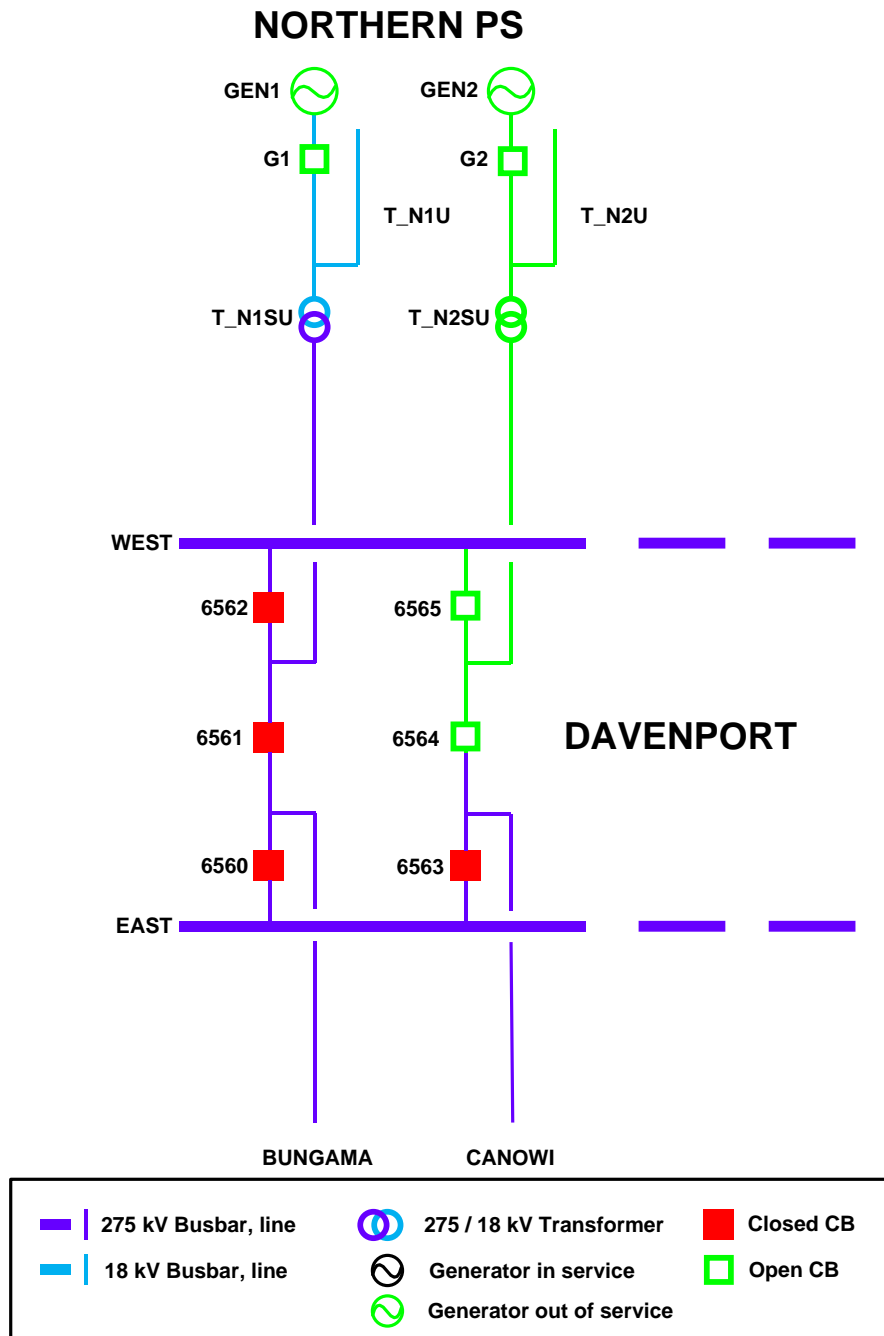
Figure 2 - Status of the power system immediately after the incident

At 0423 hrs a flashover on the Davenport – Northern Power Station No.2 275 kV Transmission Line caused the trip of the line and Northern Power Station Unit 2, initiated by the correct operation of the transmission line protection system. Northern Power Station Unit 1 also tripped approximately 10 seconds later, however the reason was not known at the time.

The status of the power system immediately after the incident is shown in Figure 2.

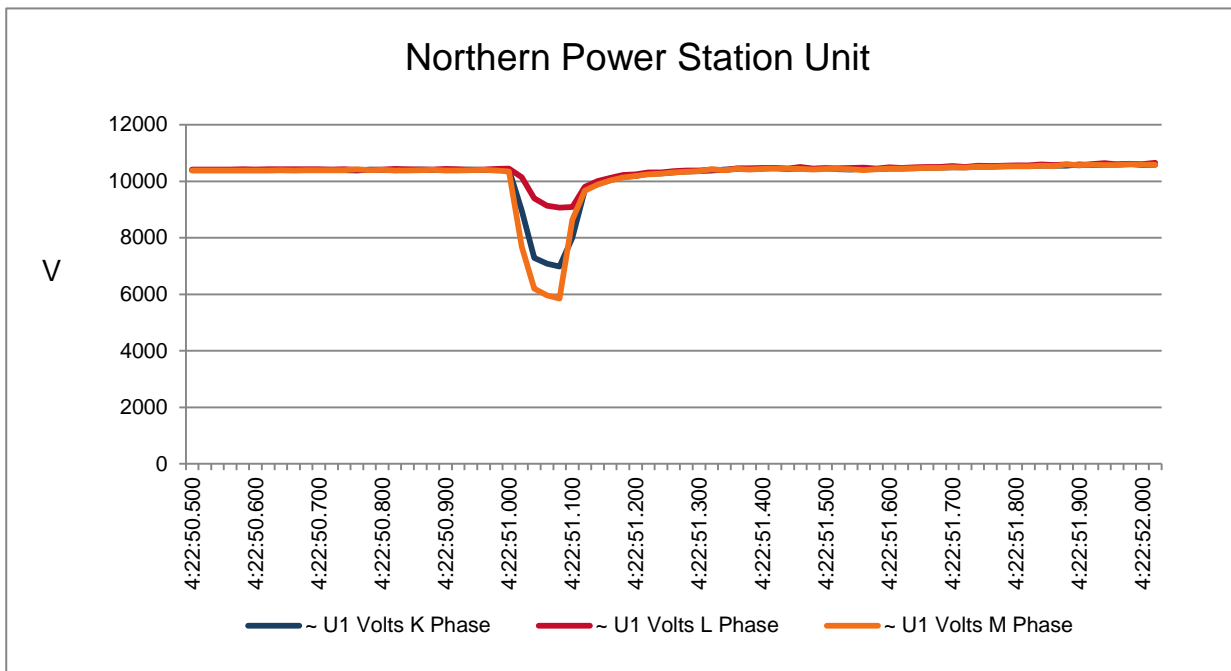
Figure 3 – Northern Power Station Unit 1 phase voltages

Further investigations from Alinta Energy have indicated that during the transmission fault the connection voltage on one phase at Northern Power Station appeared to have fallen to about 60% of the nominal value, also reducing the voltages of power station and unit auxiliary supplies. The fault was cleared in approximately 85 ms and the voltage returned to normal values. Northern Power Station Unit 1 tripped a few seconds later from a boiler trip caused by multiple coal feeder trips, which were subsequently revealed to have been initiated by false indication of low coal bunker levels. Figure 3 below shows the phase voltages at the Northern Power station Unit 1 terminals during the event.

Further investigations from Alinta Energy have revealed that the mentioned voltage depression initiated a 415 V phase failure relay³ in the Boiler Instrumentation Power Distribution Cubicles for Unit 1, triggering a change-over to the 415 V standby supply.

Additional time delay associated with the change back to the normal supply after the fault was cleared, continued to interrupt the 240 V supply to the external boiler instrumentation, in particular the Unit 1 coal bunker level switches. This voltage interruption resulted in a false indication of low coal bunker levels, tripping all coal feeders and their associated coal mills, and causing the subsequent boiler and unit trip.

The under-voltage relay for the 415 V supply changeover on Northern Power Station Unit 1 has been changed to provide an appropriate delay to ensure that the Boiler Instrument Controls Switchboard continues to be supplied from the normal 415 V supply under these significant network earth fault circumstances, albeit at a reduced voltage for a short period.

Primarily, the logic circuit supplying the low coal bunker level signal to the coal mill and feeder protection systems has been modified on both units to include an appropriate time delay to provide additional security.

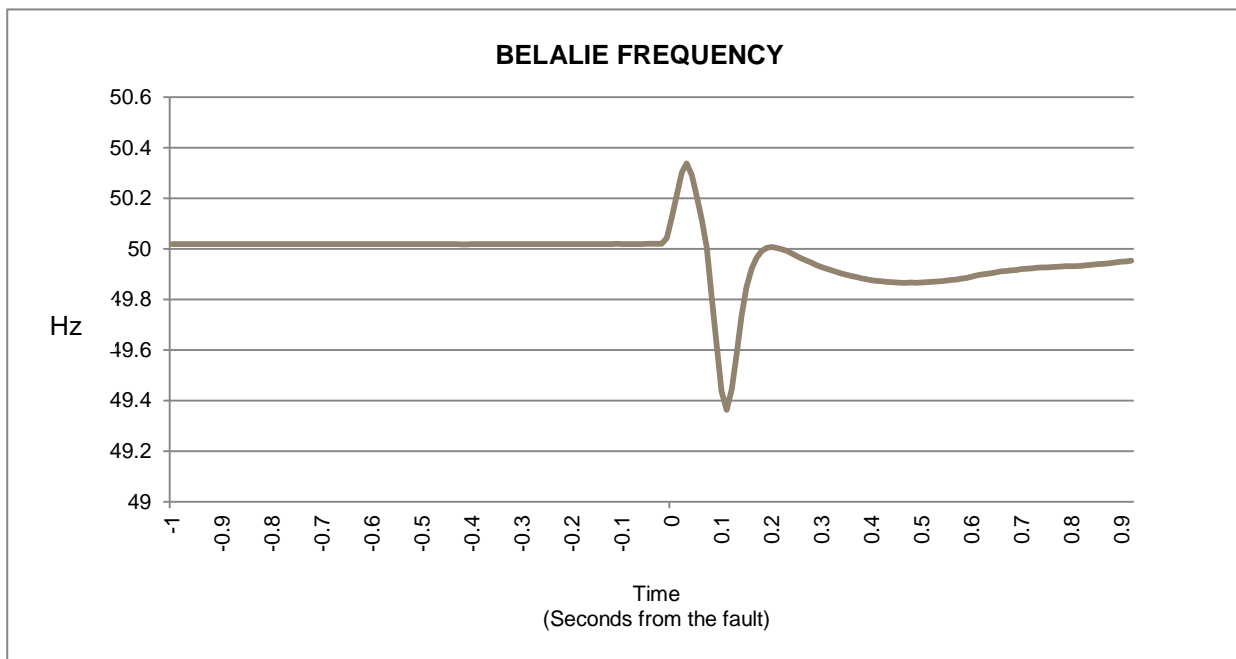
Figure 4 – Frequency at Belalie Substation

Elsewhere in the power system, voltages and frequencies remained within the normal operating bands and the power system remained in a secure operating state throughout the incident.

Figure 4 below shows the frequency measured at Belalie Substation (near Canowie) during the fault. This data was provided by ElectraNet.
