TRIP OF EAST ROWVILLE B2 AND CRANBOURNE B3 TRANSFORMERS ON 2 AUG 2014

AN AEMO POWER SYSTEM OPERATING INCIDENT REPORT FOR THE NATIONAL ELECTRICTY MARKET

PUBLISHED SEPTEMBER 2014

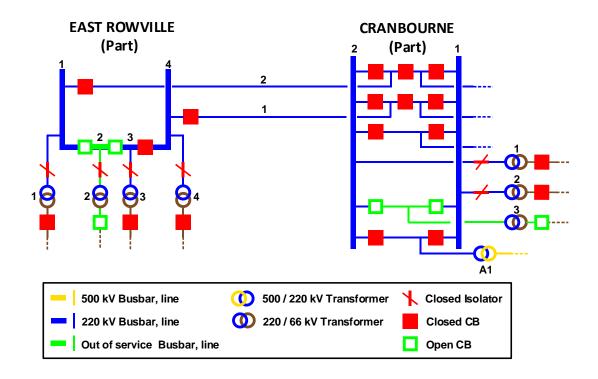
The power system after the incident

On 2 August 2014 at 1732 hrs the East Rowville No.2 and Cranbourne No.3 transformers simultaneously tripped. The transformers tripped as a result of a failed surge diverter on the primary side of the East Rowville No.2 transformer.

AusNet investigated this incident and found that a failed surge diverter caused the East Rowville No.2 transformer to trip, and a loose secondary circuit current transformer (CT) connection caused the Cranbourne No. 3 transformer to trip.

All open CBs were closed before the incident.
