Power System Operating Incident Report - Trip of Davenport-Bungama-Blyth-Para 275 kV transmission lines on 1 December 2013

PREPARED BY: AEMO Systems Capability

DATE: 10 February 2014

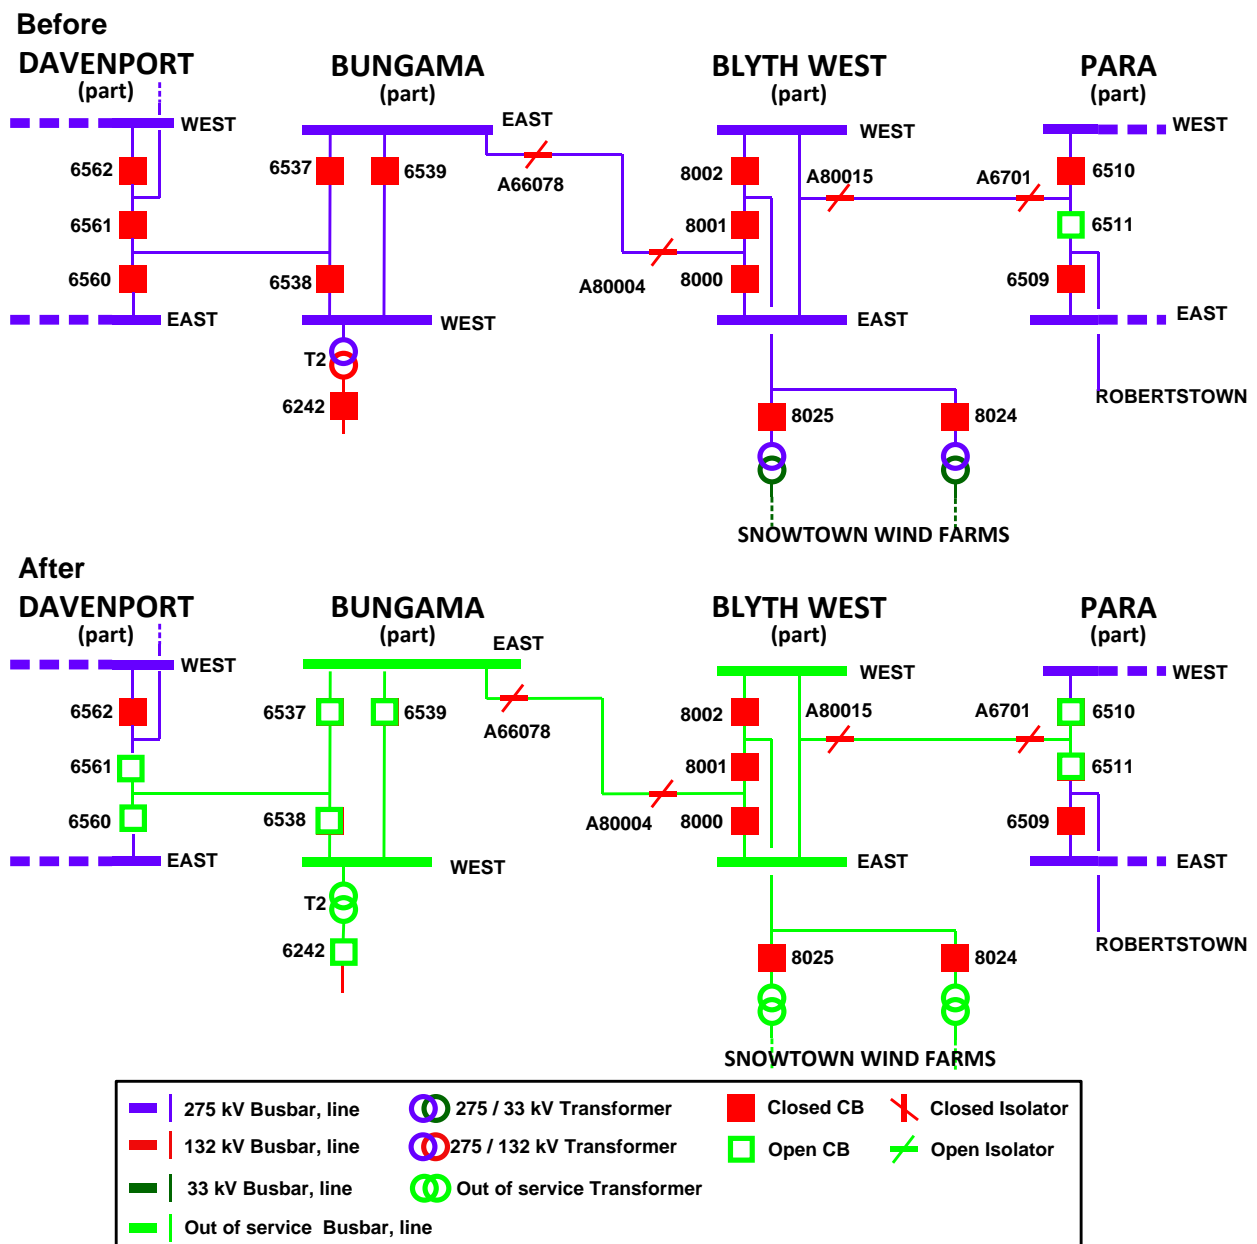
Figure 1 - Status of the power system before and after the incident

On Sunday 1 December 2013, at 0808 hrs, a current transformer failed at Bungama substation (Bungama). As a result, three 275 kV transmission lines tripped (Bungama – Davenport, Blyth West – Bungama, Blyth West – Para) and the Snowtown North and South winds farms were islanded. The wind farms were not generating at the time of the incident. No load was lost due this incident.

However, CB 6510 at Para also opened, and with CB 6511 already out-of-service⁶, this resulted in:

- Blyth West – Bungama 275 kV transmission line de-energised
- Blyth West – Para 275 kV transmission line de-energised
- Snowtown North and South wind farms islanded

The status of the power system before and after the incident is shown in Figure 1. For clarity only equipment relevant to this incident has been included in the diagrams.
