# Power System Operating Incident Report – Trip of Ringwood No.2 220 kV Busbar on 29 January 2014

PREPARED BY: AEMO Systems Capability

DATE: 4 April 2014

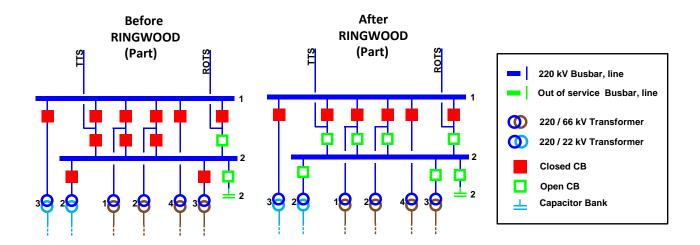
On Wednesday 29 January 2014 at 1345 hrs the Ringwood No.2 220 kV busbar tripped. There was no loss of load or generation and the power system remained secure.

The status of the power system before and after the incident is shown below. The After diagram shows all circuit breakers connected to the No.2 busbar open.
