Power System Operating Incident Report – Trip of Sydney West A2 330kV busbar and Sydney West - Liverpool 330kV transmission line on 17 November 2013

PREPARED BY: AEMO Systems Capability

DATE: 19 February 2014

STATUS: FINAL

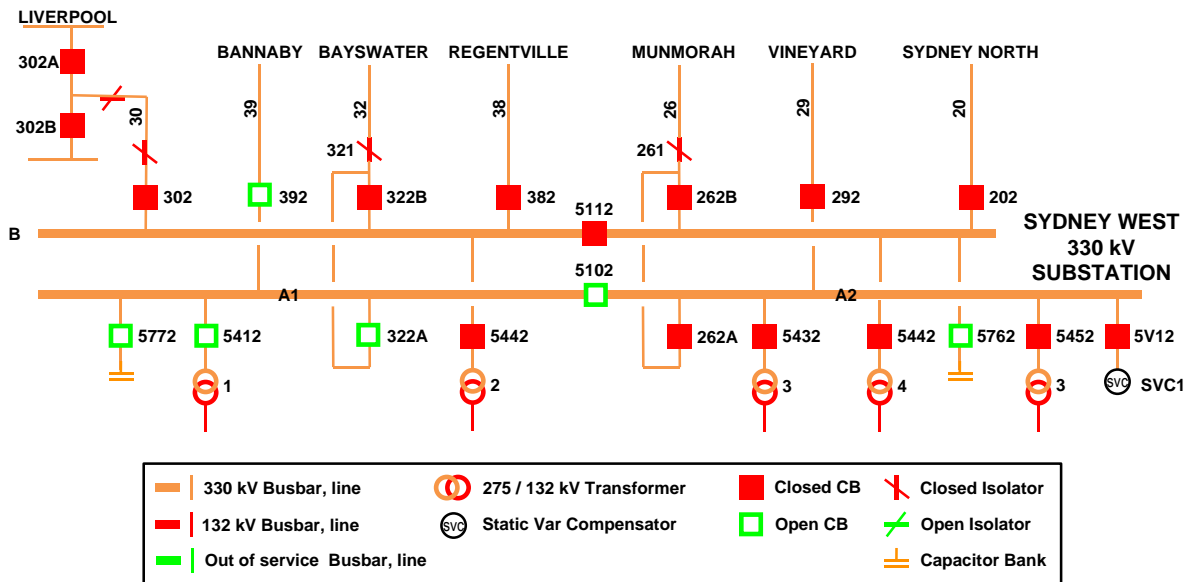
Figure 1 - Status of the power system prior to the incident

At the time of this incident, a planned outage of Sydney West A1 330 kV busbar was underway. A switching error on Sydney West A2 330 kV busbar, whilst preparing for the A1 busbar outage, caused the incident.

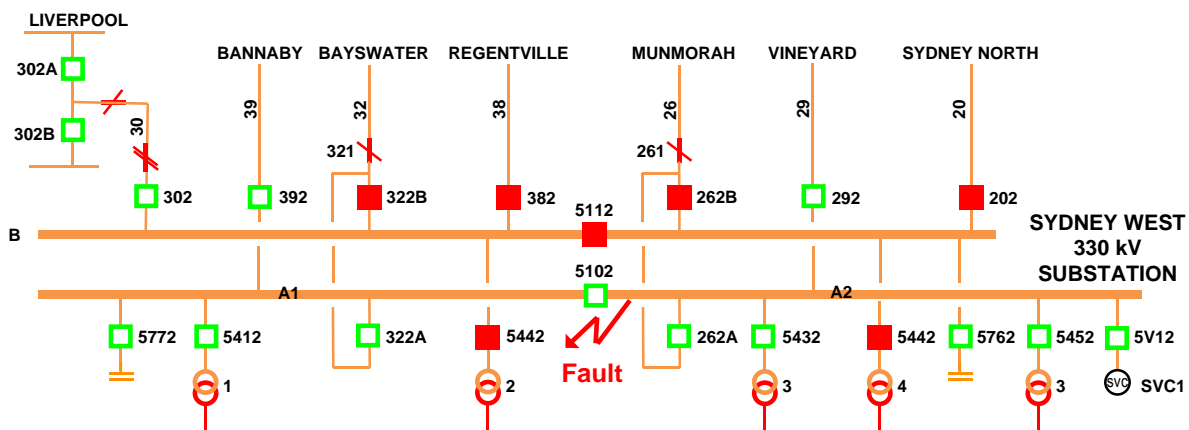
Figure 2 - Status of the power system immediately after the incident

This switching error resulted in the trip of the Sydney West A2 330 kV busbar and the Sydney West – Liverpool (30) 330 kV Transmission Line (Line 30). The A2 330 kV busbar protection operated correctly for the fault condition and cleared the busbar. Line 30 however should not have tripped. The Line 30 protection relay should have delayed the trip to allow the busbar protection to operate and clear the fault.

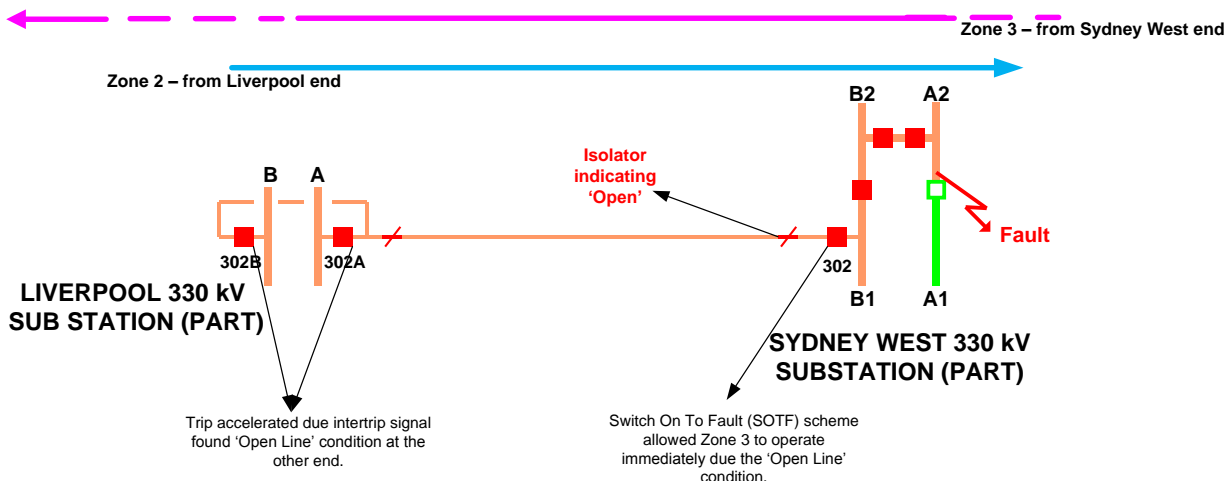
The figure below shows a simplified representation of the zones covered by the zone⁸ protections that operated at the Liverpool and Sydney West substations for the busbar fault at Sydney West. These protection operations resulted in the trip of the Sydney West – Liverpool 330 kV transmission line (the line).

The busbar fault was correctly identified and cleared by the busbar zone protection at Sydney West.

The fault was also correctly identified at Liverpool as being in protection Zone 2, and at Sydney West as being in protection Zone 3. The trip times associated with the Zone 2 and Zone 3 faults are normally delayed to prevent inadvertent trips for faults not on the protected line. For this incident the fault was not on the protected line and the line circuit breakers should not have opened immediately.

The line protection relays at Liverpool and Sydney West were unexpectedly accelerated to trip immediately. The Zone 2 and Zone 3 trip signals were accelerated because of a false line open indication from the 330 kV line isolator at Sydney West. The line isolator was closed but incorrectly indicating open. This incorrect open indication was an input to the line protection relay at Sydney West.

At the Liverpool end, the protection relay identified that the fault was in Zone 2 and sent a permission to trip signal to Sydney West. At Sydney West the trip signal was echoed back to Liverpool as the line was indicating open at Sydney West⁹. For this condition - a fault, and a trip signal from the remote end - the protection at Liverpool immediately opened the line circuit breakers. The protection operated correctly for the given input information.

At the Sydney West end, the protection relay identified that the fault was in Zone 3, and that the line was indicating open at Sydney West. For this condition – a fault, and the line open at the local end - the protection relay at Sydney West determined a Switch onto Fault (SOTF) condition and immediately opened the line circuit breaker at the Sydney West end. The protection operated correctly for given the input information.

The line isolator indication has subsequently been removed from the logic that is used to determine the open-close condition of the line. This event is therefore unlikely to reoccur.
