# Trip of Liddell-Tamworth 330 kV transmission line and Bayswater Unit 3 on 23 Oct 2014

AN AEMO POWER SYSTEM OPERATING INCIDENT REPORT FOR THE NATIONAL ELECTRICITY MARKET

FEBRUARY 2015

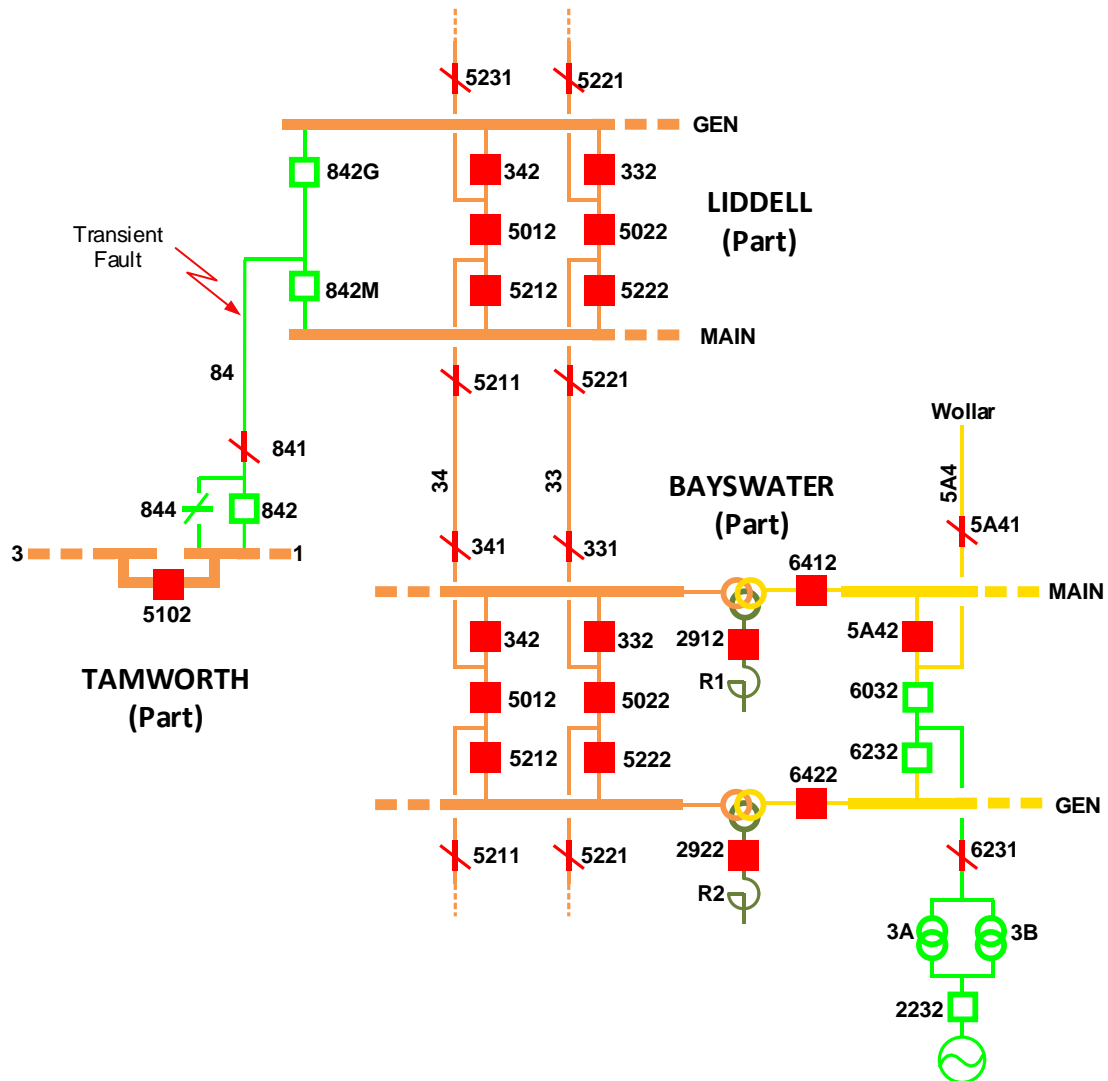
## APPENDIX 1 – POWER SYSTEM DIAGRAM

On Thursday 23 October, at 1711 hrs, the Liddell-Tamworth 330 kV 84 transmission line (Line 84) tripped and reclosed. At the same time Bayswater Power Station Generating Unit 3 (BW03) was disconnected from the transmission system and thereby tripped.

At the same time as the trip of Line 84, transmission circuit breakers (CBs) 6232 and 6032 opened at Bayswater substation. This resulted in BW03 being disconnected from the transmission system. CBs 6232 and 6032 opened due to the maloperation of the No.3 Generator Transformer Group No.2 Differential Protection Relay.

The power system after the fault (before the circuit breakers on Line 84 auto reclosed)

TransGrid subsequently found that a faulty analogue input card had generated an erroneous current signal into the No.2 protection relay. The card was replaced and No.2 Protection was returned to service at 1900 hrs Saturday 25 Oct 2015.
