Power System Operating Incident Report - Trip of Greenbank - Molendinar 275 kV Transmission Line at Greenbank End on 21 December 2013

PREPARED BY: AEMO Systems Capability

DATE: 4 February 2014

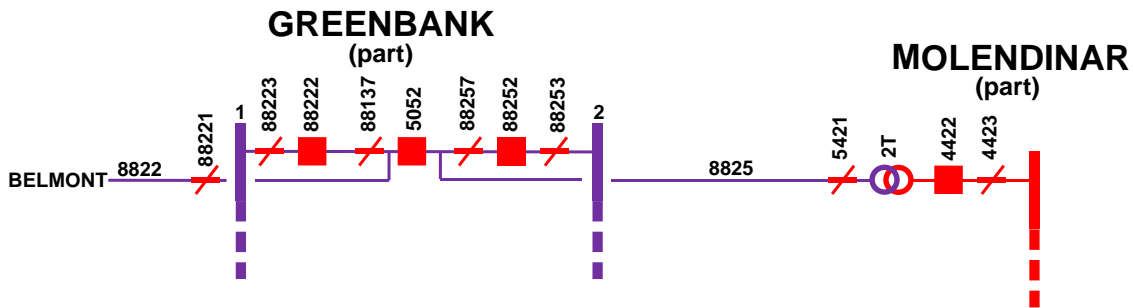
Figure 1 - Status of the power system prior to the incident

The status of the power system prior to the incident is shown in Figure 1 and after the incident in Figure 2. For clarity only equipment relevant to this incident has been included in the diagrams. Figure 1 shows the Greenbank – Molendinar Line in service. Figure 2 shows the Greenbank – Molendinar Line off-loaded and open at Greenbank.

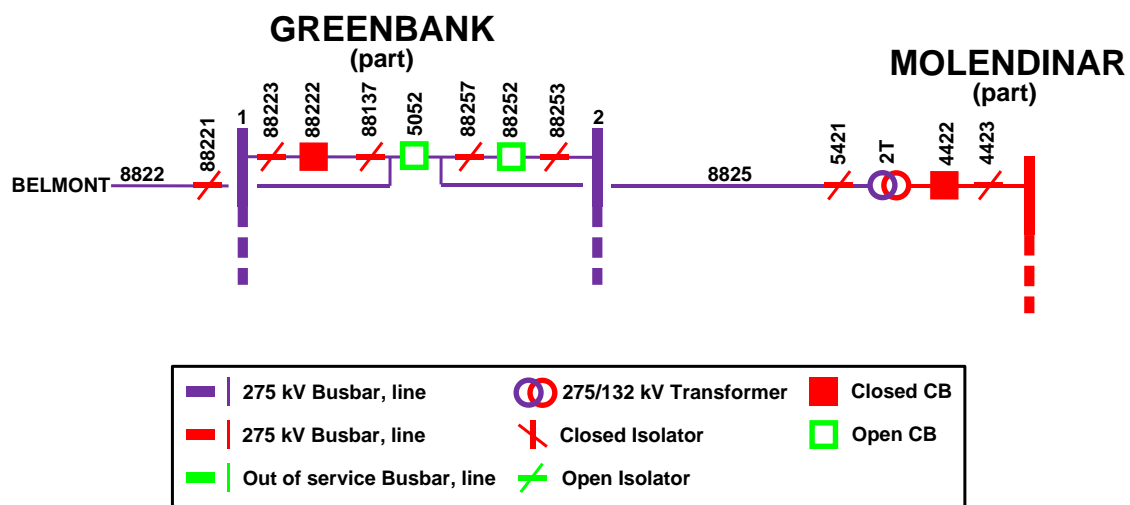
Figure 2 - Status of the power system immediately after the incident

Powerlink found that a faulty protection relay caused the incident; that is the faulty protection relay triggered 275 kV circuit breakers 5052 and 88252 at Greenbank substation to open.

1. Powerlink identified that the cause of the transmission line opening was the unexpected operation of a protection relay at Greenbank. The protection relay issued a trip signal to circuit breakers 5052 and 88252 at Greenbank before failing completely, that is the relay powered down and would not power up. The trip signal was not expected for the failure of the protection relay.

3. Powerlink immediately replaced the faulty protection relay.
4. After the protection relay was replaced, the Greenbank – Molendinar Line was returned to service at 1152 hrs. Constraint set Q-GMBO_8824_8825 was revoked at 1155 hrs.
