POWER SYSTEM IN VICTORIA NOT IN A SECURE OPERATING STATE ON 29 NOVEMBER 2016

REVIEWABLE OPERATING INCIDENT REPORT UNDER THE
NATIONAL ELECTRICITY RULES

Published: **13 July 2017**

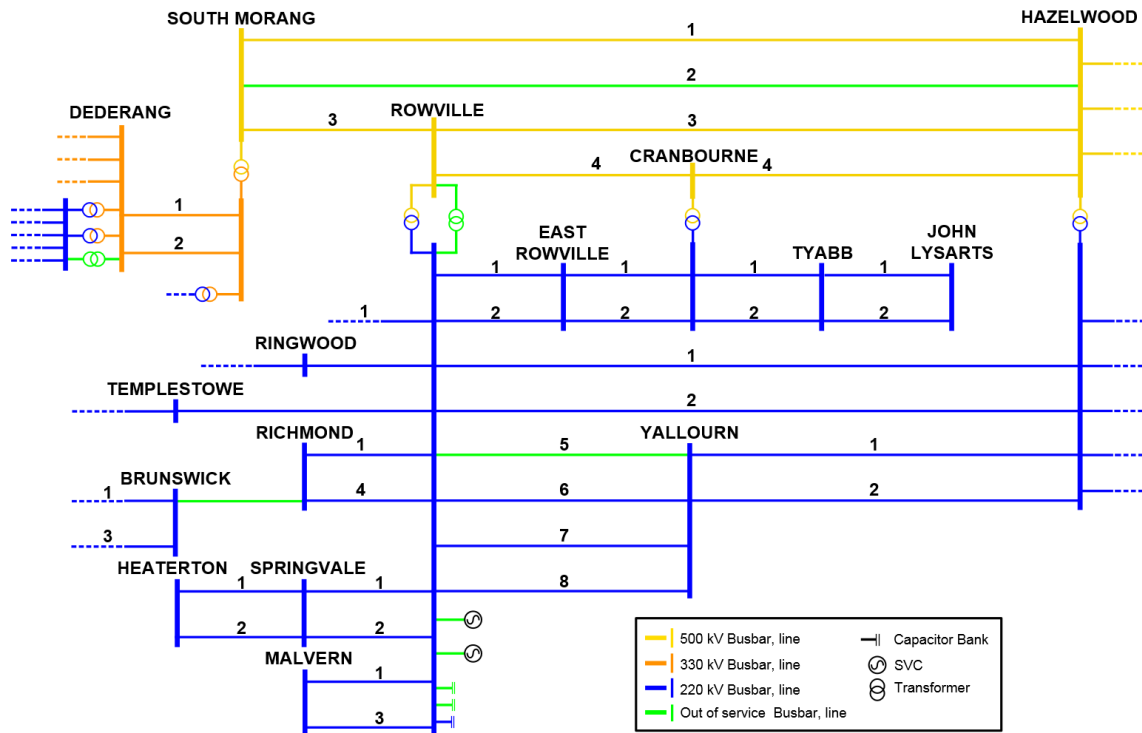
APPENDIX A. POWER SYSTEM DIAGRAM

On the morning of 29 November there were a number of planned outages in Victoria which commenced between 0500 hrs and 0609 hrs:

- Hazelwood – South Morang No. 2 500 kilovolt (kV) transmission line (outage commenced at 0500 hrs).
- Rowville No. 1 220 kV static VAr compensator (outage commenced at 0509 hrs).
- Rowville – Yallourn No. 5 220 kV transmission line (outage commenced at 0531 hrs).
- Rowville A1 500/220 kV transformer (outage commenced at 0535 hrs).
- Dederang No. 1 330/220 kV transformer (outage commenced at 0609 hrs).

There were also two pre-existing outages:

- Rowville No. 2 220 kV static var compensator (SVC).
- Brunswick – Richmond 220 kV transmission line.

Refer to Appendix A for a diagram of the relevant part of the power system during these outages.

The combination of these outages resulted in a reduction in transmission capability between the Latrobe Valley generation and South Morang, and reduced the Victoria region export limits to New South Wales and South Australia.
