330kV Busbar Trip at Vales Point substation on 3 June 2017

REVIEWABLE OPERATING INCIDENT REPORT UNDER THE
NATIONAL ELECTRICITY RULES

Published: **26 July 2017**

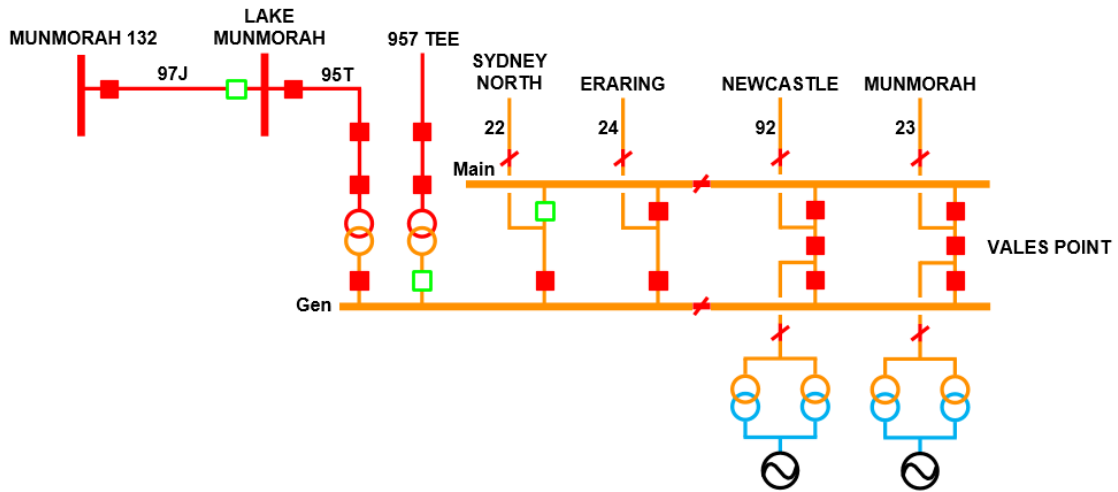
Pre-incident

- No2 330/132kV transformer at Vales Point was out of service for planned work.
- Sydney North – Vales Point Main Bus circuit breaker (CB) 222M at Vales Point was out of service for planned work.
- Lake Munmorah – Munmorah 132kV line (97J line) was open at Lake Munmorah as per normal network configuration.

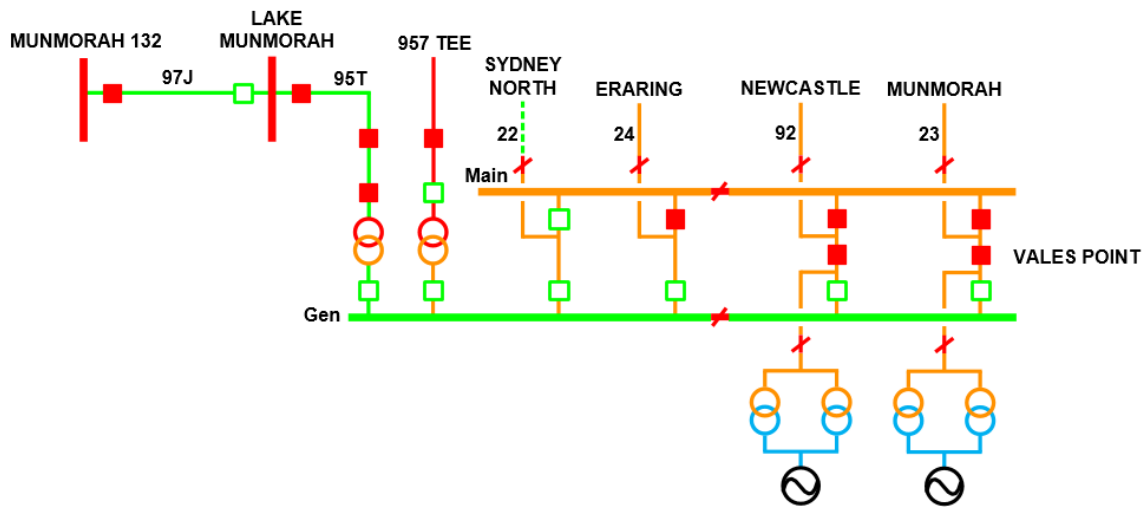
Post -incident

On Saturday 3 June 2017 at 2010 hrs, the Generator 330kV busbar at Vales Point tripped during planned protection commissioning work on the No2 330/132kV transformer at Vales Point. There was no high voltage fault on the busbar.

As a consequence of this, the Sydney North – Vales Point 330kV line was de-loaded. As well, the No1 330/132kV transformer at Vales Point and the Vales Point – Lake Munmorah 132kV line (95T line) were both de-loaded, resulting in the loss of all supply (10 MW) from the Lake Munmorah substation and auxiliary supply transformers for the Vales Point power station.

Prior to this test commencing, the protection staff had identified the need to isolate the cross tripping signal between the two relay schemes, however had only isolated one of the two links required to prevent the cross tripping. This resulted in the direct trip as soon as the test injection commenced.
