# 110 kV BUSBAR TRIP AT MUDGEERABA SUBSTATION ON 29 MARCH 2017

REVIEWABLE OPERATING INCIDENT REPORT UNDER THE  
NATIONAL ELECTRICITY RULES

Published: **12 July 2017**

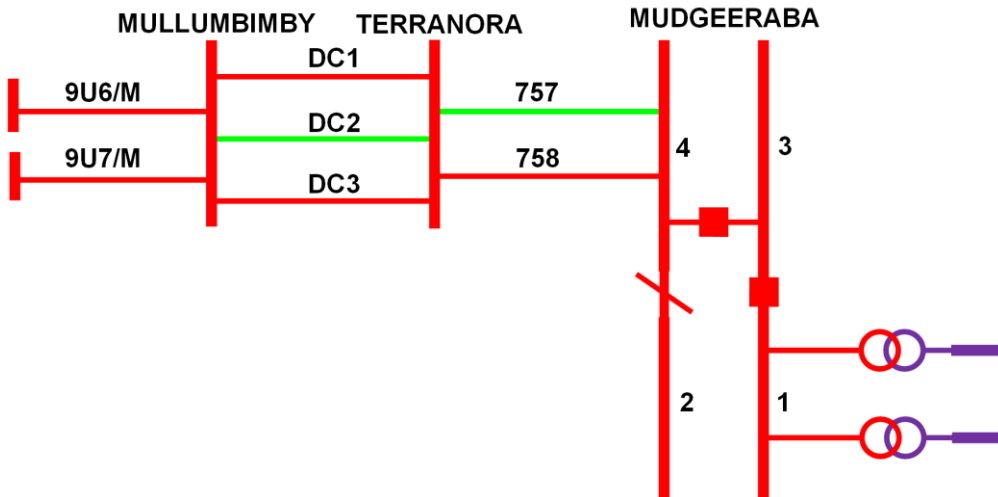
At 0840 hrs on Wednesday 29 March 2017, the Mudgeeraba No. 2 and No. 4 110 kV busbar tripped, disconnecting the 758 line. At the time of the incident, the Mudgeeraba – Terranora 757 110 kV line (757 line) was on a planned outage and all other in-service elements at Mudgeeraba substation were supplied by the Mudgeeraba No. 1 and No. 3 110 kV busbar.

System configuration before the incident. Elements not related to this incident have been omitted for clarity.

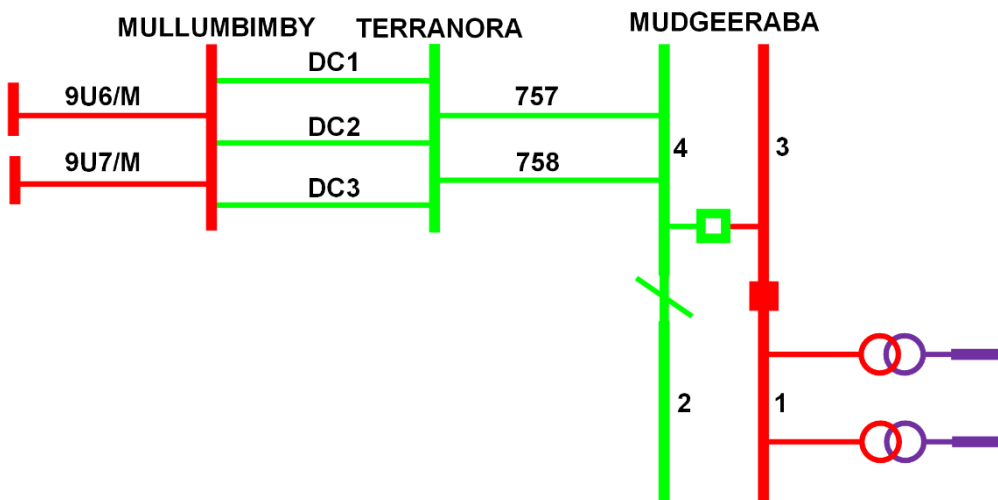
This report relates to a reviewable operating incident<sup>1</sup> that occurred at 0840 hrs on Wednesday 29 March 2017, where the Mudgeeraba No. 2 and No. 4 110 kilovolt (kV) busbars tripped out of service. As a result of the incident, the Mudgeeraba – Terranora 758 110 kV line (758 line) was disconnected, interrupting supply to Terranora Substation in New South Wales and offloading Directlink.

The Mudgeeraba No. 2 and No. 4 110 kV busbar tripped as a result of the operation of the busbar ‘Y’ protection system during the transfer of secondary circuits from the existing busbar protection scheme to a new protection scheme. Operation of the busbar protection initiates trip signals to all circuit breakers connected to the busbar.

System configuration immediately after the incident. Elements not related to this incident have been omitted for clarity.

In response to this incident, Powerlink implemented additional precautions to prevent any further unexpected operation of the busbar protection while the protection upgrade work continued. The protection upgrade was completed on 31 March 2017.
