Trip of 330 kV A Busbar at Capital Substation on 9 May 2018

November 2018

Reviewable Operating Incident Report under the
National Electricity Rules

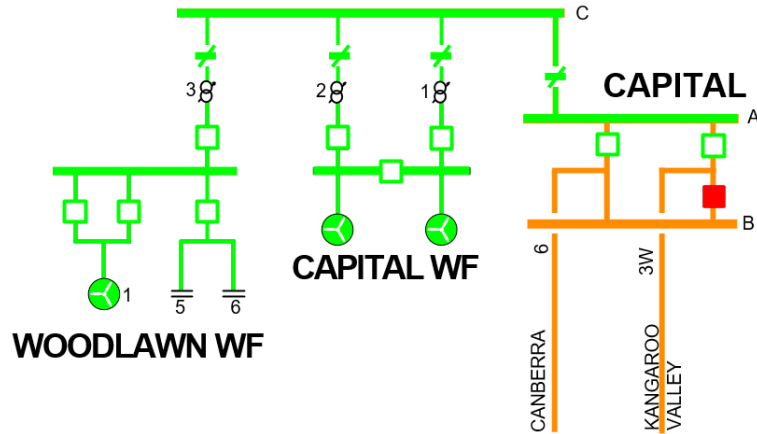
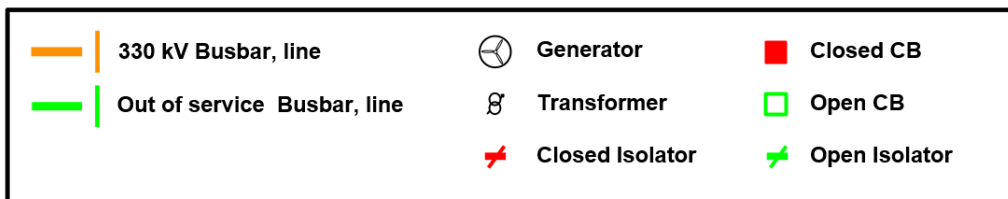
A1. Power system diagram

See Appendix A1 for a diagram showing Capital substation immediately after the incident.

The diagram below shows Capital substation immediately after the incident.
