Trip of the Calliope River – Boyne
Island 7145 132 kV line, Gladstone
Power Station Unit 1, and No. 3
Potline at Boyne Island on
16 February 2018

March 2019

Reviewable Operating Incident Report under the
National Electricity Rules

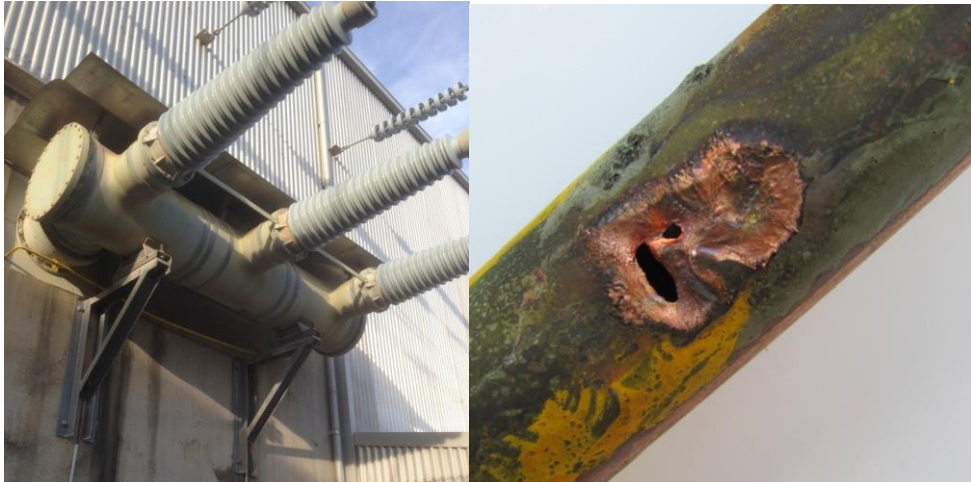
Figure 1 7145 line bushing

- Operation of the surge arrestors caused the earth potential at Boyne Island substation to rise, causing a current to flow into the GIS. A copper pipe used to supply SF₆ gas¹¹ to the 7145 line bushing assembly

became part of this current path. Arcing between a support clamp and the copper pipe caused the copper pipe to fail and release the SF₆ gas from 7145 line bushing assembly. Figure 1 shows the 7145 line bushing assembly with the yellow copper SF₆ pipe and the resulting damage to the pipe.

The 7145 line was automatically reclosed at the Calliope River end 10 seconds after the fault, and manually reclosed at the Boyne Island end at 2120 hrs. At 2149 hrs on 16 February 2018, BSL requested the 7145 line be removed from service to allow repairs to the bushing assembly. The repairs were completed, and the 7145 line returned to service at 1102 hrs on 18 February 2018.
