Trip of the Rowville No. 2 500 kV
Busbar and A2 500/220 kV
Transformer on 18 January 2018

March 2019

Reviewable operating incident report under the
National Electricity Rules

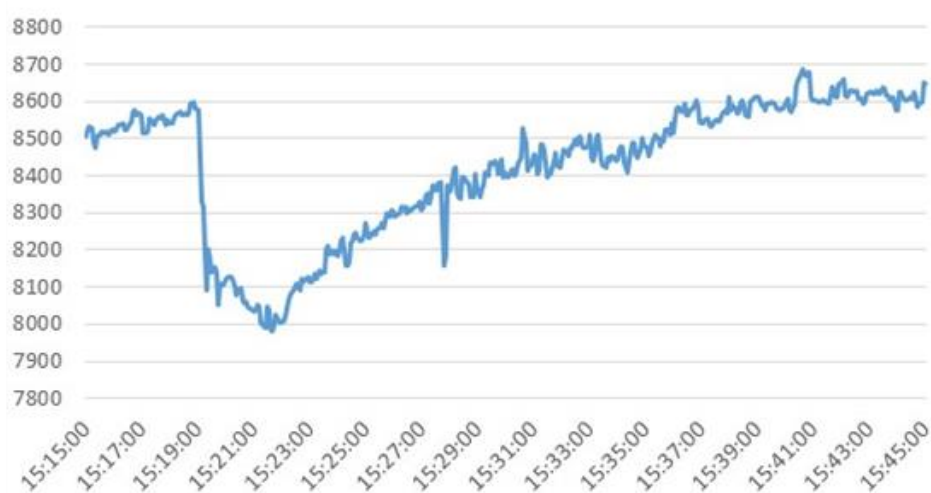
Figure 1 Victoria region demand (MW)

There was a reduction of around 600 MW in the Victoria region demand coincident with this incident. This reduction in demand occurred within the distribution networks and was caused by the voltage disturbance on the power system as a result of the fault at ROTS. The demand returned to pre-fault levels within 20 minutes, as shown in Figure 1. No bulk supply points were disconnected from the transmission network and AEMO did not instruct any load shedding.

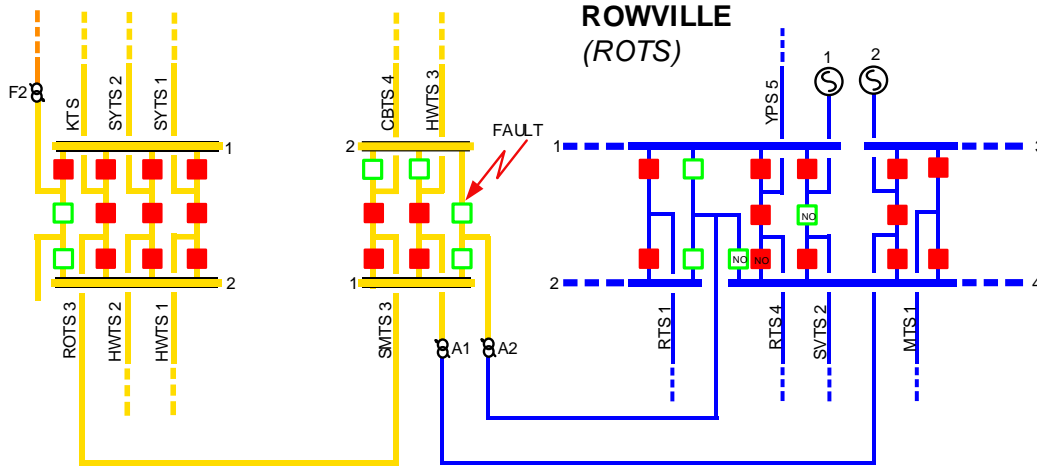
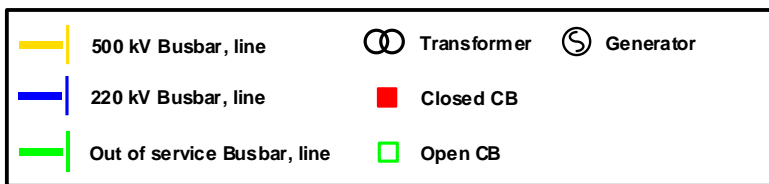
A1. Power system diagram

At 1519 hrs on Thursday 18 January 2018, the ROTS No. 2 500 kV busbar, the ROTS A2 500/220 kV transformer, and the ROTS–SMTS line at SMTS tripped simultaneously. The ROTS end of the ROTS–SMTS line did not trip. Appendix A1 provides a diagram of the relevant part of the power system immediately after the incident.

The diagram below shows the relevant part of the power system immediately after the incident.
