# Trip of Wurdong 275 kV No. 1 Busbar on 14 June 2018

**November 2018**

Reviewable operating incident report under the  
National Electricity Rules

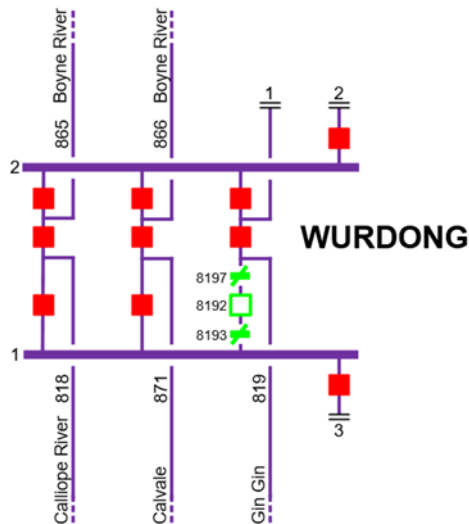
**Before**

The diagrams below show the status of switchgear at Wurdong substation before and immediately after this incident.

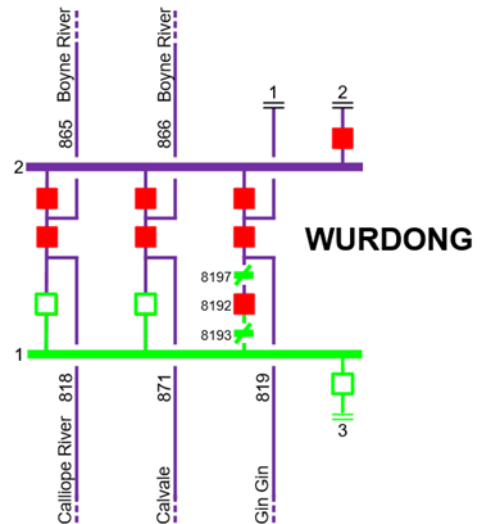
**After**

At 0806 hrs on Thursday, 14 June 2018, the No. 1 busbar at Wurdong substation tripped during planned secondary systems replacement works associated with circuit breaker (CB) 8192. No other transmission elements were impacted, except the Wurdong No.3 275 kV capacitor (No. 3 capacitor) which is connected to the No. 1 busbar. See Appendix A1 for a diagram of Wurdong Substation before and immediately after the event.
