Trip of the Sydenham–Moorabool No. 2 500 kV line and the Sydenham–Keilor 500 kV line on 18 February 2019

October 2019

Reviewable Operating Incident Report under the
National Electricity Rules

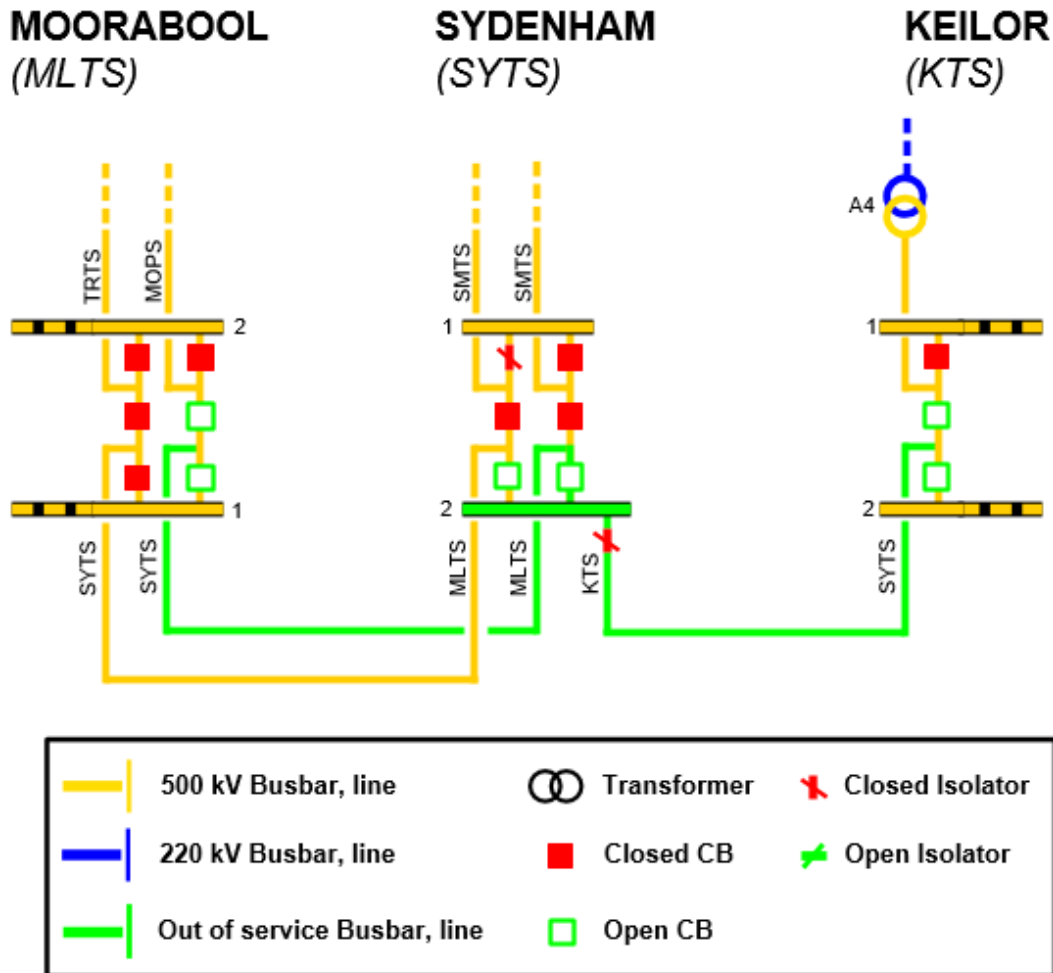
A1. System diagram

At 1956 hrs on 18 February 2019, the SYTS-MLTS 2 and SYTS-KTS lines tripped simultaneously. As there are no line circuit breakers on the SYTS-KTS line at SYTS this also resulted in the outage of the No2 500kV busbar at SYTS. Refer to Appendix A1 for a diagram showing the relevant part of the power system immediately after the incident.

The diagram below provides an overview of part of the power system immediately after the incident.
