Chapel Street Liapootah No. 2  
220 kV line and Chapel Street  
220 kV CB S752 trip, 16 January  
2020

**June 2020**

Reviewable Operating Incident Report under the  
National Electricity Rules

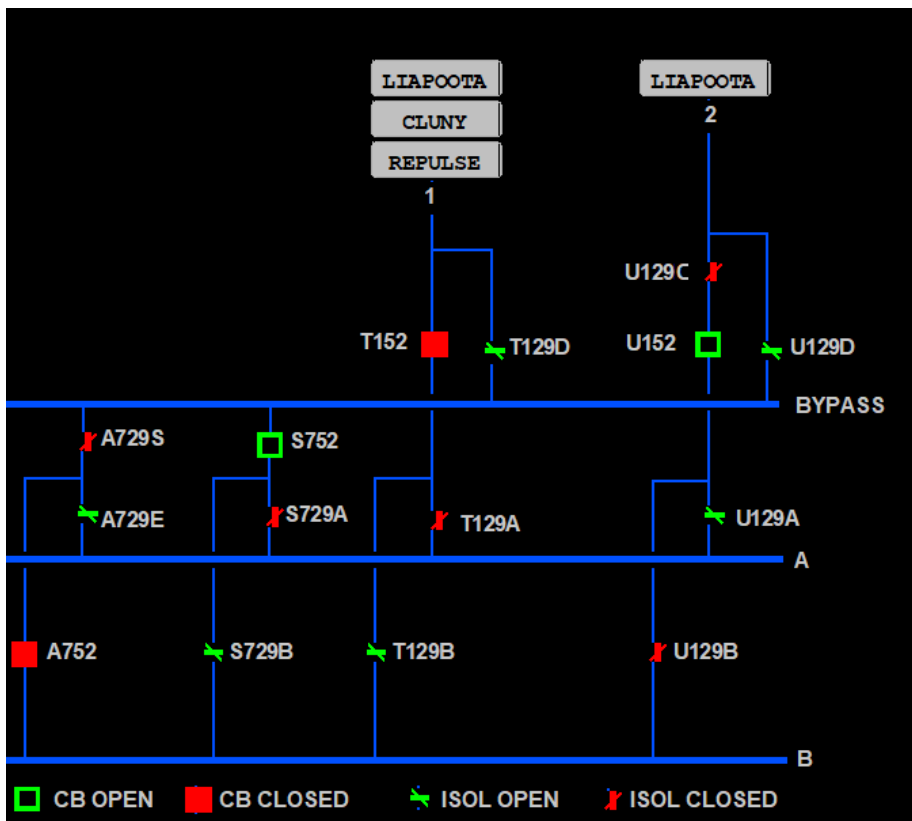
**Figure 1 Chapel Street Liapootah No. 2 220 kV line diagram**

Coincident with the trip of the Chapel Street Liapootah No.2 220 kV line, CB S752 also tripped. This was not an expected outcome for the fault on the Chapel Street Liapootah No. 2 220 kV line.

Chapel Street CB U152 connects through isolator U129C from the Chapel Street Liapootah No.2 220 kV line to Chapel Street 220kV bus A and B. Isolator U129D connects to the bypass bus, with CB S752 connecting the bypass bus to the bus A and B – refer Figure 1 below. Relay outputs on the U187/121B Protection Relay (Schweitzer SEL 311L-7) at Chapel Street Substation include latch bits to activate the relay outputs to the appropriate circuit breakers based on whether the line connection is made to bus A/B or the bypass bus (as per U129C and U129D status). It was identified by the contractor and TasNetworks during the site inspection on 17 January that that a copy and paste error had been made when updating the settings of the U187/121B Protection Relay (Schweitzer SEL 311L-7) at Chapel Street Substation on 13 January 2020, resulting in the relay acting as if the line was connected to both bus A/B and the standby bus. This resulted in the opening of the bypass CB S752 at the same time as the line CB U152.

The erroneous settings were corrected by the technician at 1645 hrs on 17 January 2020, with a settings comparison performed between existing settings and the latest as installed settings to confirm the modifications had been made correctly.

- When making simple setting changes in SEL devices, it is advised to modify each individual equation, not to rely on copy and paste from one equation to another.
- Both a visual inspection in the terminal window and a setting comparison directly after every change are required, to confirm only requested modifications were made.
