Failure of 275 kV Current Transformer at Brinkworth Substation on 16 October 2020

February 2021

Reviewable Operating Incident Report under the
National Electricity Rules

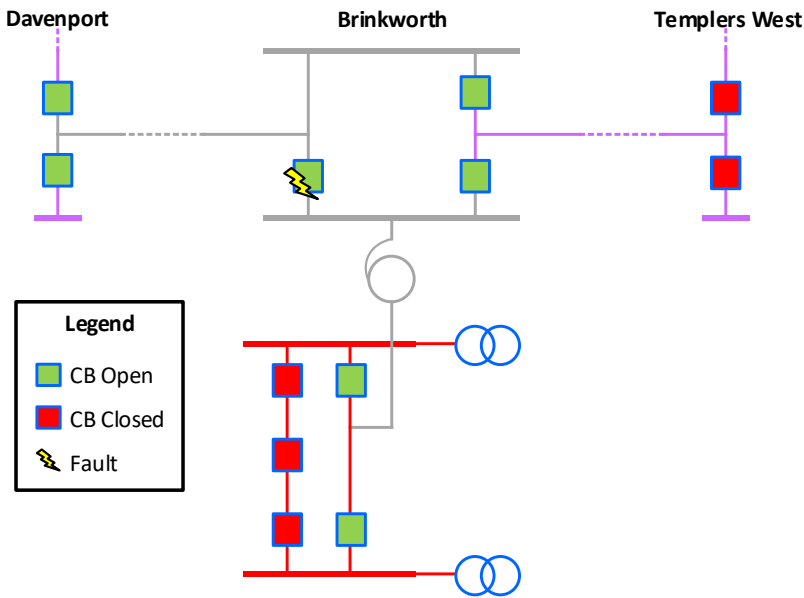
Figure 1 Post fault configuration

At approximately 0610 hrs on 16 October 2020, the Brinkworth – Davenport 275 kV line and the Brinkworth 275/132 kV No. 3 transformer tripped due to a high voltage fault on the power system. The Brinkworth – Templers West 275 kV line also tripped at the Brinkworth end only, leaving the Brinkworth east and west 275 kV busbars de-energised, as shown in Figure 1.

CB fail protection associated with CB 6530 at Brinkworth then operated to trip all three phases of the Davenport – Brinkworth 275 kV line, the No. 3 275/132 kV transformer at Brinkworth and the Brinkworth – Templers West 275 kV line at the Brinkworth end. The resulting power system configuration is shown in Figure 1. The total time to clear the fault was approximately 280 milliseconds (ms)..
