Torrens Island Power Station A 275 kV West bus, 20 January 2020

July 2020

Reviewable Operating Incident Report under the
National Electricity Rules

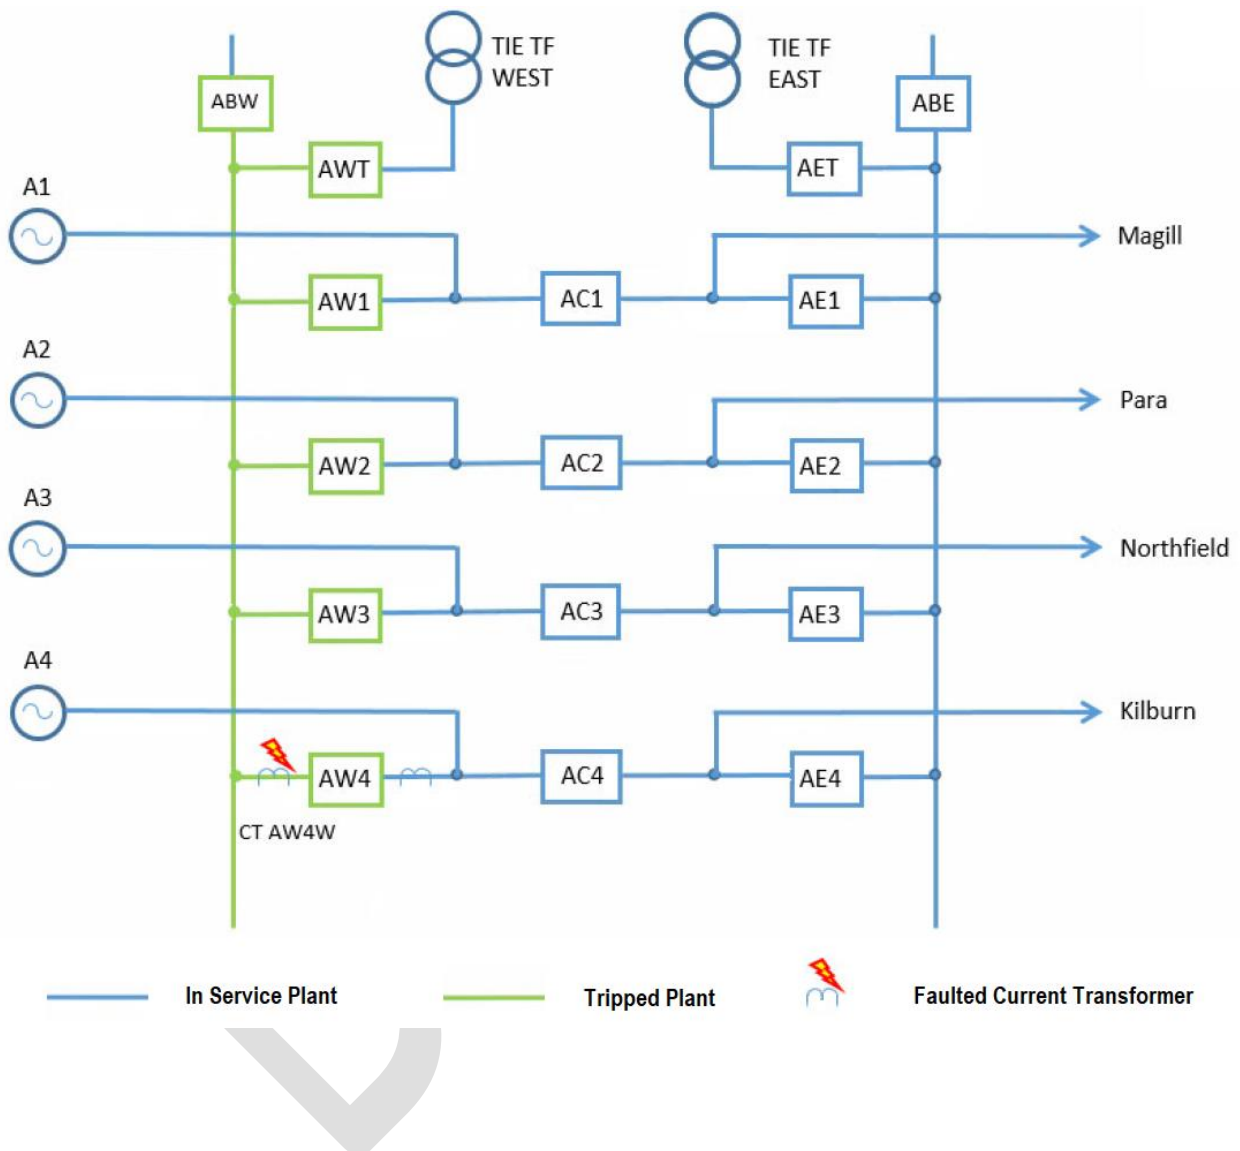
Figure 1 TIPS A 275 kV substation network configuration, post-incident.

Figure 1 in Appendix A2 shows the network configuration at TIPS A 275 kV substation following the trips of the TIPS A 275 kV West Bus. Investigation by ElectraNet determined that CBs AW1, AW2, AW3, AW4, and AWT had tripped at TIPS A 275 kV substation, with CB ABW tripping at TIPS B 275 kV substation. A sequence of events for the incident is provided in Table 1 of Appendix A1.

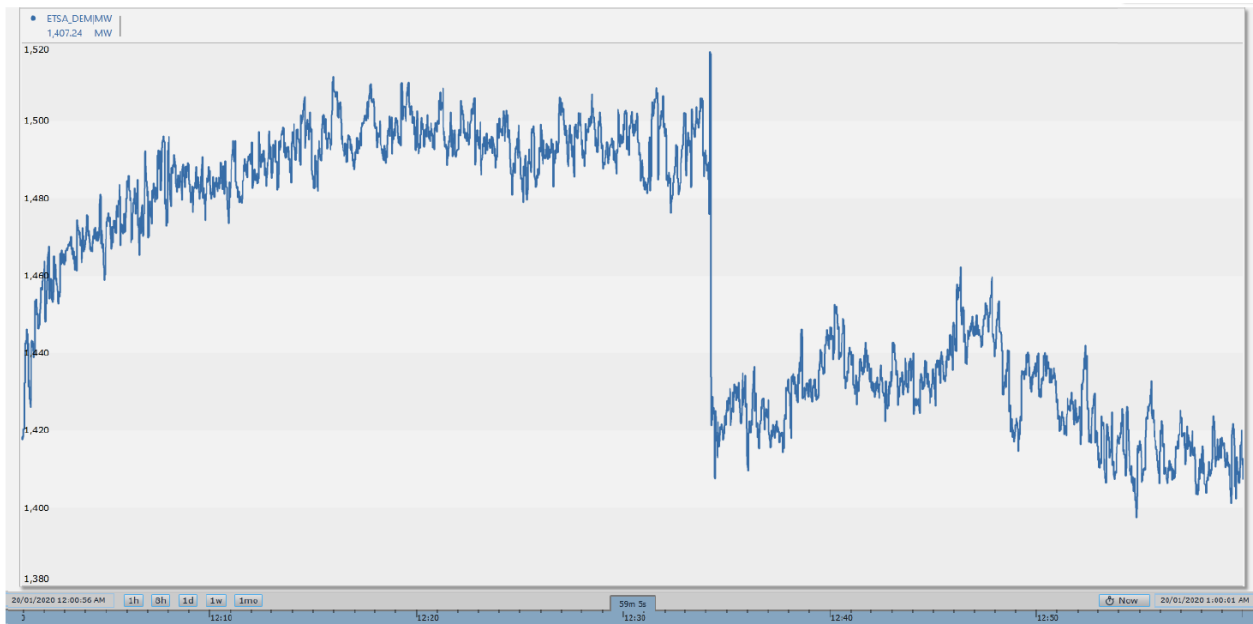
Figure 2 ElectraNet record of SA power network active power (MW) load during the incident.

ElectraNet records for 20 January 2020, following the tripping of the TIPS A West Bus, show a reduction of approximately 100 MW of load from SA Power Networks. ElectraNet reported this reduction was most likely due to the momentary voltage depression caused by the flashover fault at the TIPS A 275 kV substation.

Figure 2 in Appendix A3 shows the recorded power on the South Australian power network at the time of the incident, indicating a sharp drop in power levels at the time of the TIPS A 275 kV West Bus trip.

The chart below shows the recorded power on the SA power network at the time of the incident¹¹, indicating a sharp drop in the power levels at the time of the TIPS A 275 kV West Bus trip, equivalent to approximately 100 MW of customer load.
