Trip of Mount England – Wivenhoe 823 and 824 275 kV lines on 30 September 2020

January 2021

Reviewable Operating Incident Report under the National Electricity Rules

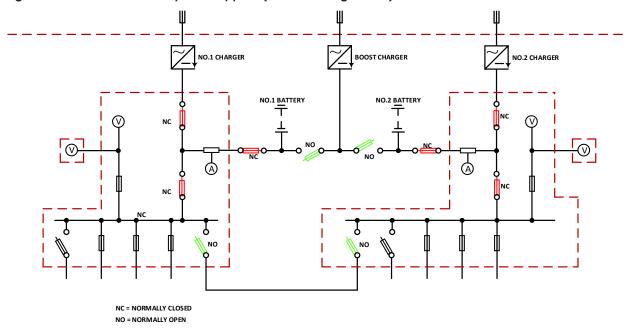
Figure 1 WPS 24V control system supplies (normal configuration)

This incident was caused by the loss of the 24 V control system supplies. The 24 V control system comprises two separate charger/battery systems with a spare or boost charger available to be connected to either of the systems as shown in Figure 1.

On 16 September 2020 the No. 2 charger failed, and the boost charger was connected to the No. 2 battery to maintain supply to the No. 2 24 V busbar.
