Trip of Liddell Unit 1 and 83 Line on 7 February 2020

July 2020

Reviewable Operating Incident Report under the
National Electricity Rules

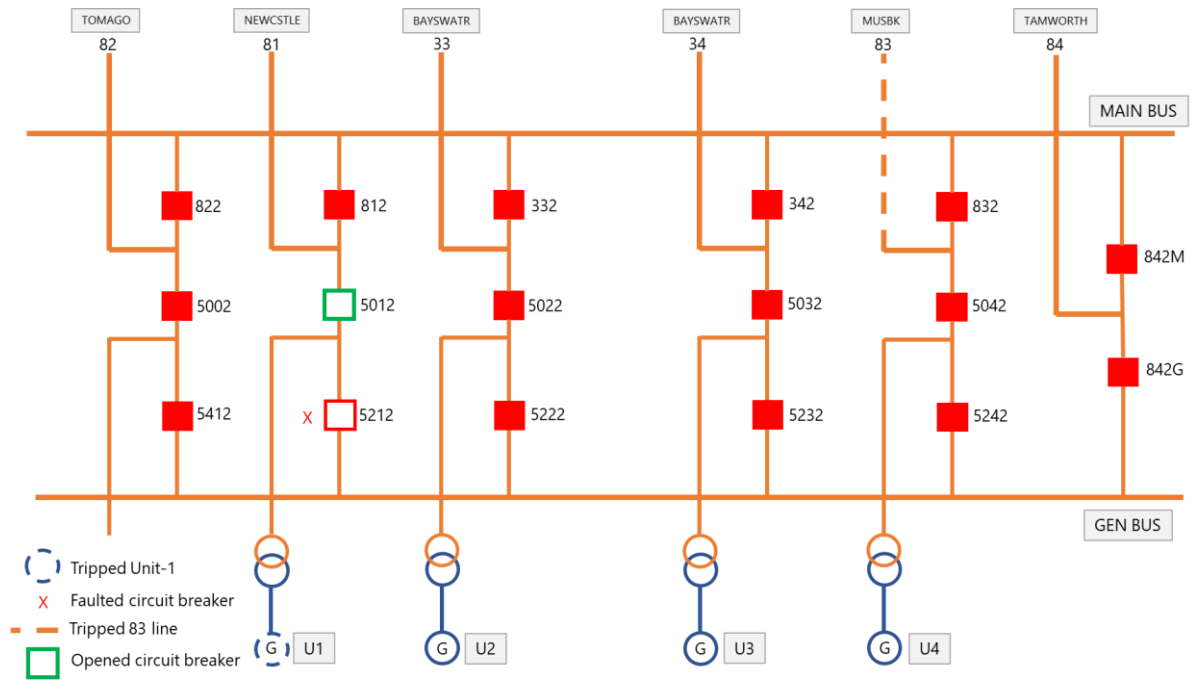
Figure 1 Simplified single line diagram of 330 kV Liddell substation

At 04:10:50 hrs on Friday 7 February 2020, Liddell Unit 1 tripped on pole discrepancy on CB 5212 during its synchronisation. Liddell Unit 1 was energised via the CB 5212, but it opened immediately. However, white phase of CB 5212 failed to open fully, resulting in tripping and reclosure of Liddell – Muswellbrook 83 line at the Muswellbrook end.

TransGrid confirmed that the cause of the trip of 83 line was the failure of white phase on CB 5212 to open fully, resulting in a partial (single-phase) fault that was seen by the 83 DEF and distance protection elements.

The diagram below provides an overview of part of the power system immediately after the incident .

TransGrid confirmed that Weak Infeed protection is designed to pick up low level earth faults that are very close to one end and cannot be seen from the other end. As 83 line is relatively short, this is an unlikely scenario, hence the Weak Infeed setting in the Liddell end of 83 Line Protection Scheme was disabled on 7 February 2020 to avoid any similar maloperation.
