Newport 220 kV Bus 1 and
Fishermans Bend 220/66 kV
Transformer B2 Trip on 14 May 2021

November 2021

Reviewable Operating Incident Report under the
National Electricity Rules

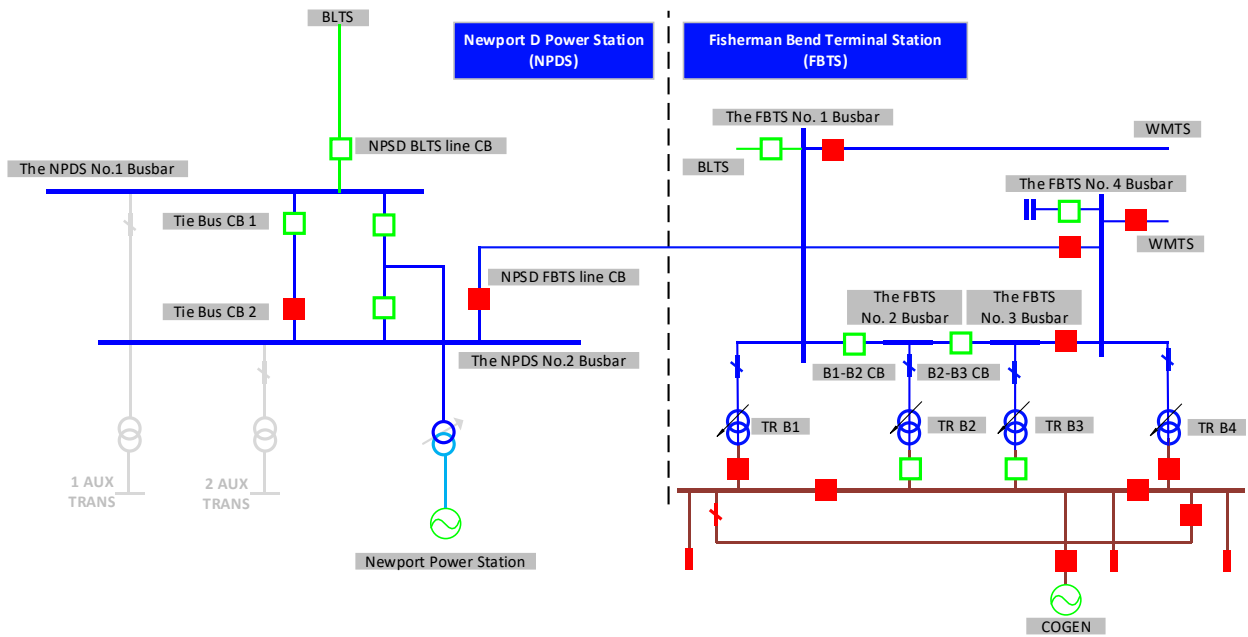
Figure 1 Configuration for NPDS and FBTS immediately after the incident

Incident cause	<ul style="list-style-type: none"> • Post-incident investigation by AusNet concluded that an internal arc fault in the white phase busbar chambers at NPSD⁴ occurred and triggered the X and Y high impedance busbar protection. • Coincident with the fault at NPSD at 1521 hrs, the FBTS B2 220/66 kV transformer Y REF protection operated for the fault at NPSD. This was not expected as the fault was outside the protection zone of the Y REF protection.
Power system response (facilities and services)	<p>Post incident investigation by AusNet has concluded that:</p> <ul style="list-style-type: none"> • The Y REF protection of the FBTS B2 220/66 kV transformer had the correct settings. • The cause of operation of the Y REF protection was linked to the current transformer (CT) of the B1-B2 CB, which was likely saturated before the REF protection operation. • The CT of the B2-B3 CB was not saturated for the same fault at NPSD. • The CT specifications were correct and the test results of both CTs were consistent. The saturation of CT of B1-B2 CB was likely caused by an uneven CT remanence⁵. • The FBTS B2 220/66 kV transformer X REF protection did not operate for the same fault at NPSD. <p>AusNet advised that during an equipment restoration process, if any equipment is identified as tripping due to a protection operation, the restoration process would stop, and the cause of trip investigated. However, during restoration of the NPSD No. 1 busbar, AusNet attempted restoration of the NPSD No. 1 busbar three separate times. Post incident investigation has confirmed that:</p> <ul style="list-style-type: none"> • When the first trip of the NPSD No. 1 busbar happened (Step 3, Incident key events), the AusNet controller did not notice SCADA alarms indicating the trip was initiated by protection operation. In addition, given that the NPSD No. 1 busbar remained energised for around 3 minutes and 36 seconds, from 1458 hrs to 1501 hrs, the controller incorrectly assumed that the NPSD – BLTS 220 kV line CB tripped mechanically. After testing the CBs operation (Step 4, Incident key events), a second attempt to restore the NPSD No. 1 busbar was made. As described earlier, if the SCADA alarms were noticed at Step 3, Incident key events, the restoration process would have stopped, and the cause of trip would be investigated. • After the first trip of the NPSD No. 1 busbar, the SCADA alarms reset while the protection relays had not been reset and their output signals remained active. The second trip of the NPSD No. 1 busbar happened immediately after the NPSD – BLTS 220 kV line CB was closed (Step 5, Incident key events) as the bus protection relay trip outputs were still active. There were no new SCADA alarms indicating a fault caused the trip of the NPSD – BLTS 220 kV line CB. • Therefore, a third attempt to restore the NPSD – BLTS 220 kV line CB was made. This resulted in simultaneous trip of the NPSD No. 1 busbar and the FBTS B2 220/66 kV transformer. At this point the AusNet controller

Details
	identified protection operation alarms in the SCADA system and ceased attempts to re-energise the affected equipment.
Rectification	To prevent the recurrence of this type of incident, the following actions were completed by AusNet: <ul style="list-style-type: none"> • The NPSD No. 1 busbar white phase chambers were replaced, and high voltage testing was carried out. • The FBTS B2 220/66 kV transformer Y REF protection setting was modified, as recommended by the relay manufacturer. • In order to raise awareness and prevent multiple attempts to restore equipment following protection operation, details of this incident have been discussed at AusNet's controller working group.
Power system security	The power system remained in a secure operating state throughout this incident.
Reclassification	AEMO assessed whether to reclassify this incident as a credible contingency event ⁶ . AusNet advised AEMO that the cause of the trip of the NPDS No. 1 busbar and the FBTS B2 220/66 kV transformer had been identified and the incident was unlikely to reoccur. Based on this advice, AEMO determined the incident was unlikely to reoccur and therefore correctly determined that reclassification as a credible contingency event was not required.
