Trip of Burnie No. 2 Transformer

September 2021

Reviewable Operating Incident Report under the
National Electricity Rules

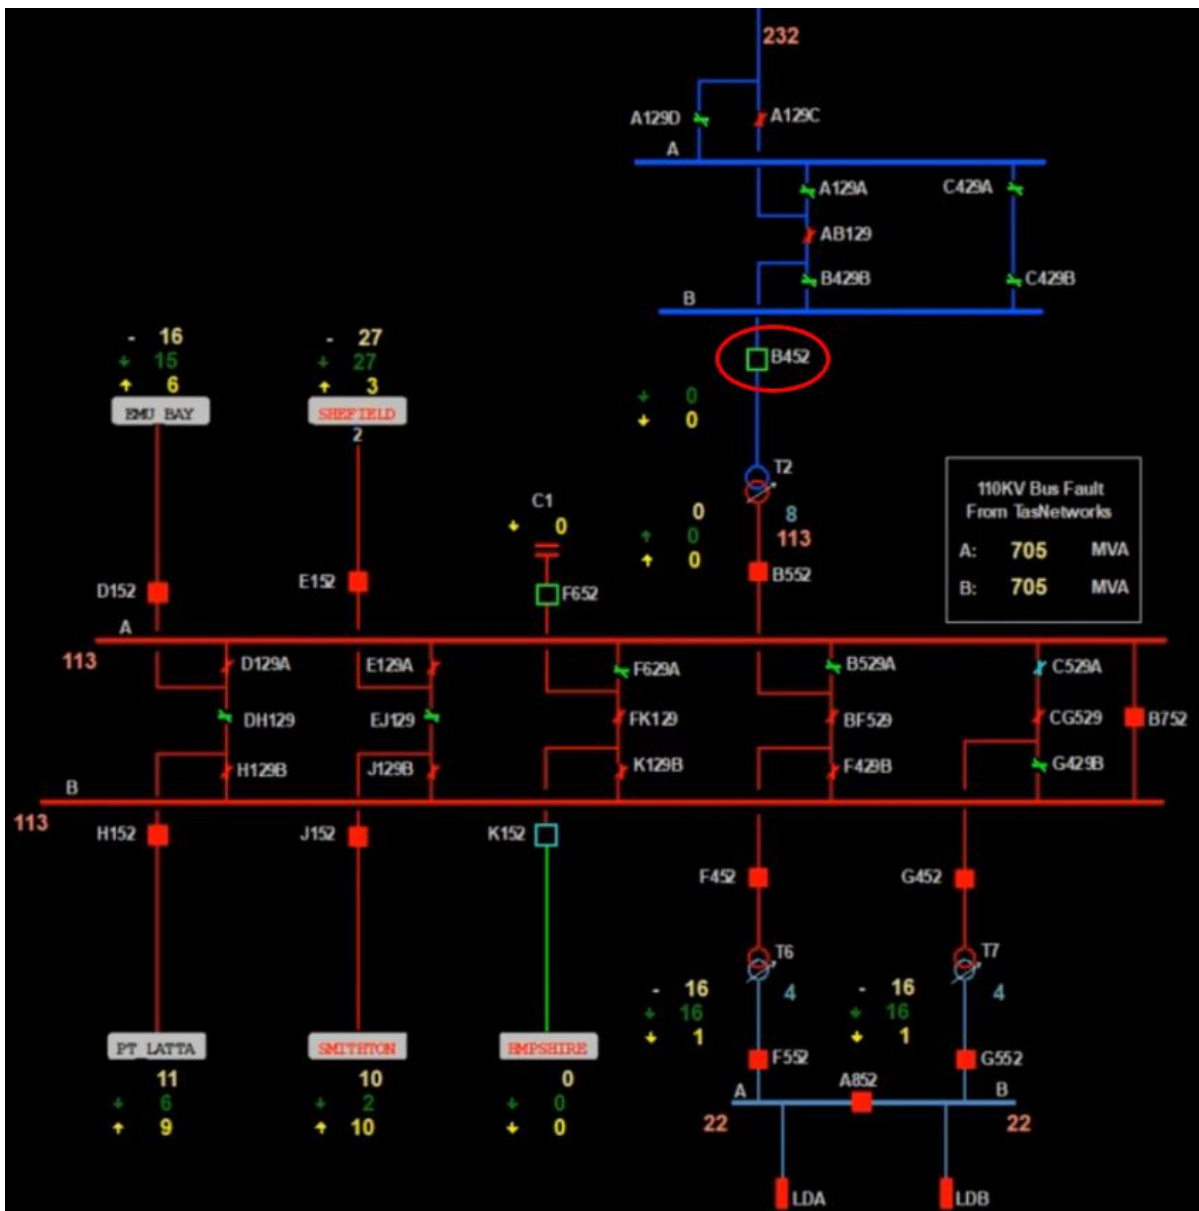
Figure 1 Incident diagram – System configuration immediately following the incident

Incident key events	<ol style="list-style-type: none"> At 1027 hrs on 12 May 2021: <ul style="list-style-type: none"> The B452 CB at Burnie was inadvertently operated. The protection schemes operated successfully to trip the B452 CB, de-energising the Burnie No.2 220/110 kV transformer on the 220 kV side only. At 1030 hrs on 12 May 2021, TasNetworks advised AEMO that the B452 CB was inadvertently operated during a planned protection outage at Burnie and that the event was unlikely to reoccur. The Burnie No. 2 220/100 kV transformer was successfully returned to service at 1034 hrs on 12 May 2021 through the manual close of the B452 CB. <p>Figure 1 shows the system conditions immediately after the incident.</p>
Incident cause	<p>TasNetworks confirmed to AEMO that:</p> <ul style="list-style-type: none"> At 1027 hrs on 12 May 2021, staff onsite inadvertently tripped the B452 CB during the planned protection outage of the Burnie A 110 kV bus. At the time of the incident, staff were performing in-service isolations within the 110 kV Bus Zone Protection Panel. The trip was caused by one of the technicians creating a short circuit via an insulated screwdriver between the Trip Pos Bus and the B452 CB trip link when they were isolating the B452 trip circuit as per TasNetworks' procedure. The control wiring configuration and trip location is shown in Figure 2.

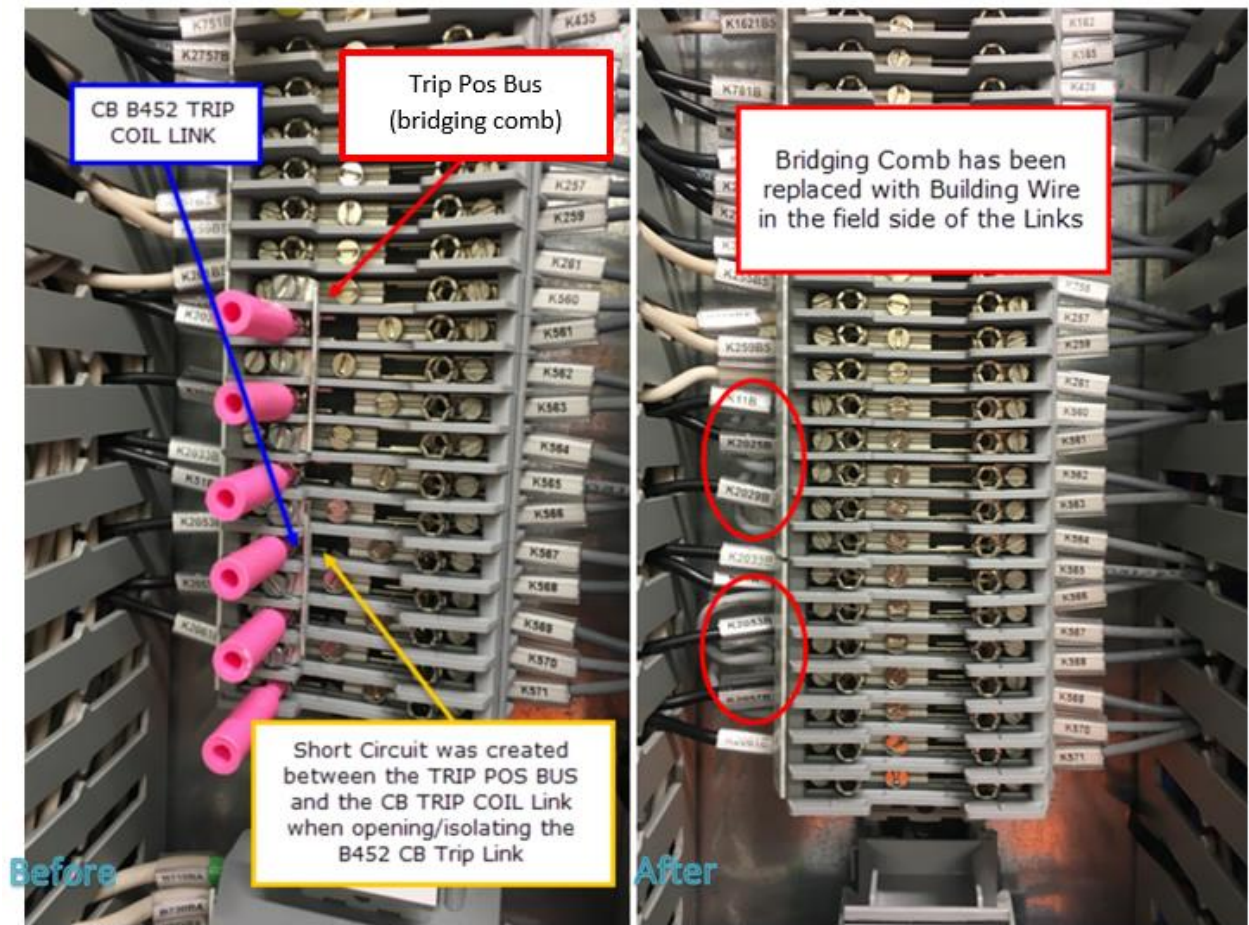
Figure 2 Incident diagram – B452 circuit breaker control wiring before and after replacement of bridging comb

Details
	<ul style="list-style-type: none"> The B452 CB was the only CB within the 110 kV Bus Panel wired using a Trip Pos Bridging Comb mounted on top of the URTK/S links (the proximity of the Trip Pos Bridging Comb to the URTK/s links increases the risk of incidents like this occurring).
Power system response (facilities and services)	The protection systems operated as designed and successfully tripped the B452 CB.
Rectification	Immediately following this incident, the Trip Pos Bus bridging combs were replaced with building wire during the isolation. This removes the risk of future inadvertent tripping of the B452 CB due to the bridging combs being in the location of isolation. The control wiring configuration after the replacement of the bridging combs is shown in Figure 2.
Power system security	The power system remained in a secure operating state throughout this incident and the Frequency Operating Standards ⁴ was met for this incident.

Recommendations	AEMO recommends that TasNetworks replaces any bridging combs mounted on top of URTK/S links to reduce potential for inadvertent tripping at other sites.
