Trip of multiple transmission elements at Davenport 275 kV substation

March 2022

Reviewable Operating Incident Report under the National Electricity Rules

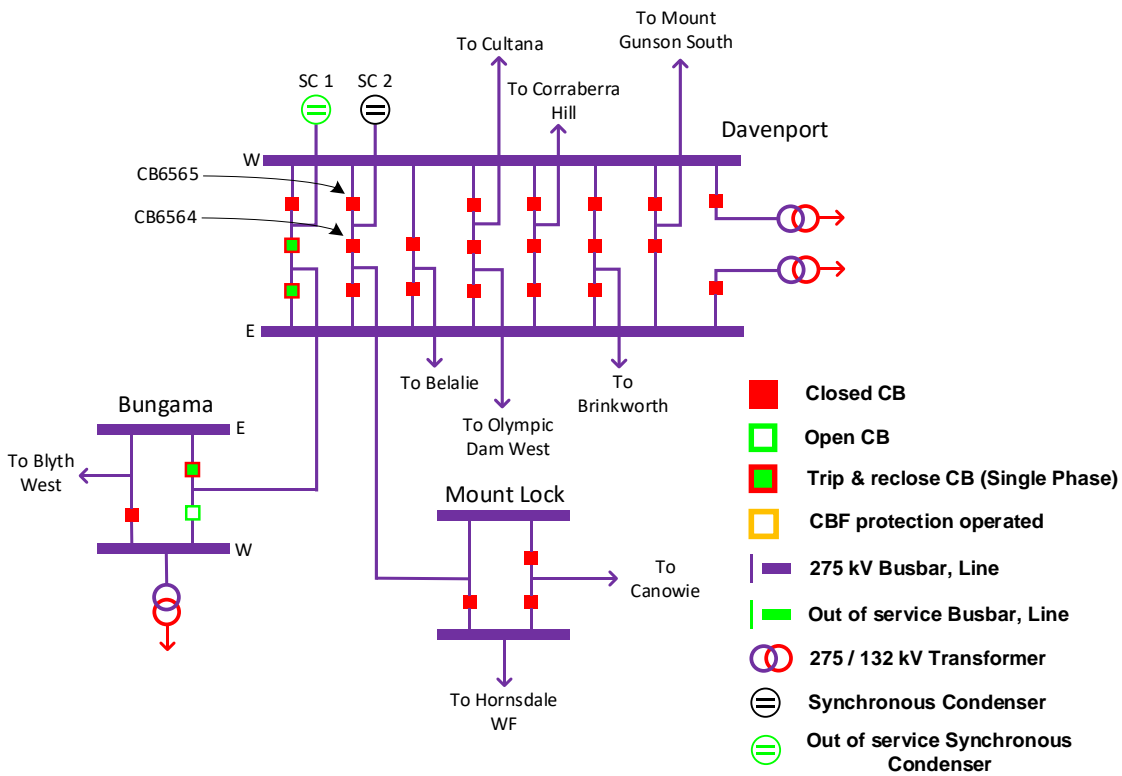
Figure 1 Incident diagram prior to CBF protection operation

Incident key events	<ol style="list-style-type: none"> At 1555 hrs on 28 September 2021, a lightning strike caused a U phase fault on the Bungama – Davenport 275 kV line. The fault was cleared within 61 ms. Subsequently (between 196 ms and 227 ms after the fault was cleared) the following elements tripped: <ul style="list-style-type: none"> The Davenport 275 kV West Bus. The Davenport No. 2 Synchronous Condenser. The Davenport – Mount Lock 275 kV line. At 1730 hrs on 28 September 2021, the Davenport 275 kV West Bus and the Davenport – Mount Lock 275 kV line were returned to service. At 2025 hrs on 28 September 2021, ElectraNet advised the cause of the incident had been identified and isolated and was unlikely to reoccur. At 2031 hrs on 28 September 2021, the Davenport No. 2 Synchronous Condenser was returned to service.
Incident cause	<p>Post incident investigation by ElectraNet has confirmed that:</p> <ul style="list-style-type: none"> The Bungama – Davenport 275 kV line distance and differential protection systems operated correctly clearing the fault caused by the lightning strike within 61 ms. Subsequently, Circuit Breaker Fail (CBF) protection on circuit breakers CB6564 and CB6565 operated unexpectedly (see Figure 1). This CBF protection operation tripped the Davenport 275 kV West Bus, the Davenport – Mt Lock 275 kV line and the Davenport No. 2 Synchronous Condenser (see Figure 2). At the time of the fault, the Davenport No. 2 Synchronous Condenser was in service and supplied approximately 1,000 A into the single-phase fault on the Bungama – Davenport 275 kV line. The resultant fault current caused an overload element to unexpectedly pickup in the Set 2 Davenport No. 2 Synchronous Condenser Generator Step-Up Transformer (GSUT) protection system. This transient overload element pickup caused the CBF protection on both CB6564 and CB6565 to erroneously pick up even though no trip signal had been sent to these circuit breakers.

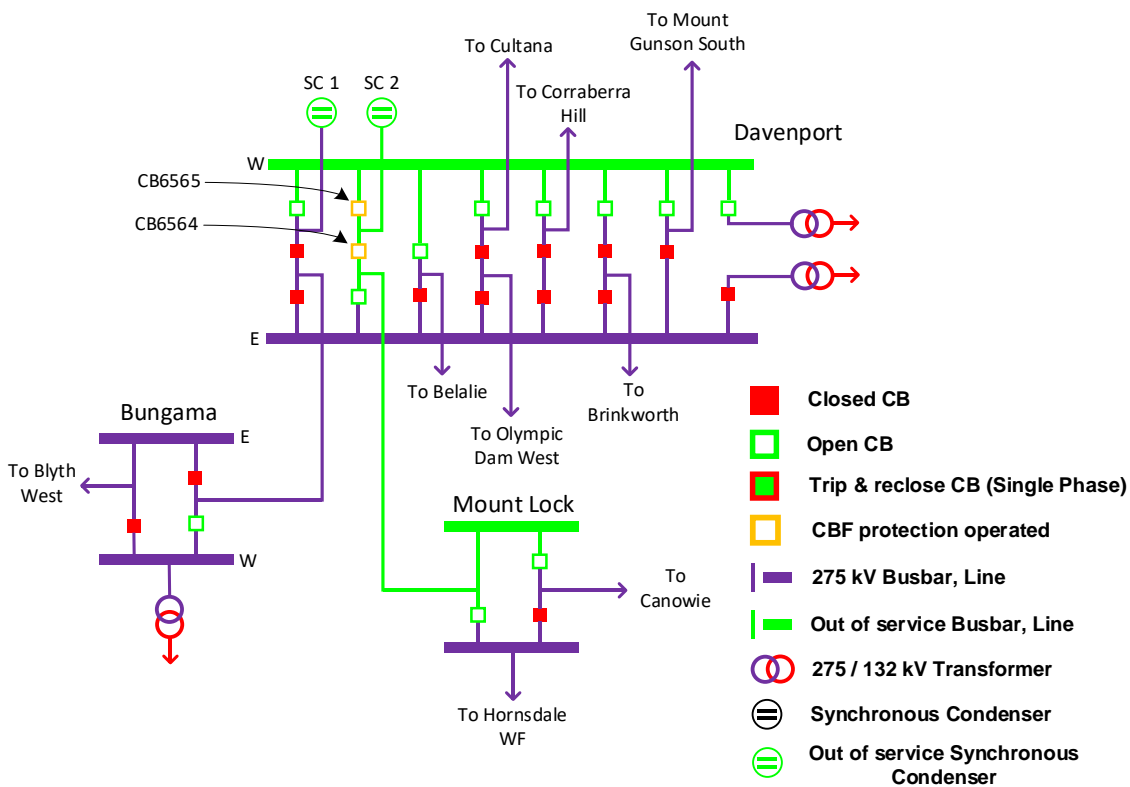
Figure 2 Post-incident diagram

Conclusions	<p>AEMO has concluded that:</p> <ol style="list-style-type: none"> 1. The single-phase fault on the Bungama – Davenport 275 kV line was caused by a lightning strike. The protection systems associated with this line operated correctly and cleared the fault. 2. The simultaneous trip of the Davenport 275 kV West Bus, the Davenport No. 2 Synchronous Condenser, and the Davenport – Mount Lock 275 kV line was caused by an incorrect operation of CBF protection due to an overload element pickup on the Davenport No. 2 Synchronous Condenser's GSUT Set 2 protection. 3. AEMO correctly identified the need to reclassify this incident as a credible contingency until the cause of the incident had been identified and isolated. 4. The power system remained in a secure operating state throughout this incident. 5. ElectraNet has confirmed that this issue is not present at the Robertstown Synchronous Condensers. 6. ElectraNet is reviewing the standard logic for this protection implementation to avoid similar issues in future protection systems that use the same logic. This review is expected to be completed in Q2 2022.

Details	
Power system response (facilities and services)	There were no other material impacts on the broader power system, load or generation.
Rectification	<p>At 1920 hrs on 28 September 2021, ElectraNet disabled the overload protection in Davenport No. 2 Synchronous Condenser's GSUT Set 2 protection. Overload protection systems with identical settings have also been disabled at Davenport No. 1 Synchronous Condenser and Yadnarie Transformer 1.</p> <p>ElectraNet has confirmed that:</p> <ul style="list-style-type: none"> • All protection systems with overload protection settings identical to the Davenport No.2 Synchronous Condenser have been disabled. • ElectraNet is reviewing the standard logic for this protection implementation to avoid similar issues in future protection systems that use the same logic. Until the review is complete, the overload protection for the Davenport Synchronous Condensers will be provided by their respective GSUT Set 1 protection systems. ElectraNet's review is expected to be completed in Q2 2022. • The Robertstown Synchronous Condensers' GSUT have different protection relays and protection settings to those used on the Davenport Synchronous Condensers. Therefore, the Robertstown Synchronous Condensers are not impacted by the settings issue identified by ElectraNet during this incident.
