Trip of Rowville Terminal Station – Yallourn Power Station No. 8 220 kV line

June 2022

Reviewable Operating Incident
Report under the National
Electricity Rules

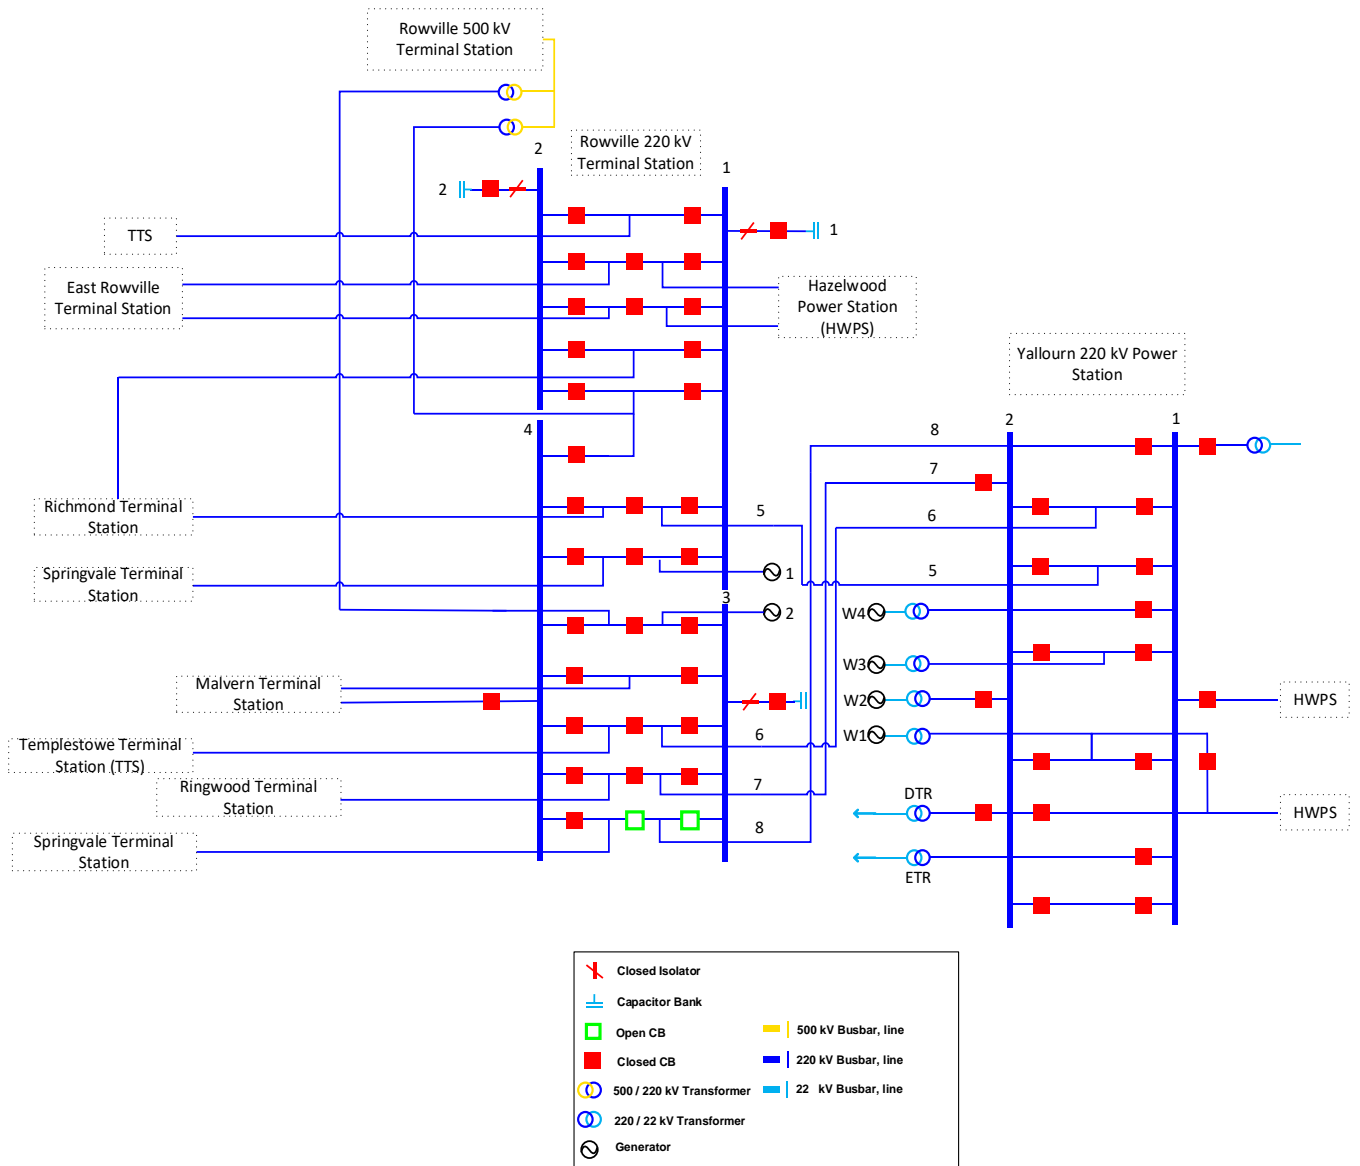
Figure 1 Incident diagram – Post-incident diagram (all elements were in service prior to the incident)

Details	
Reviewable operating incident type	Non-credible contingency events impacting critical transmission elements.
Incident details	This report relates to reviewable operating incidents ³ that occurred on 30 December 2021 and 6 January 2022 in Victoria. Both incidents involved the trip of the Rowville Terminal Station (ROTS) – Yallourn Power Station (YPS) No. 8 220 kV line at the ROTs end only.
Incident classification	Protection/control system – protection system maloperation.
Generation impact	Nil
Customer load impact	Nil
Incident key events	<p>Incident number 1 – 30 December 2021:</p> <ol style="list-style-type: none"> At 2055 hrs on 30 December 2021 the ROTs-YPS No. 8 220 kV line tripped at the ROTs end only (see Figure 1). At 2056 hrs on 30 December 2021, AusNet closed the open Circuit Breakers (CBs) at ROTs. At 2057 hrs the ROTs-YPS No. 8 line tripped at both ends and remained out of service. At 0000 hrs on 31 December 2021, AusNet advised AEMO that the circuit trip was due to a malfunction of the Set X protection due to a faulty communications card at ROTs. At 0152 hrs on 31 December 2021, the ROTs-YPS No. 8 220 kV line was returned to service. At 0216 hrs on 31 December 2021, AusNet confirmed to AEMO that the communications card at ROTs had been replaced and the event was unlikely to re-occur. <p>Incident number 2 – 6 January 2022:</p> <ol style="list-style-type: none"> At 2042 hrs on 6 January 2022, a single ended trip of the ROTs-YPS No. 8 220 kV line re-occurred, tripping at the ROTs end only (see Figure 1). At 2044 hrs on 6 January 2022, AusNet closed the open CBs at ROTs putting the ROTs-YPS No. 8 220 kV line back on load.

Incident cause	Post-incident investigation confirmed that both incidents were caused by maloperation of distance protection. In both incidents, this was due to communication disturbances, which led to a loss of synchronism between protection relays at both ends on the line. However, in both incidents this asynchronism caused only the relay at ROTs end to trip. The root cause of the communication disturbances was not identified upon AusNet's investigation.
Power system response (facilities and services)	There were no other material impacts on the broader power system, load or generation.
Rectification	Following the first incident on 31 December 2021, as a precaution AusNet replaced the communication card for the ROTs-YPS No. 5, 6, 7 and, 8. However, the incident re-occurred on 6 January 2022 and AusNet identified further rectifications as outlined below:

Details	
	<ul style="list-style-type: none"> AusNet has modified the distance protection settings in the affected L90 relays on the ROTS-YPS 220 kV lines to desensitise the distance protection for similar communication disturbances. These protection setting changes include increasing current supervision for distance protection and addition of an interlock current differential trip with disturbance detector. Given these changes, AusNet has advised the incident is unlikely to re-occur. The relay manufacturer has confirmed that for the L90 Line Differential relays involved in both incidents to operate, there needs to be inter-relay communication between the devices located at each line end. Following the communication disturbance, the relay devices were required to synchronise in order to return the Line Differential element back to normal operation. The synchronisation process caused the sampling frequency to deviate from the system frequency significantly and led to the maloperation of the distance element in both incidents as voltage memory was used for distance polarisation. In addition, the relay manufacturer confirmed that a firmware update is available for the L90 relay which will prevent protection maloperation for similar communication issues in the future. AusNet has only experienced this issue on L90 relays and has advised that this is unlikely to be a widespread issue at this time. AusNet believes that specific communication disturbances can cause the maloperation of the distance protection in all versions of the L90 relays which are using older firmware. AusNet is unable to identify the root cause of the communication disturbance experienced during this incident.
