Buronga 220 kV isolator failure and trip of multiple transmission elements on 25 July 2022

May 2023

Reviewable Operating Incident
Report under the National
Electricity Rules

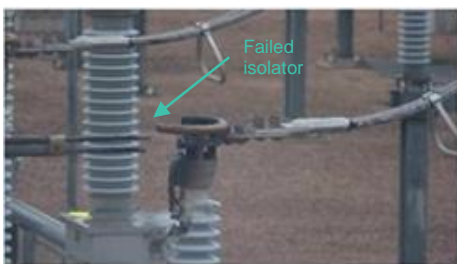
Figure 1 Isolator X31 at Buronga 220 kV substation after the incident

The initial trip of the Buronga 220 kV busbar was caused by the failure of the Buronga – Balranald 220 kV transmission line (X3) isolator X31 (see Figure 1) on the line side of the blue phase. Transgrid has advised that there is insufficient physical evidence left from the isolator to test. Based on the available information, Transgrid concluded isolator X31 most likely failed as it had not locked into place correctly when it was last closed approximately eight months prior. Over time the isolator contacts heated to a point where contact pressure was lost and created a feedback loop where loss of contact pressure created more heat causing further contact pressure loss, and at this point, minor arcing contributed to contact tip erosion, thermal runaway and ultimately isolator failure. This is the only known failure of this type on the Transgrid network, and consequently no trends exist based on isolator manufacturer, design, maintenance, or condition. As such there are no other assets that Transgrid believes are currently at risk of similar failure.

As isolator X31 was located within the Buronga 220 kV busbar protection zone, the protection operated as expected and tripped the Buronga 220 kV busbar to clear the fault (see Section 2.3.2).

The cause of this incident was identified, and the faulty isolator was bypassed prior to the Buronga – Balranald 220 kV transmission line's (X3's) return to service. Transgrid advised that protection systems in New South Wales operated as designed and there were no similar issues on remaining isolators at Buronga or Balranald. AEMO was satisfied that another occurrence of this event was unlikely under the current circumstances. Therefore, AEMO correctly identified that reclassification was not required.

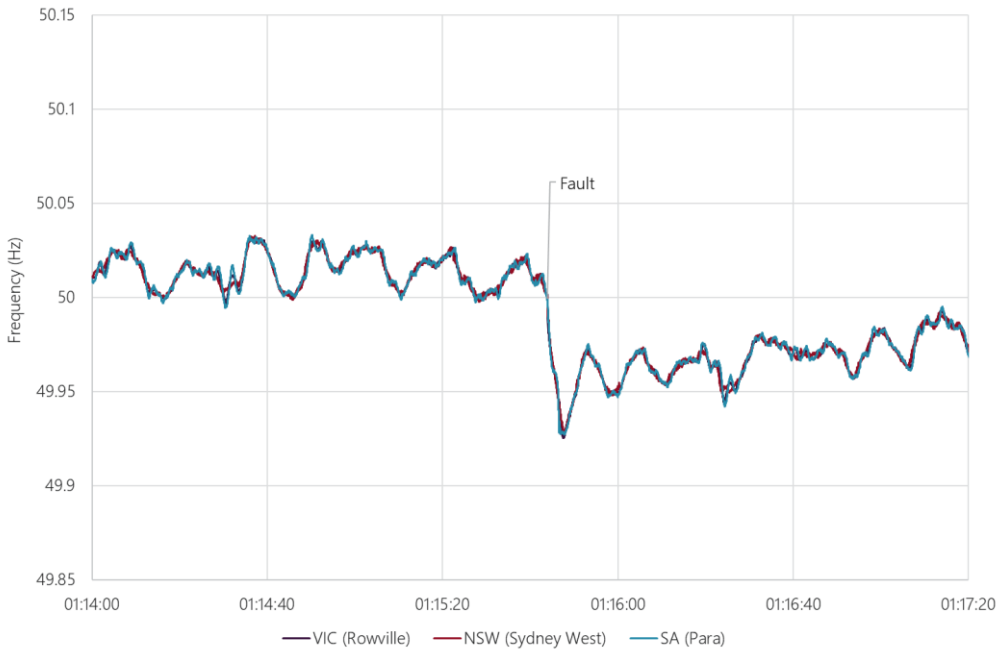
Figure 2 Power system frequency on 25 July 2022

As shown below in Figure 2, as a result of the non-credible contingency at 0115 hrs, the system frequency reached a minimum of 49.925 hertz (Hz). The frequency did not leave the normal operating frequency band throughout the incident. The power system remained in a secure operating state throughout this incident and the Frequency Operating Standard (FOS)⁸ was met for this incident.

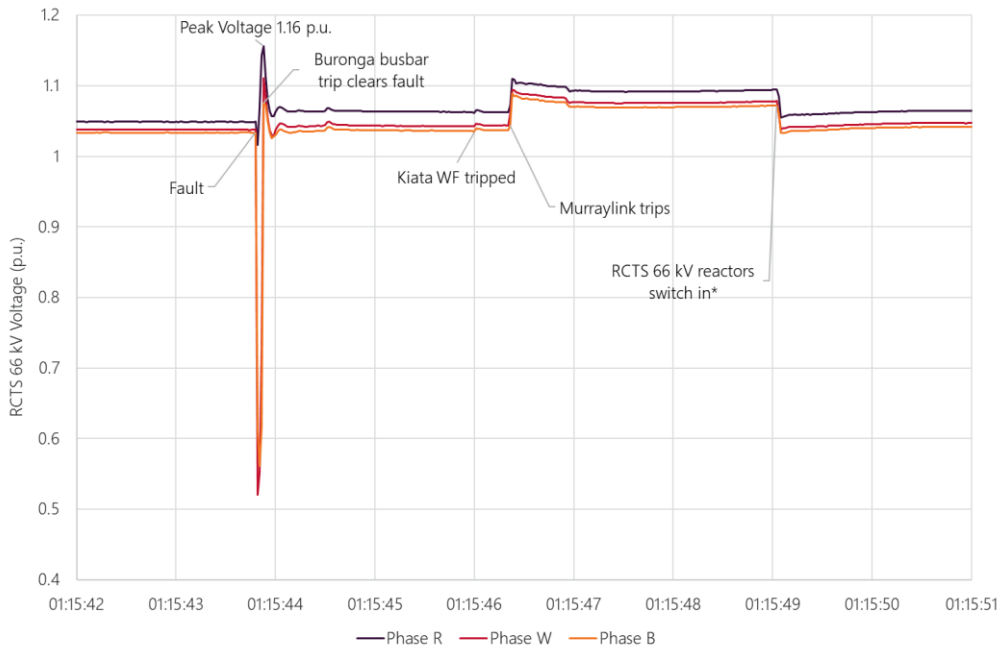
Figure 3 Voltage at RCTS 66 kV busbar on 25 July 2022 – high speed monitor data

At no point during this incident were transmission system voltages outside of relevant voltage limits defined in the NER, or specified by NSPs in their limits advice to AEMO. Figure 3 shows the voltage at RCTS 66 kV as recorded by high speed monitoring. It can be seen that voltage increased following trip of Murraylink, and reduced following subsequent automatic voltage control switching of RCTS 66 kV reactor No. 1 and No. 2.

* Supervisory control and data acquisition (SCADA) on the CBs at RCTS recorded that RCTS 66 kV 15 MVar reactor No. 2 switched in at 01:15:52 and RCTS 66 kV 15 MVar reactor No. 1 switched in at 01:15:54. Based on the high speed monitor data, AEMO has concluded that both reactors switched in at 01:15:49.

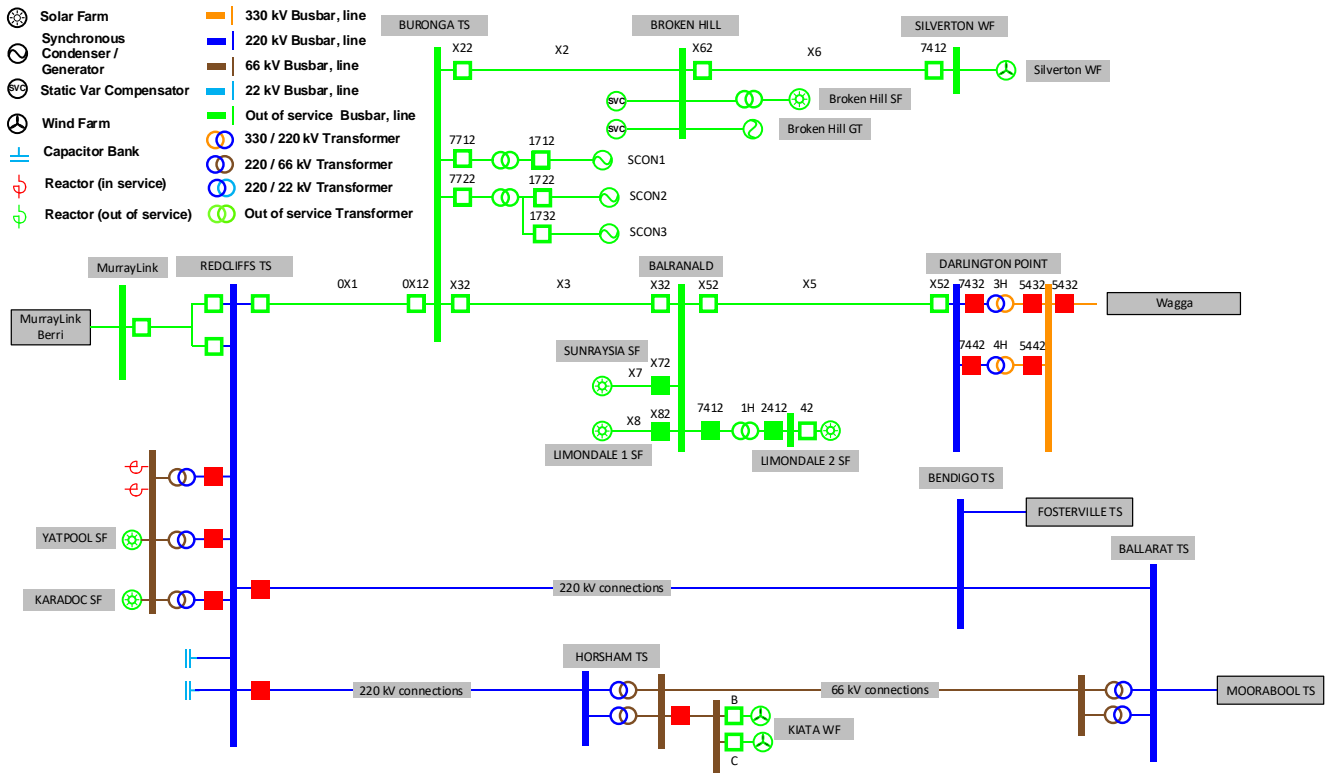
Figure 5 Post-incident diagram

At 0115 hrs on 25 July 2022, the X31 isolator at Buronga substation failed, resulting in a 220 kV phase to ground fault on blue phase. Based on the location of the isolator, the Buronga 220 kV busbar tripped, disconnecting 220 kV lines from Buronga to Red Cliffs, Balranald and Broken Hill, and as a result initiated a number of control schemes and subsequent line trips in south-western New South Wales and north-western Victoria as well as the trip of Kiata WF. A total of 40 MW of load was disconnected at Balranald, Broken Hill, Buronga and Silverton substations. Table 4 contains the sequence of events and the network restoration process. A diagram of the post-incident network configuration is shown in Figure 5 of Appendix A1.
