Power System Oscillations in South Australia on 23 June 2022

February 2023

Reviewable Operating Incident
Report under the National
Electricity Rules

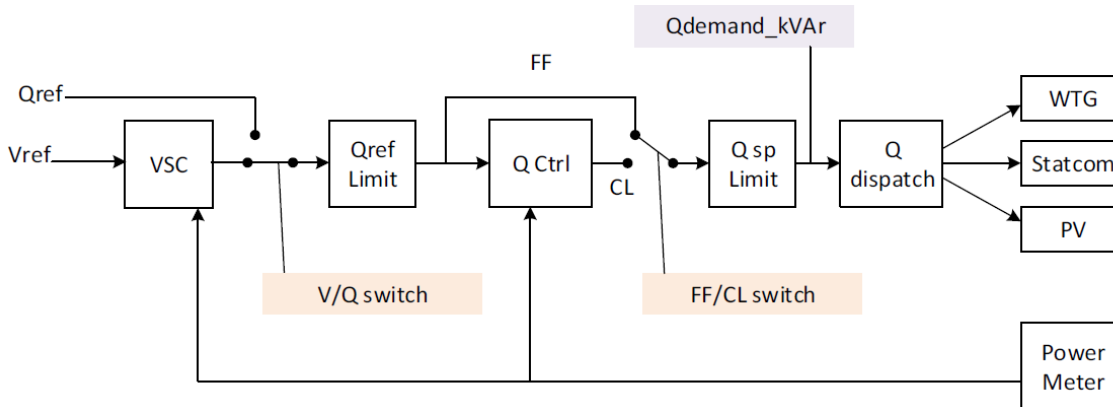
Figure 1 High level voltage and reactive power control block diagram of PAREP's park controller

To ensure predictable and stable operation during the test, the outer control loop was changed from voltage control 'Vref' to reactive power control 'Qref' and the generator control system's inner reactive power control loop was bypassed by setting it to feed forward 'FF' mode. The communication fail-safe test was completed at approximately 2000 hrs on 22 June 2022. The control system code that was introduced by the wind turbine OEM staff during the communication fail-safe testing was incorrect, because it was missing the functionality to revert the control system automatically to its normal operating mode. Following the completion of the test, the logic in the code, due to the error, did not revert the inner control loop to closed loop 'CL' reactive power control but continued

to remain in feed forward 'FF' configuration with outer control loop being returned to voltage control 'Vref' (see Figure 1).

The control system code that was introduced by wind turbine OEM staff during the communication fail-safe testing was incorrect, because it was missing the functionality to revert the inner control loop from feed forward 'FF' control mode to closed loop 'CL' reactive power control for normal operation. Therefore, once the communication fail-safe testing was completed, the outer-control loop was returned to voltage control, but the inner reactive power control loop was incorrectly left in feed forward 'FF' mode. This control configuration led to instability due to the absence of closed loop 'CL' reactive power control in the inner control loop.

Following the incident, PAREP's control system code was corrected to ensure the inner control loop is changed to closed loop mode once the communication is restored, and it is safe to restart the wind turbine generators.

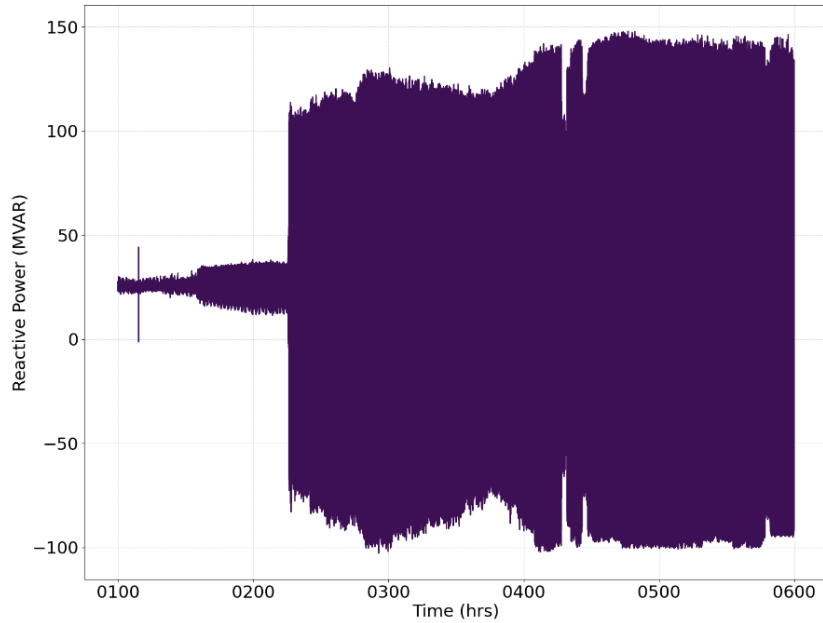
Figure 2 Reactive power at the PoC of PAREP

Post incident analysis shows that around 0109 hrs on 23 June 2022, a disturbance was seen on the PAREP PoC. Prior to the incident, the reactive power output and voltage at PAREP PoC was around 26.5 MVar and 1.037 per unit (p.u.), respectively.

The reactive power and voltage at the PoC of PAREP are shown in Figure 2 and Figure 3 respectively. Following this disturbance, small but gradually increasing oscillations are seen in the reactive power (Figure 2) and voltage (Figure 3).

These oscillations persisted for almost five hours until ElectraNet opened the CBs at Davenport to disconnect PAREP. During this time period, a maximum peak-to-peak magnitude oscillation of 247 MVar in reactive power output and 0.077 p.u. in PoC voltage was recorded.

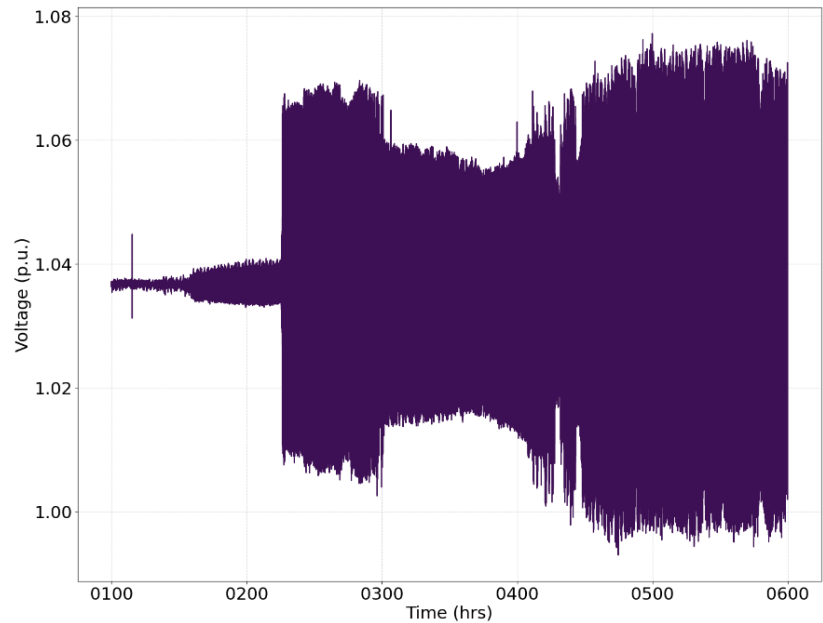
Figure 3 Voltage at the PoC of PAREP

- At no point during this incident were transmission system voltages outside of relevant voltage limits (to confirm, the voltage at PAREP PoC oscillated between 0.992 p.u. and 1.077 p.u. during the incident).

- Voltage and reactive power oscillations persisted for almost five hours with a maximum measured peak-to-peak voltage magnitude of 0.077 p.u. at PAREP PoC.

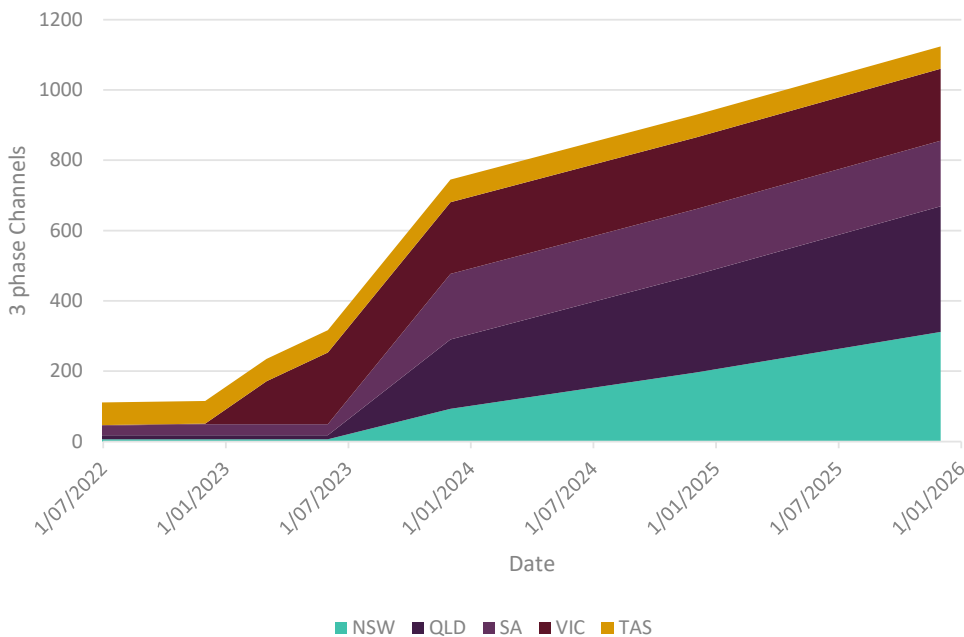
Figure 4 Planned NEM HSM monitor installations

During this incident, ElectraNet and AEMO were not aware of the voltage and reactive power oscillations until customers (including major industrial customers) and SAPN contacted ElectraNet. At present, AEMO has no automated reporting or alarming capabilities to monitor power system stability issues arising from control interactions between IBR. AEMO is working with TNSPs to improve high speed monitoring capabilities and implement tools to provide operators with visibility in real time. The project is being co-ordinated as part of AEMO’s Operations Technology Roadmap¹⁴ to uplift operational capability and help manage system security in the context of a power system increasingly dominated by IBR. Figure 4 presents the total number of high-speed monitor channels¹⁵ planned for installation as part of this project and, when they are expected to become available.

As part of the same project, there are plans to develop operational tools (including alarms and dashboards) to improve operator visibility of system oscillations. These tools will help operators identify the source of oscillations
