# Trip of Bulli Creek – Braemar and Bulli Creek – Dumaresq 330 kV Lines on 5 November 2022

May 2023

Reviewable Operating Incident  
Report under the National  
Electricity Rules

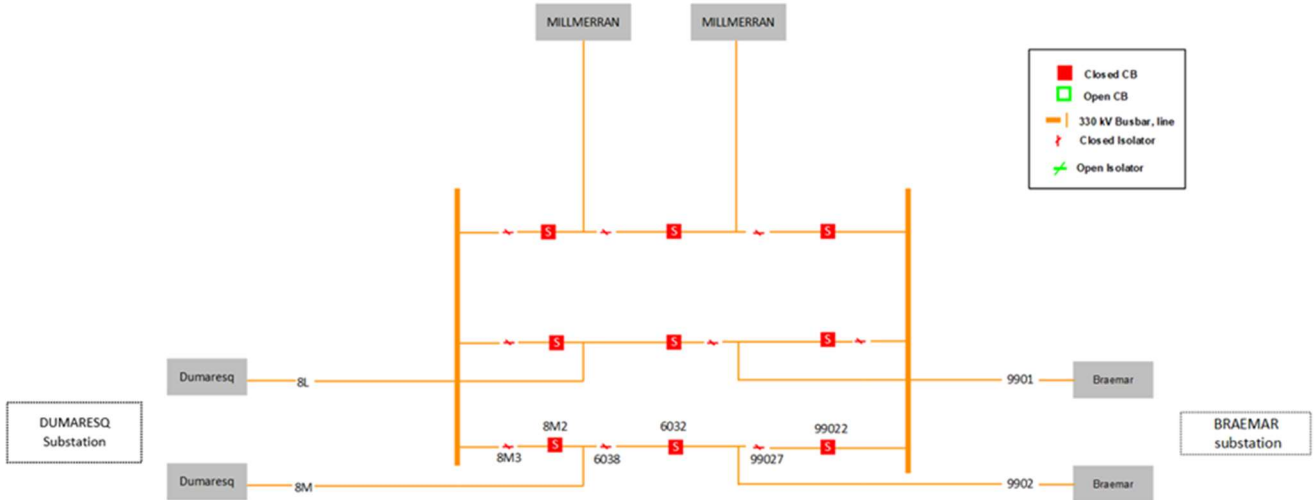
Figure 1 Pre-incident diagram (Bulli Creek)

Details	
<b>Reviewable operating incident type</b>	Multiple contingency events impacting critical transmission elements that occurred within 30 minutes of each other.
<b>Incident details</b>	This report relates to a reviewable operating incident <sup>3</sup> that occurred on 5 November 2022 in Queensland. This incident involved the trip of the Bulli Creek – Braemar 330 kilovolt (kV) line (9902 Line), shortly followed by the trip of the Bulli Creek – Dumaresq 330 kV line (8M Line).
<b>Incident classification</b>	Protection/control system maloperation – intermittent fault with a current transformer sensor.
<b>Generation impact</b>	No generation was lost as a result of this event.
<b>Customer load impact</b>	No customer load was tripped or automatically shed in response to this incident.
<b>Pre-incident conditions</b>	Prior to the event, all 330 kV lines between Bulli Creek, Braemar and Dumaresq were in service (see Figure 1).

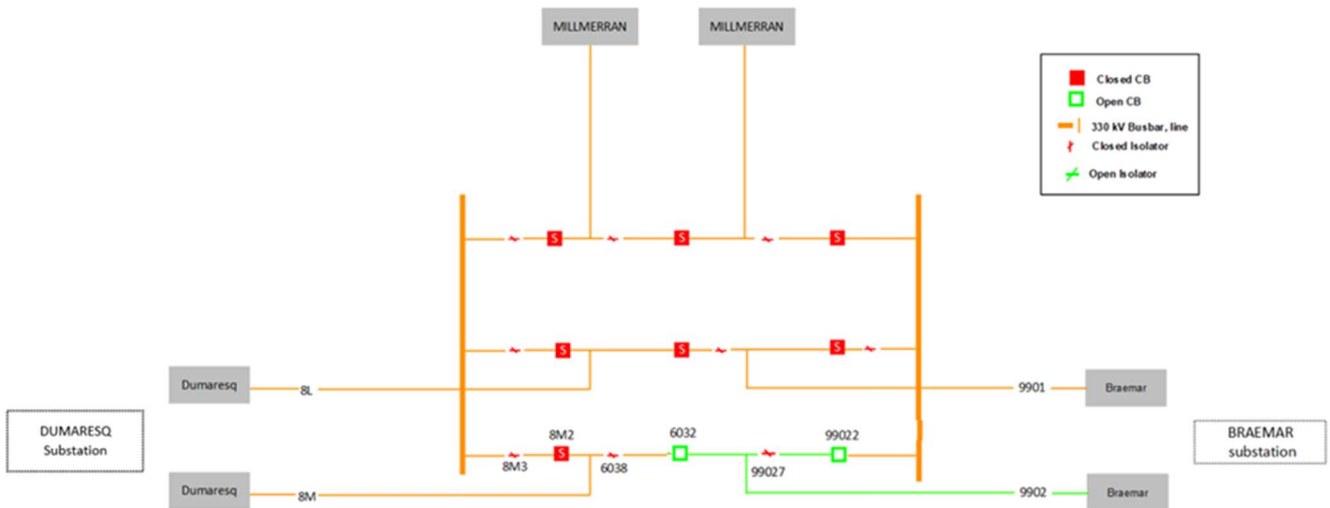
Figure 2 Post-incident diagram (Bulli Creek) Trip of 9902 Line

<b>Incident key events</b>	On 5 November 2022, the following events occurred: <ul style="list-style-type: none"> <li>At 0651 hrs on the 9902 Line tripped, auto reclosed and tripped to lockout<sup>4</sup>.</li> <li>At 0659 hrs the 8M Line tripped. There was no auto reclose operation associated with the 8M Line.</li> <li>At 0921 hrs the 8M Line was returned to service.</li> <li>At 1511 hrs the 9902 Line X protection was isolated.</li> <li>At 1528 hrs the 9902 Line was returned to service.</li> </ul>
<b>Incident cause</b>	Post incident investigation by Powerlink has confirmed: <ul style="list-style-type: none"> <li>At 0651 hrs on 5 November 2022, the X differential protection of the 9902 Line unexpectedly operated due to an incorrect output from a faulty current transformer sensor on the 330 kV circuit breaker (CB6032) at Bulli Creek. This X differential protection operation tripped the 9902 Line (see Figure 2).</li> <li>At 0659 hrs, the CB6032 Circuit Breaker Fail (CBF) protection system unexpectedly operated to trip the 330 kV circuit breaker 8M2 at Bulli Creek and initiated an inter-trip to the Dumaresq 330 kV substation. Once triggered, the CBF protection operated as designed to trip 330 kV circuit breakers 8M2 and 5012 and disconnect the 8M Line (see Figure 3).</li> <li>The X differential protection and the CBF protection for CB6032 use the output from same faulty CB3602 current transformer sensor. Powerlink's investigation concluded that the faulty current transformer sensor output continued for a duration of time sufficient to cause the CBF protection of CB6032 to operate despite no primary current flow through the open circuit breaker.</li> </ul>

<b>Conclusions</b>	<p>AEMO has concluded that:</p> <ol style="list-style-type: none"> <li>1. On 5 November 2022, the 9902 Bulli Creek - Braemar 330 kV line (9902 Line) tripped due to the unexpected operation of its X differential protection. This protection operated due to a faulty current transformer sensor on the 330 kV circuit breaker CB6032 at Bulli Creek 330 kV substation. The faulty current transformer sensor then caused the CB6032 CBF protection to unexpectedly operate, causing the Bulli Creek - Dumaresq 330 kV line (8M Line) to trip.</li> <li>2. The cause of this incident was identified by Powerlink and AEMO was satisfied that the event was unlikely to reoccur under the current circumstances. Therefore, AEMO correctly identified that reclassification was not required.</li> <li>3. The power system remained in a secure operating state and the Frequency Operating Standard was met throughout this incident.</li> <li>4. The root cause of the incident has been identified as a protection and control system maloperation. Powerlink replaced the current transformer sensor and restored the X protection into service on the 6 November 2022.</li> </ol>

<b>Power system response (facilities and services)</b>	There was no other material impact on the broader power system, load or generation.
<b>Rectification</b>	On 9 December 2022, Powerlink confirmed to AEMO that the trip of both lines was due to an intermittent fault with a current transformer sensor at Bulli Creek 330 kV substation. Powerlink informed AEMO that on 6 November 2022 the faulty sensor had been replaced and the 9902 Line X protection was returned to service.
