Trip of Bungama – Davenport and Bungama – Blyth West 275 kV lines

July 2022

Reviewable Operating Incident
Report under the National
Electricity Rules

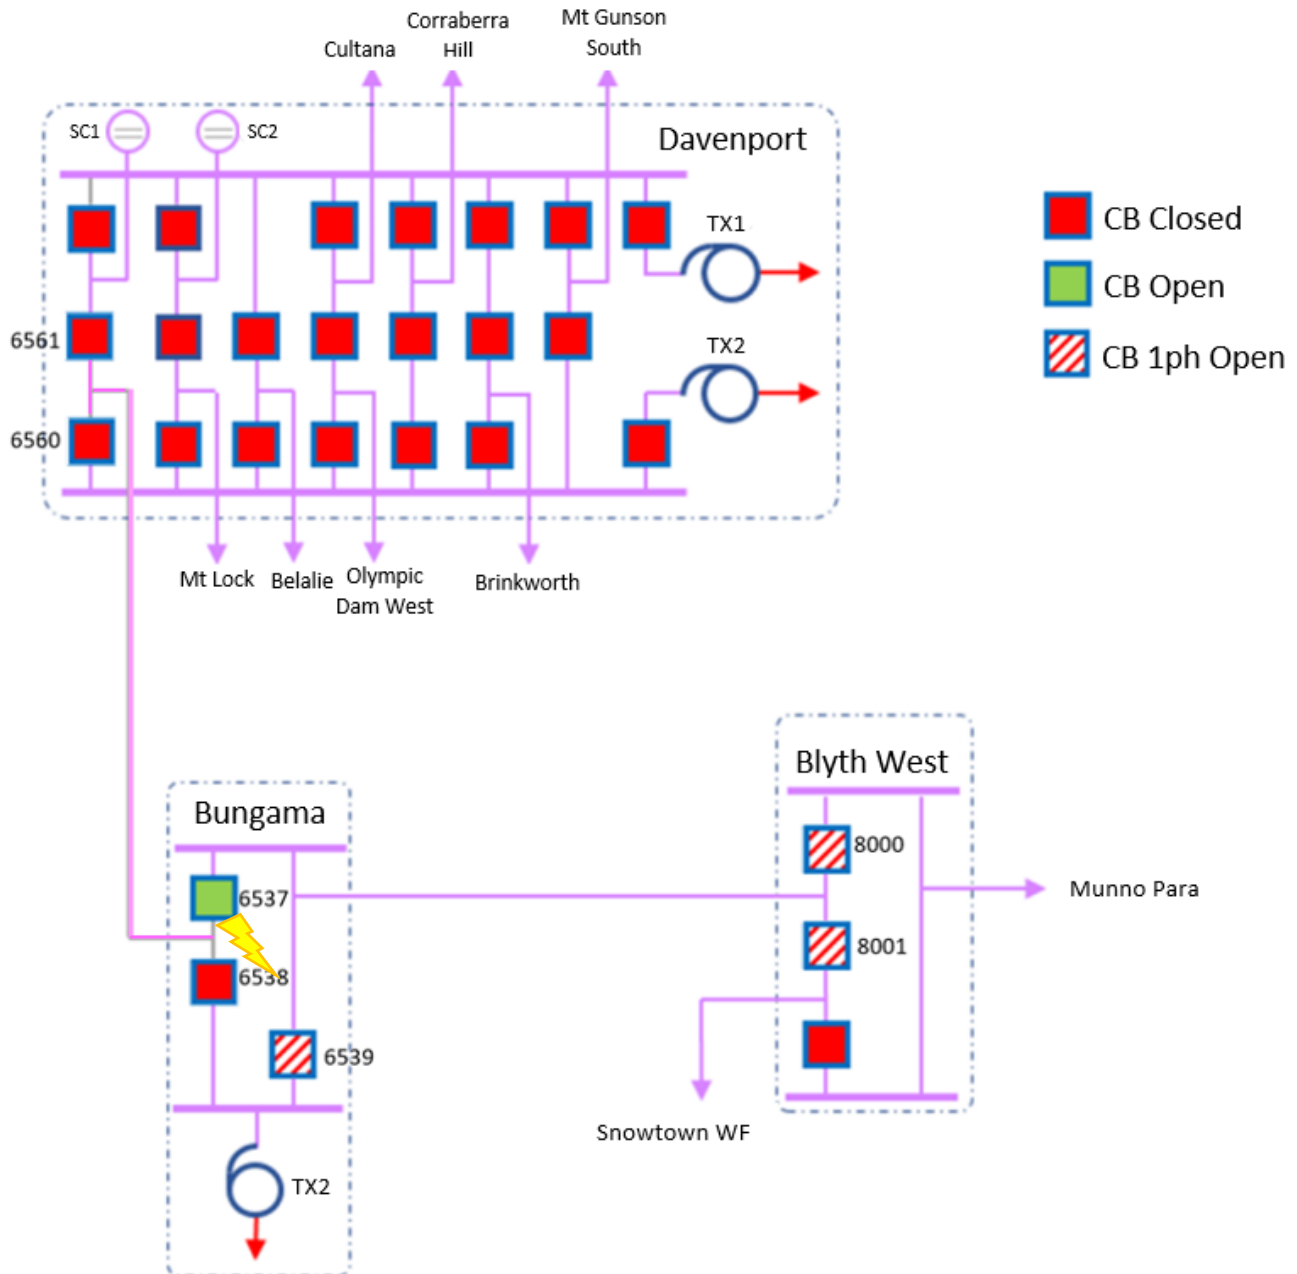
Figure 1 Simplified network configuration approximately 49 ms after the incident following initial CB operations

At 0945 hrs on 11 February 2022, a 'W' phase fault was detected by the Bungama – Blyth West 275 kV line protections. These protections operated, causing the three-phase trip of CB 6537 at Bungama and the single phase trip of CB 6539 at Bungama and CB 8000 and CB 8001 at Blyth West³. This de-energised the 'W' phase of the Bungama – Blyth West 275 kV line.

However, due to the location of the fault, it was not cleared and the Bungama CB 6537 CB fail protection subsequently operated to clear the fault. The CB fail protection tripped CB 6538 at Bungama and inter-tripped CB 6561 and CB 6560 at Davenport. This deenergised the Davenport – Bungama 275 kV line and successfully cleared the fault from the system.

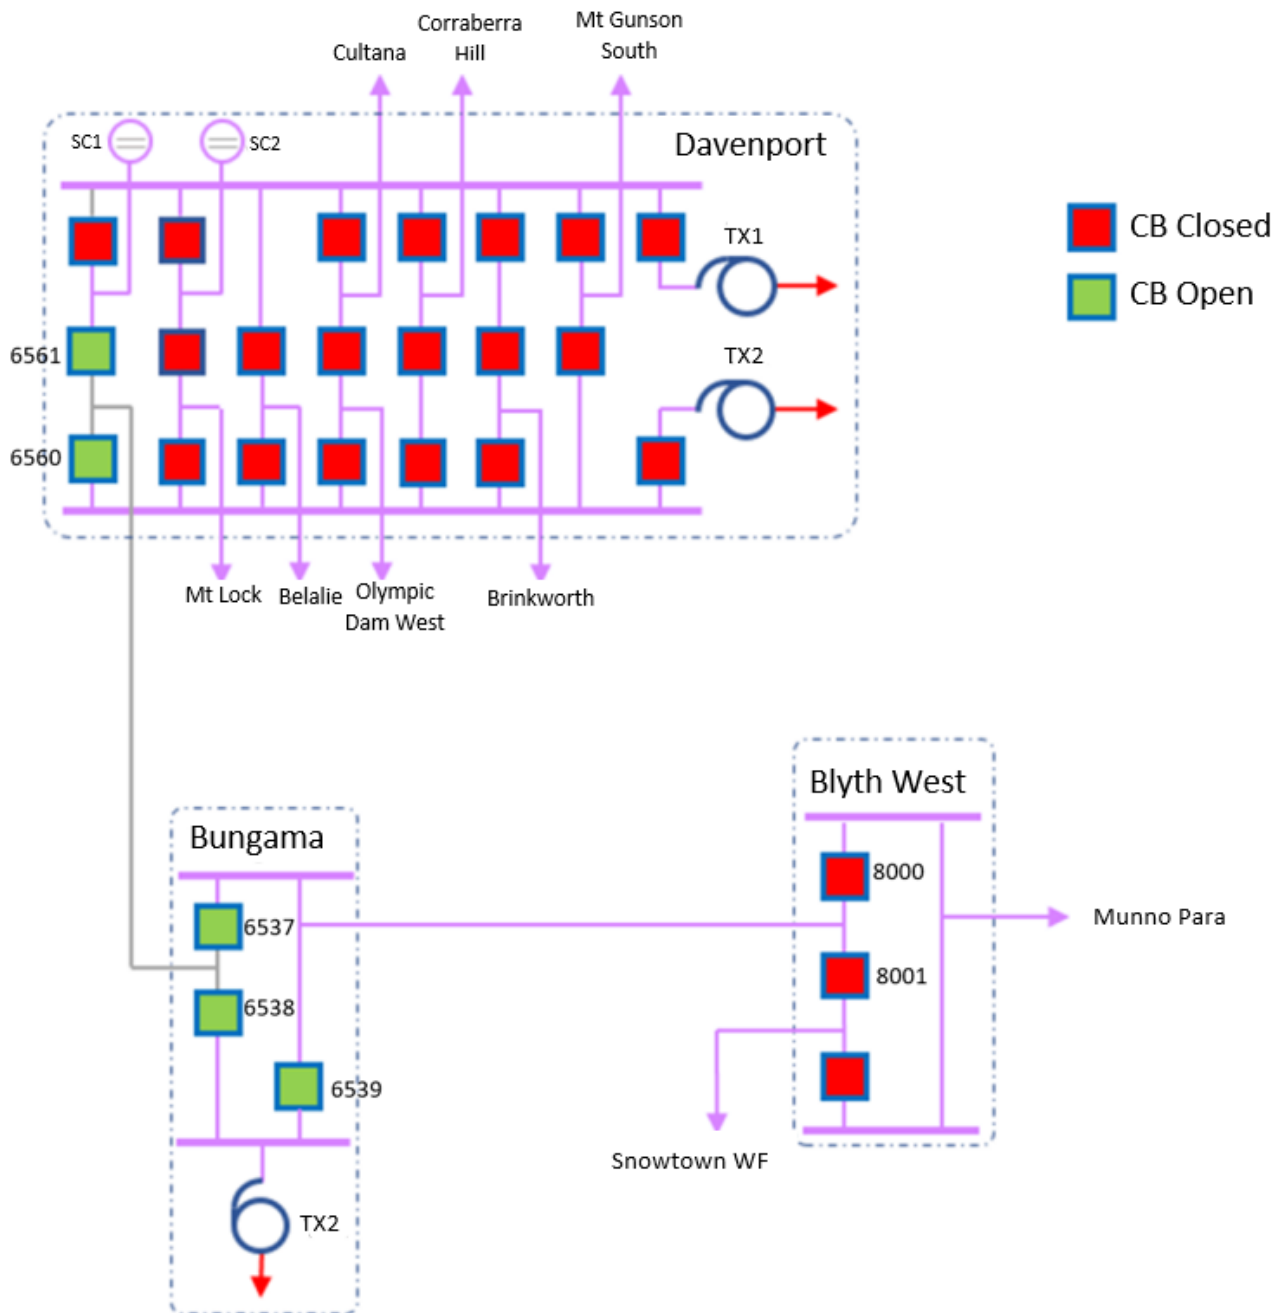
Figure 2 Simplified network configuration after fault clearance and three-phase trip of CB 6539 due to protection maloperation

Subsequently, 255 ms after the initial fault, phases 'U' and 'V' of CB 6539 at Bungama unexpectedly tripped and CB 6539 was locked out of auto-reclose. This resulted in phases 'U' and 'V' of the Bungama – Blyth West 275 kV line being open at the Bungama end only.

Subsequently, 255 ms after the initial fault, CB 6539 at Bungama, which had already opened phase 'W' due to the operation of the Bungama – Blyth West 275 kV line protection, was unexpectedly three-phase tripped by the Bungama – Blyth West 275 kV line Set X protection and therefore locked out of auto-reclose. ElectraNet has confirmed that the trip was due to the operation of a relay logic timer which was designed to ensure three-phase tripping for developing multi-phase faults. This timer is not implemented in the line protection relay at Blyth West. The protection operated as designed, however ElectraNet was not aware that it was enabled in the Bungama – Blyth West 275 kV line protection relay at Bungama, so the three-phase trip of CB 6539 for this event was not expected. In response to this incident, the logic timer in the Bungama – Blyth West 275 kV line protection relay at Bungama was disabled on 6 April 2022. ElectraNet has confirmed that the three-phase tripping of line circuit breakers for developing multi-phase faults is already ensured by other features of the line protection relays.

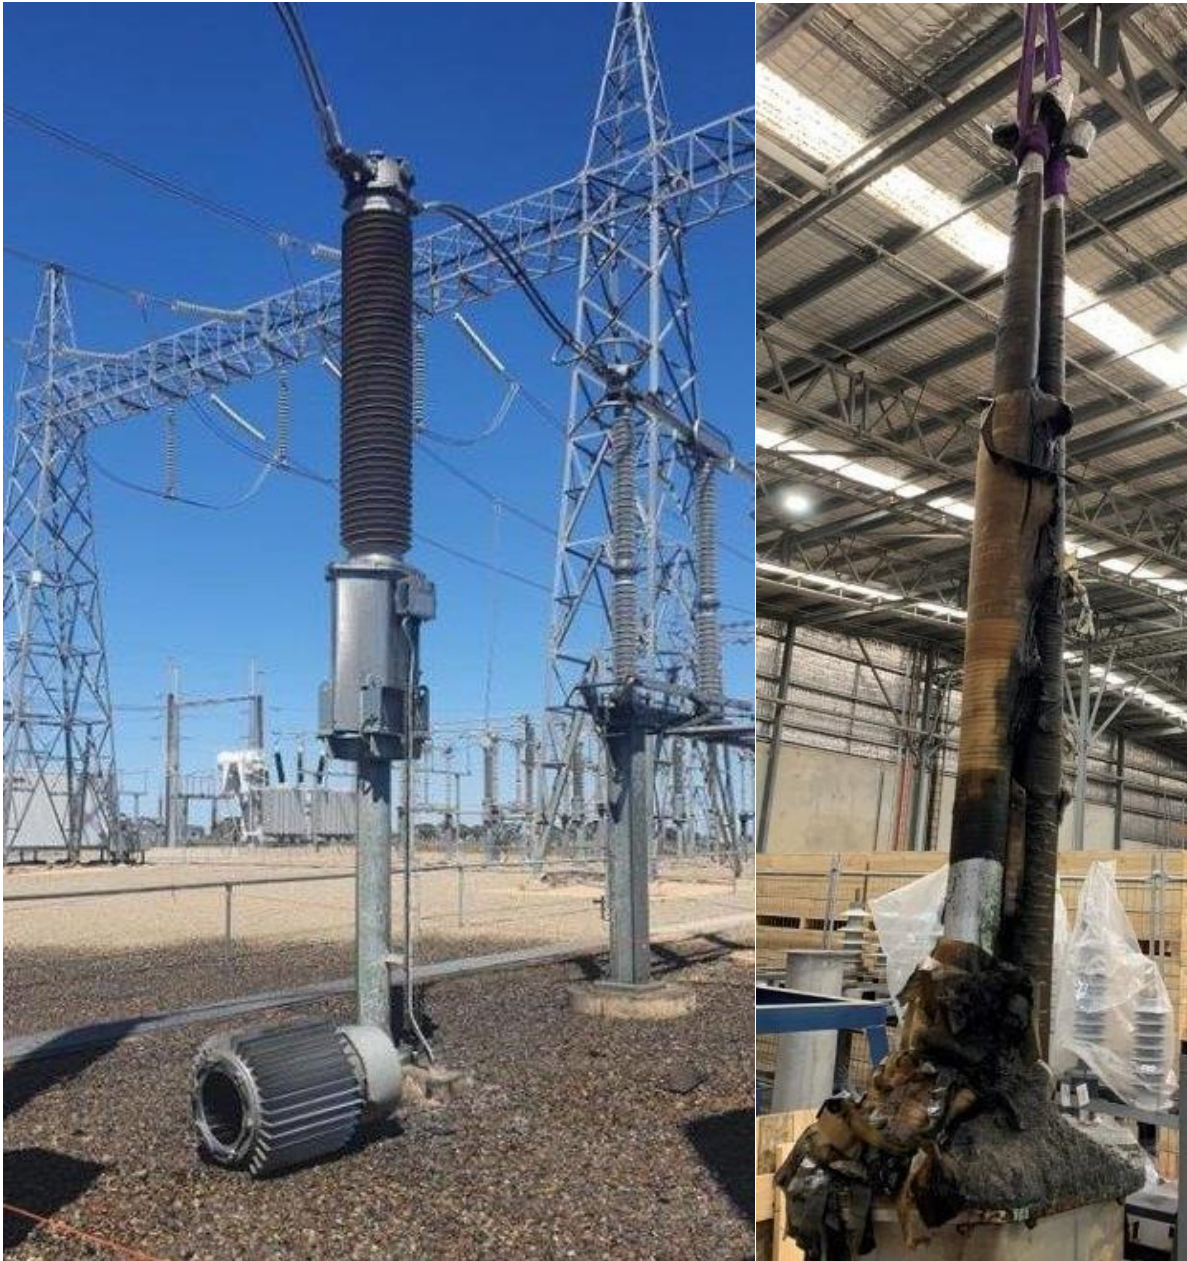
Figure 3 Failed CT in substation yard (left) and interior of failed CT after it was dismantled (right)

1. The 'W' phase fault was caused by the explosive failure of the Current Transformer (CT) at Circuit Breaker (CB) 6537 at Bungama substation. Based on advice from ElectraNet, AEMO understands that the type of CT that failed in this incident is exhibiting an undesirable and elevated risk of failure. Appendix A2 contains images of the failed CT.

ElectraNet has confirmed that the cause of the 'W' phase fault on the Bungama – Blyth West 275 kV line was a failed CT on the 'W' phase of CB 6537 at Bungama. Cores of the CT of CB 6537 are part of both the Bungama – Blyth West 275 kV line protection scheme and the Bungama – Davenport 275 kV line protection scheme. The position of the failed 'W' phase CT at Bungama was on the Davenport feeder side of CB 6537, but the location of the flashover within the CT was inside the protected zone of the Bungama – Blyth West 275 kV line protection. This resulted in the fault being identified as in-zone by the Bungama – Blyth West 275 kV line protection and out-of-zone by the Bungama – Davenport 275 kV line protection. The fault was detected correctly by the Bungama – Blyth West 275 kV line Set X differential and Set Y distance protections, which initiated the three-phase trip of CB 6537 at Bungama and the single-phase trip of the 'W' phase of CB 6539 at Bungama and CB 8000 and CB 8001 at Blyth West⁵. The protection operated as designed and successfully de-energised the 'W' phase of the Bungama – Blyth West 275 kV line in 49 ms.

Given that the position of the failed 'W' phase CT at Bungama was on the Davenport feeder side of CB 6537, the operation of the Bungama – Blyth West 275 kV line protection did not clear the fault from the system. As a result, the Set X and Set Y CB fail protection for CB 6537 at Bungama operated as designed to trip CB 6538 at Bungama and inter-trip CB 6561 and CB 6560 at Davenport, clearing the fault in 220 ms.

At 1049 hrs on 11 February 2022, a site inspection carried out by maintenance personnel confirmed that the 'W' phase CT at CB 6537 at Bungama had failed and was the cause of the 'W' phase fault. As a consequence, CB 6537 and the failed CT were isolated. ElectraNet also isolated CB 6538 to allow for the cleaning of oil on the associated isolators and the testing of its CTs.

At 1225 hrs on 11 February 2022, CB 6539 at Bungama was closed to return the Bungama – Blyth West 275 kV line to service. At 1509 hrs on 13 February 2022, CB 6538 was closed re-energising the Bungama – Davenport 275 kV line. ElectraNet replaced the CT at CB 6537 at Bungama and returned it to service at 1231 hrs on 25 February 2022.

- A detailed analysis is currently being undertaken, in partnership with the CT manufacturer, to determine the root cause of the CT failures and the associated failure risk.
- A replacement strategy for high-risk locations is currently being developed.
