# Trip of Eildon Power Station No. 2 220 kV Bus on 27 January 2022

July 2022

Reviewable Operating Incident Report under the National Electricity Rules

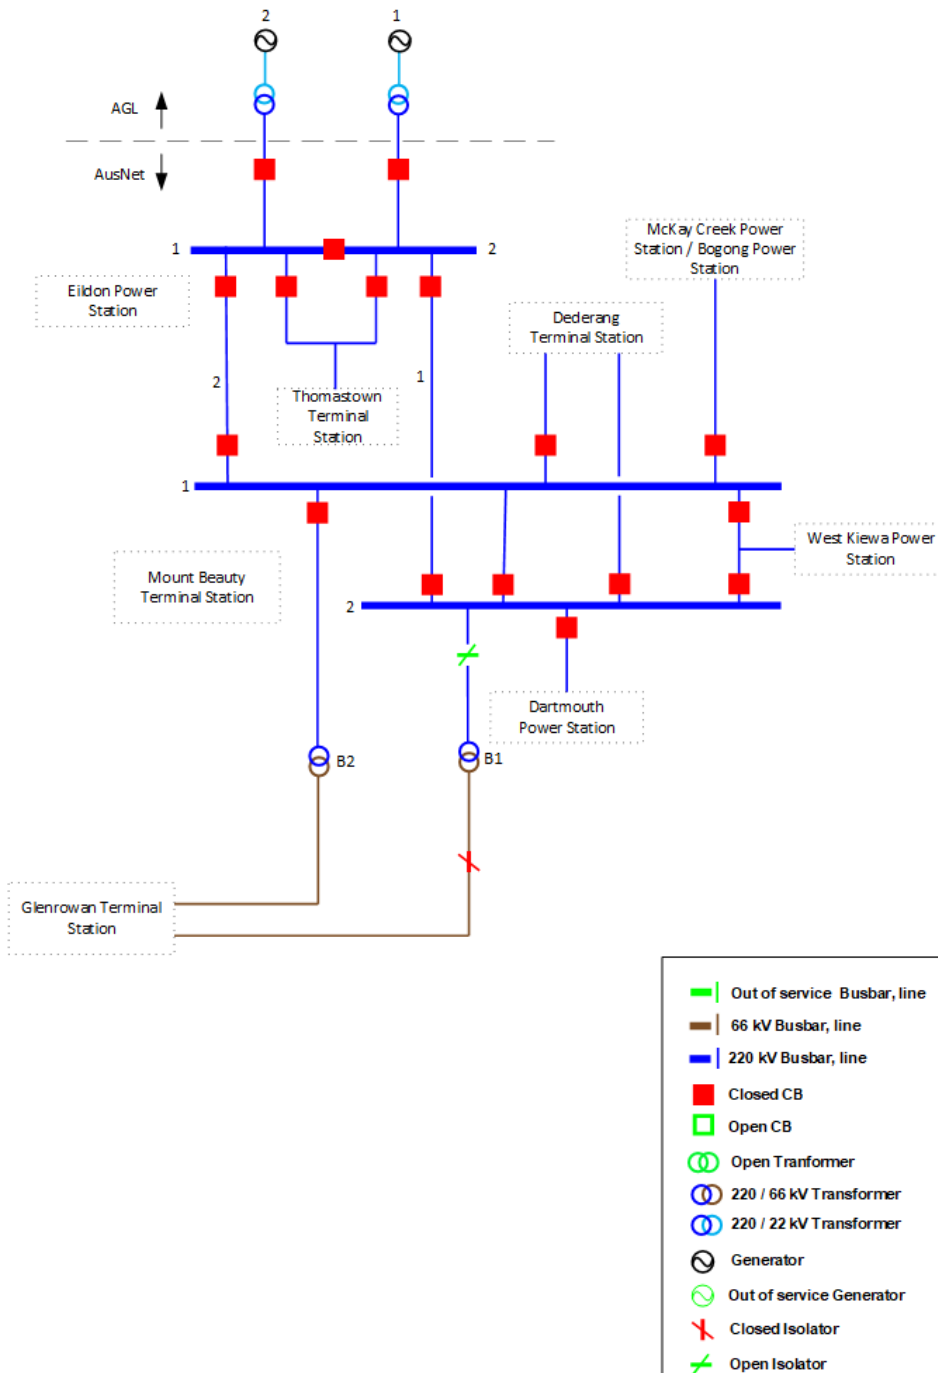
**Figure 1 Pre-incident diagram**

The diagram below provides an overview of part of the power system immediately after the incident.
