# Trip of the George Town – Hadspen 220 kV No. 2 line at George Town end only on 17 February 2022

July 2022

Reviewable Operating Incident  
Report under the National  
Electricity Rules

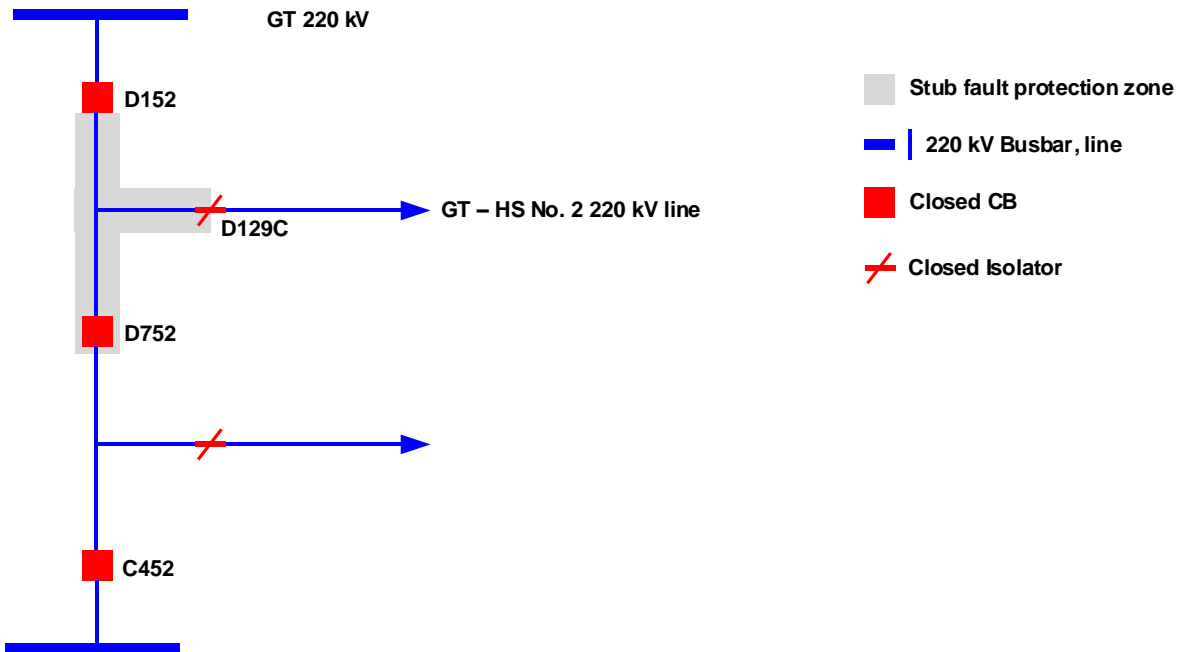
Figure 1 Incident diagram – system prior to the trip of D152 and D752 circuit breakers (CBs)

<b>Incident cause</b>	<p>Post incident investigation by TasNetworks has confirmed:</p> <ul style="list-style-type: none"> <li>At 1829 hrs on 17 February 2022, the stub bus protection scheme implemented in relay D199B maloperated to disconnect the GT — HS 220 kV No. 2 transmission line. TasNetworks confirmed that there was no fault on the network.</li> <li>The stub bus protection element of the protection is only armed when disconnecter D129C is open (see Figure 1). When armed, the stub bus protection operates as an instantaneous over-current protection.</li> <li>At the time of the trip, the D199B relay spuriously registered the D129C disconnecter as being open for 3 milliseconds (ms) and hence initiated tripping of circuit breakers D152 and D752 as designed even though the disconnecter D129C was physically closed (see Figure 2). The spurious registration of D129C disconnecter being open was most likely caused by an incorrect internal state within the relay.</li> <li>TasNetworks has identified secondary causes of the incident as:               <ul style="list-style-type: none"> <li>The use of single input disconnecter statuses for the stub bus protection design, and</li> <li>The D199B relay's contact input debounce setting being set too low to inhibit a transient logic change in the relay.</li> </ul> </li> </ul>

<b>Power system response (facilities and services)</b>	There were no other material impacts on the broader power system, load, or generation.
<b>Rectification</b>	<p>To address the issue identified through this event, TasNetworks has increased the relay disconnecter position input binary contact debounce time from 2 ms to 16 ms and increased the stub bus protection pickup current setting from 0.2 per unit (p.u.) (240 amps [A]) to 1 p.u. (1,200 A) on relay D199B. Further, in future designs, dual input status of line disconnecter will be used to arm the scheme to enhance the security of stub bus protection scheme. In dual input configuration, both the normally open contact and normally closed contact are used to determine the state of the primary plant.</p> <p>To address similar issues associated with other relays, TasNetworks has also undertaken the following remedial actions:</p>
