Trip of Sydney North 330/132 kV Transformer and 132 kV busbar

May 2022

Reviewable Operating Incident
Report under the National
Electricity Rules

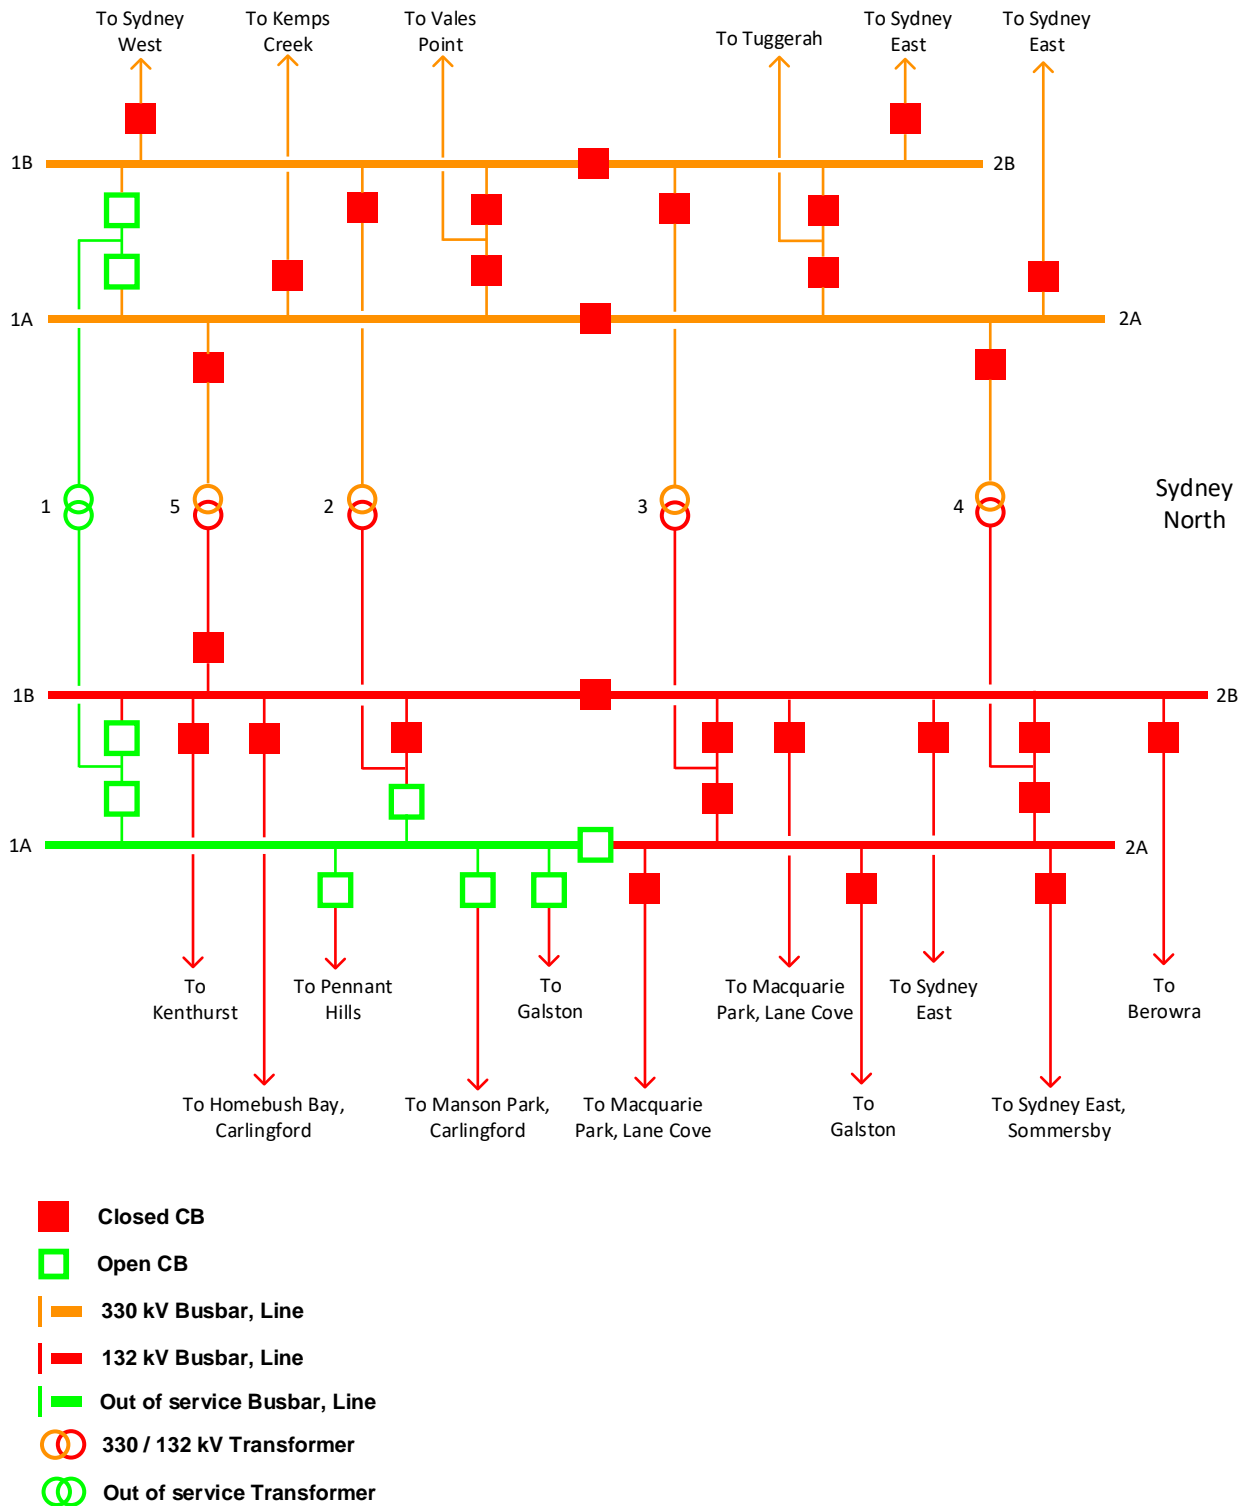
Figure 1 Post-incident diagram

| Details | |
|--|---|
| Incident key events | <ol style="list-style-type: none"> At 2111 hrs on 10 February 2022, the Sydney North 330/132 kV No. 1 Transformer and the 132 kV 1A busbar tripped (see Figure 1). At 1941 hrs on 12 February 2022, the Sydney North 132 kV 1A busbar was returned to service. At 2028 hrs on 12 February 2022, the Sydney North 330/132 kV No. 1 Transformer was returned to service. |
| Incident cause | Post-incident investigation by Transgrid has confirmed that at 2111 hrs on 10 February 2022, one insulator string on the overhead conductor between the Sydney North 132 kV 1A busbar and the Sydney North 330/132 kV No. 1 Transformer failed. The insulator string failure caused a phase to earth fault outside the busbar protection zone. The unrestrained differential protection tripped the Sydney North 330/132 kV No. 1 Transformer and cleared the fault in 59.4 ms. However, the conductor was left hanging on the underslung insulator and the disconnecter on the Sydney North 330/132 kV No. 1 Transformer Bay. Approximately 10 seconds later, the hanging conductor caused a flashover to the Sydney North 132 kV 1A busbar. The busbar protection operated and cleared the fault in 58.6 ms. The protection systems which operated during this incident operated correctly and in line with expected performance. |

| Details | |
|--|---|
| Rectification | On 12 February 2022, Transgrid replaced all insulator strings on the Sydney North No. 1 Transformer Bay which were of the same type as the insulator string which failed. Transgrid has also confirmed that the other bays at Sydney North substation do not contain the same type of insulator which failed during this incident. Transgrid has initiated a review of substations likely to contain the same type of insulator which failed during this incident, and has put in place a separate inspection program to inspect the identified substations within the next 12 months. Based on the current low rate of failure rate, Transgrid considers the risk of future failures to be low. |
