Trip of Waratah West B 330 kV Busbar on 25 May 2022

September 2022

Reviewable Operating Incident
Report under the National
Electricity Rules

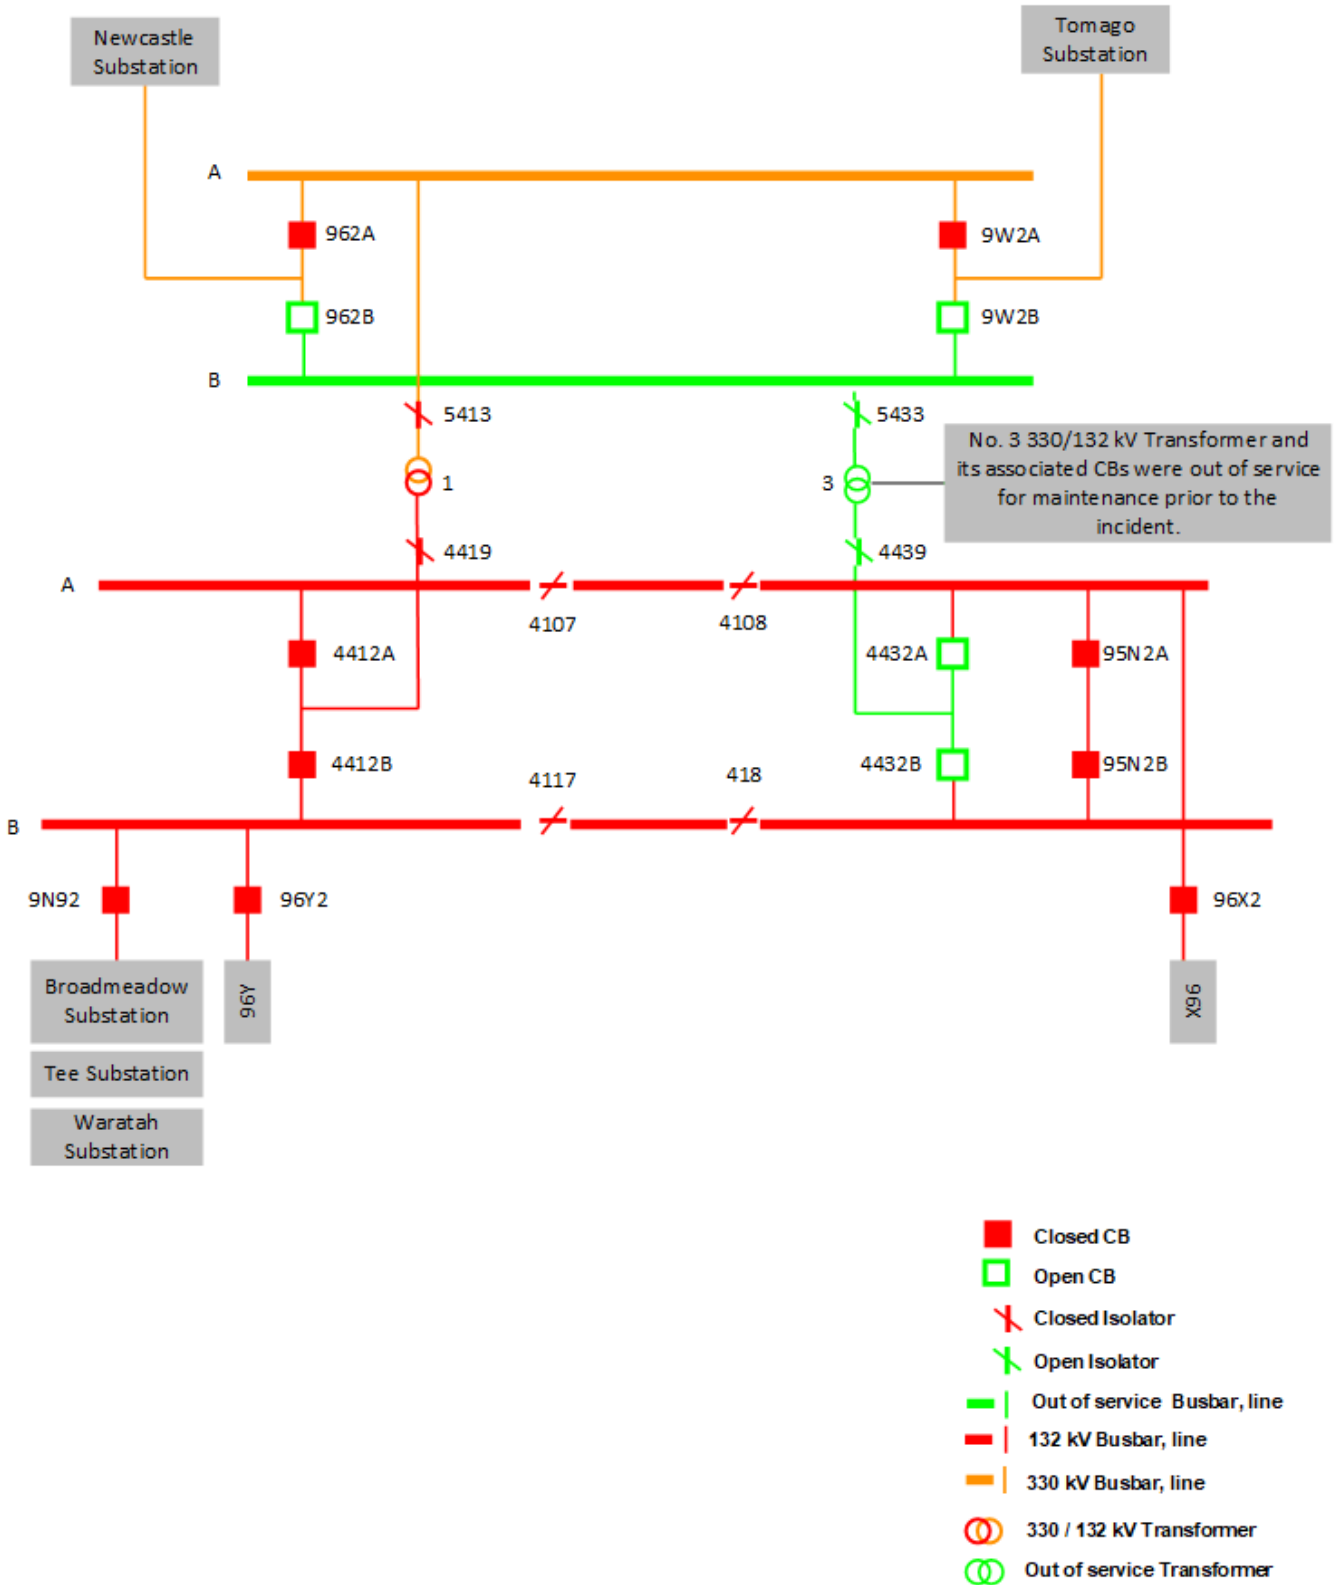
Figure 1 Incident diagram

Details	
Reviewable operating incident type	Non-credible contingency event impacting critical transmission elements.
Incident details	This report relates to a reviewable operating incident ³ that occurred on 25 May 2022 in New South Wales. The incident involved the trip of the Waratah West B 330 kilovolt (kV) Busbar.
Incident classification	Other causes – incorrect isolation information in Transgrid database.
Generation impact	Nil.
Customer load impact	Nil.
Pre-incident conditions	Transgrid staff were carrying out maintenance activities on the Waratah West No. 3 330/132 kV transformer at the time of the busbar trip. In addition, the Waratah West No. 3 330/132 kV transformer 132 kV circuit breakers (CBs) were opened to undergo maintenance.
Incident key events	<ol style="list-style-type: none"> At 1250 hrs on 25 May 2022, the Waratah West B 330 kV busbar and its associated CBs (CB 9W2B and CB 962B) tripped (see Figure 1). At 1429 hrs on 25 May 2022, the Waratah West B 330 kV busbar was returned to service.

Incident cause	<p>Post incident investigation by Transgrid has confirmed:</p> <ul style="list-style-type: none"> On 25 May 2022, the isolations established to allow work on the Waratah West No. 3 330/132 kV transformer secondary systems were incorrect. The transformer's on load tap changer (OLTC) Buchholz trip links were isolated instead of its trip input links. Due to these incorrect isolations, planned work on the transformer's secondary systems caused the Waratah West No. 3 330/132 kV transformer No. 1 protection to operate unexpectedly. The transformer protection operated in line with its settings and opened CB 9W2B and CB 962B successfully, disconnecting the Waratah West B 330 kV busbar from the system. Transgrid has identified the root cause of this incident as incorrect information in the database used to identify the isolations required for secondary system work on the transformer. Transgrid has confirmed that its protection link database information has now been updated with the correct link numbers.

Conclusions	<p>AEMO has concluded that:</p> <ol style="list-style-type: none"> 1. On 25 May 2022, incorrect isolations on the Waratah West No. 3 330/132 kV transformer secondary system caused the transformer protection to operate during planned secondary system works. This protection operation tripped CB 9W2B and 962B disconnecting the Waratah West B 330 kV Busbar from the system. 2. Transgrid has identified the root cause of this incident as incorrect information in the database used to identify the isolations required for secondary system work on the transformer. Transgrid has confirmed the protection links database used during this incident has been updated with the correct link numbers to avoid the reoccurrence of any similar incidents. Furthermore, Transgrid has also checked a sample of the relays involved in this incident, cross checking site drawings and link details in their protection link database. This review has confirmed that this incident was an isolated event and unlikely to reoccur. 3. The power system remained in a secure operating state throughout this incident and the Frequency Operating Standard was met for this incident.

Details	
Rectification	<p>Following the trip of the Waratah West B 330 kV busbar, Transgrid staff identified the correct isolation link by cross checking the following sources of information:</p> <ul style="list-style-type: none"> • The onsite link schedule. • The links recorded in Transgrid's protection link database. • The available site drawings. <p>The isolations were corrected by Transgrid staff prior to the Waratah West B 330 kV busbar's return to service. Transgrid has confirmed the protection links database used during this incident has been updated with the correct link numbers to avoid the reoccurrence of any similar incidents.</p> <p>Transgrid has also checked a sample of the relays involved in this incident, cross checking site drawings and link details in its protection link database. This review has confirmed that this incident was an isolated event and unlikely to reoccur.</p>

Recommendations	<p>AEMO recommends that network service providers (NSPs) consider updating working practices to include a cross check of all available sources of isolation information (such as site drawings, databases, and as built diagrams) prior to establishing isolations and commencing work.</p>
