Trip of Woree No. 1 132 kV Busbar and Woree No. 1 275/132 kV Transformer on 26 April 2022

September 2022

Reviewable Operating Incident
Report under the National
Electricity Rules

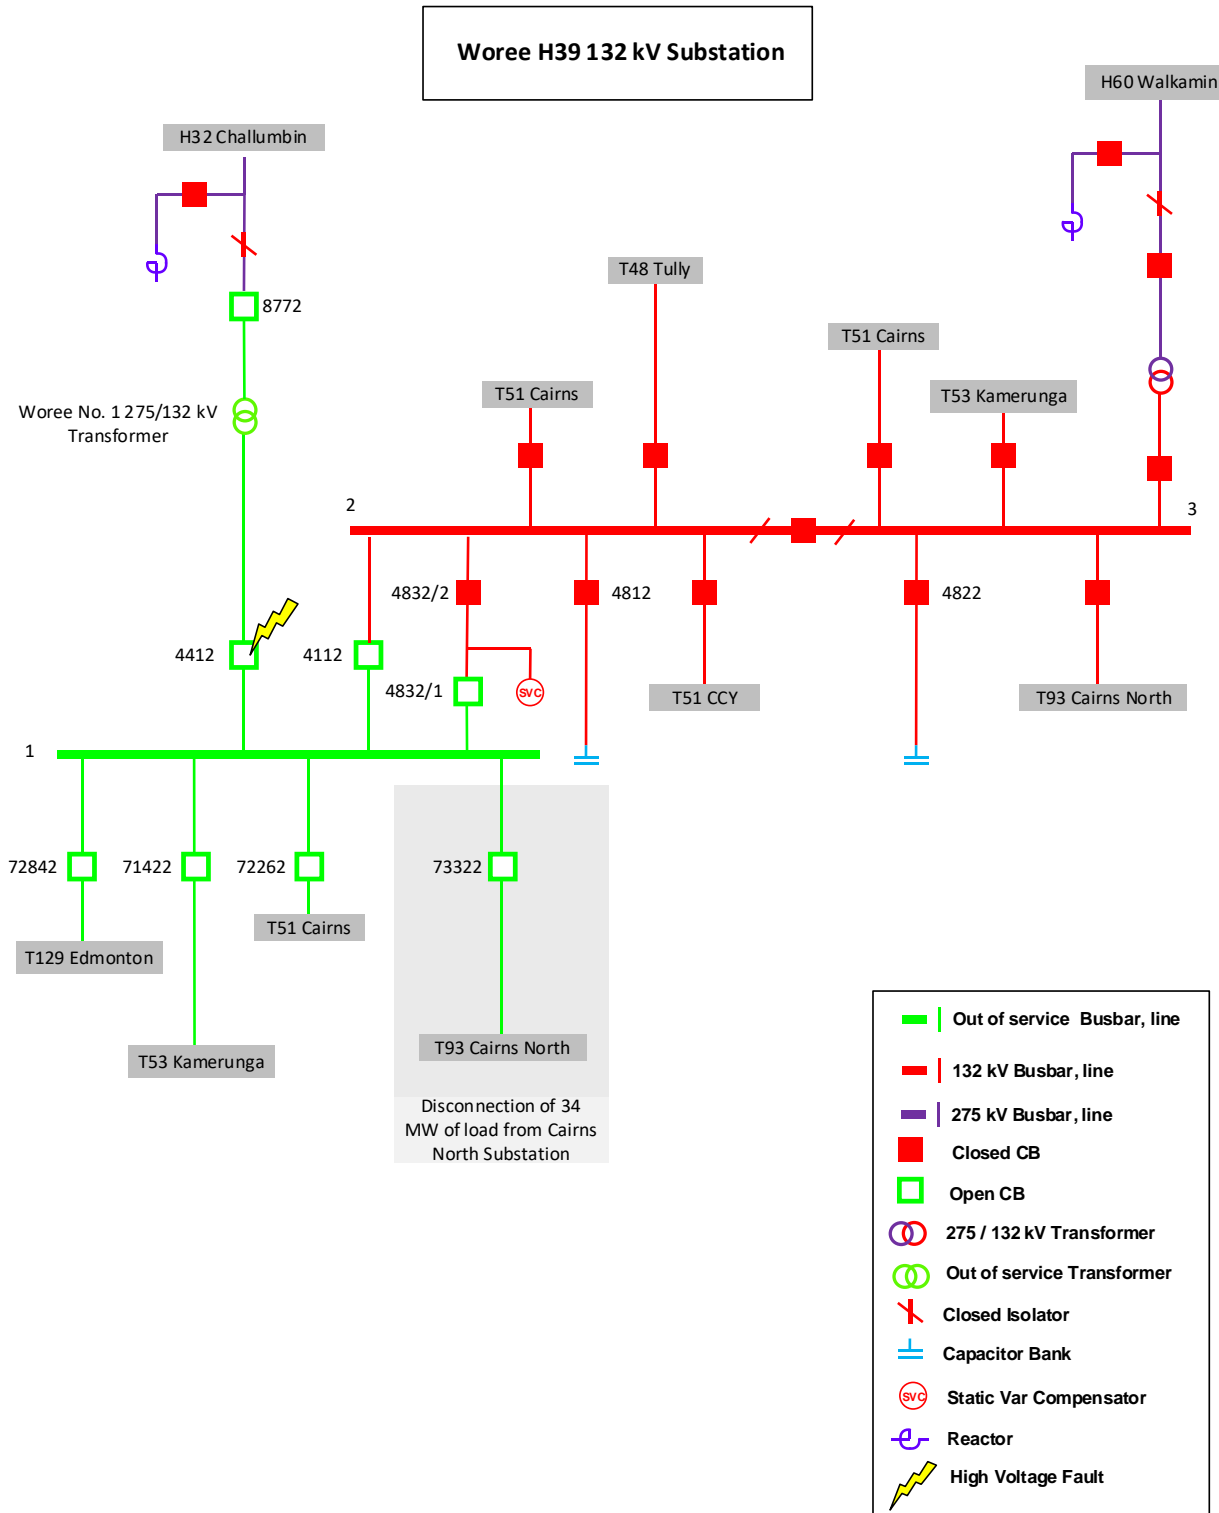
Figure 1 Incident diagram

Incident cause	<p>Post incident investigation by Powerlink has confirmed –</p> <ul style="list-style-type: none"> On 26 April 2022 at Woree Substation, an internal single phase to earth fault occurred within Woree No. 1 Transformer 132 kV CB 4412 (see Figure 1). The cause of the fault was assessed and determined to be an insulation breakdown internal to the CB pole. The occurrence of a high voltage single phase to earth fault associated with the Woree No. 1 Transformer 132 kV CB 4412 resulted in the operation of a Bus zone protection and Transformer protection. The Bus zone protection and Transformer protection operated as expected and the Woree No. 1 132 kV Busbar and Woree No. 1 275/132 kV Transformer tripped accordingly. Upon receipt of the trip signals, all relevant CBs operated and opened successfully, and the identified fault was cleared in less than 72 milliseconds. As expected for the Busbar protection operation, the Cairns North to Woree 132 kV No. 2 circuit tripped, disconnecting 34 MW of load supplied from EQL's Cairns North Substation.

The diagram below provides an overview of the affected parts of the power system immediately after the incident.

Details	
Rectification	<p>Following the trip of the Woree No. 1 Busbar on 26 April 2022, Powerlink isolated the Woree No. 1 Transformer 132 kV CB 4412 from the Woree 132 kV Busbar to undergo repair and returned the Busbar to service. The CB faulty phase pole was removed from CB 4412 and a replacement pole was installed. Powerlink completed tests on CB 4412 after the repair process to ensure it was ready for service. Following successful completion of testing, CB 4412 was reconnected to the Woree No. 1 132 kV Busbar and the No. 1 275/132 kV Transformer was returned to service on 21 May 2022.</p> <p>Powerlink advised it does not consider the CB insulation breakdown fault experienced during this incident to be a systemic issue.</p>
Power system security	<p>The power system remained in a secure operating state throughout this incident. The Frequency Operating Standard⁴ was met for this incident.</p>
