Farrell – Reece – Pieman 220 kV No. 2 line three-phase fault on 23 May 2023

February 2024

Reviewable Operating Incident
Report under the National
Electricity Rules

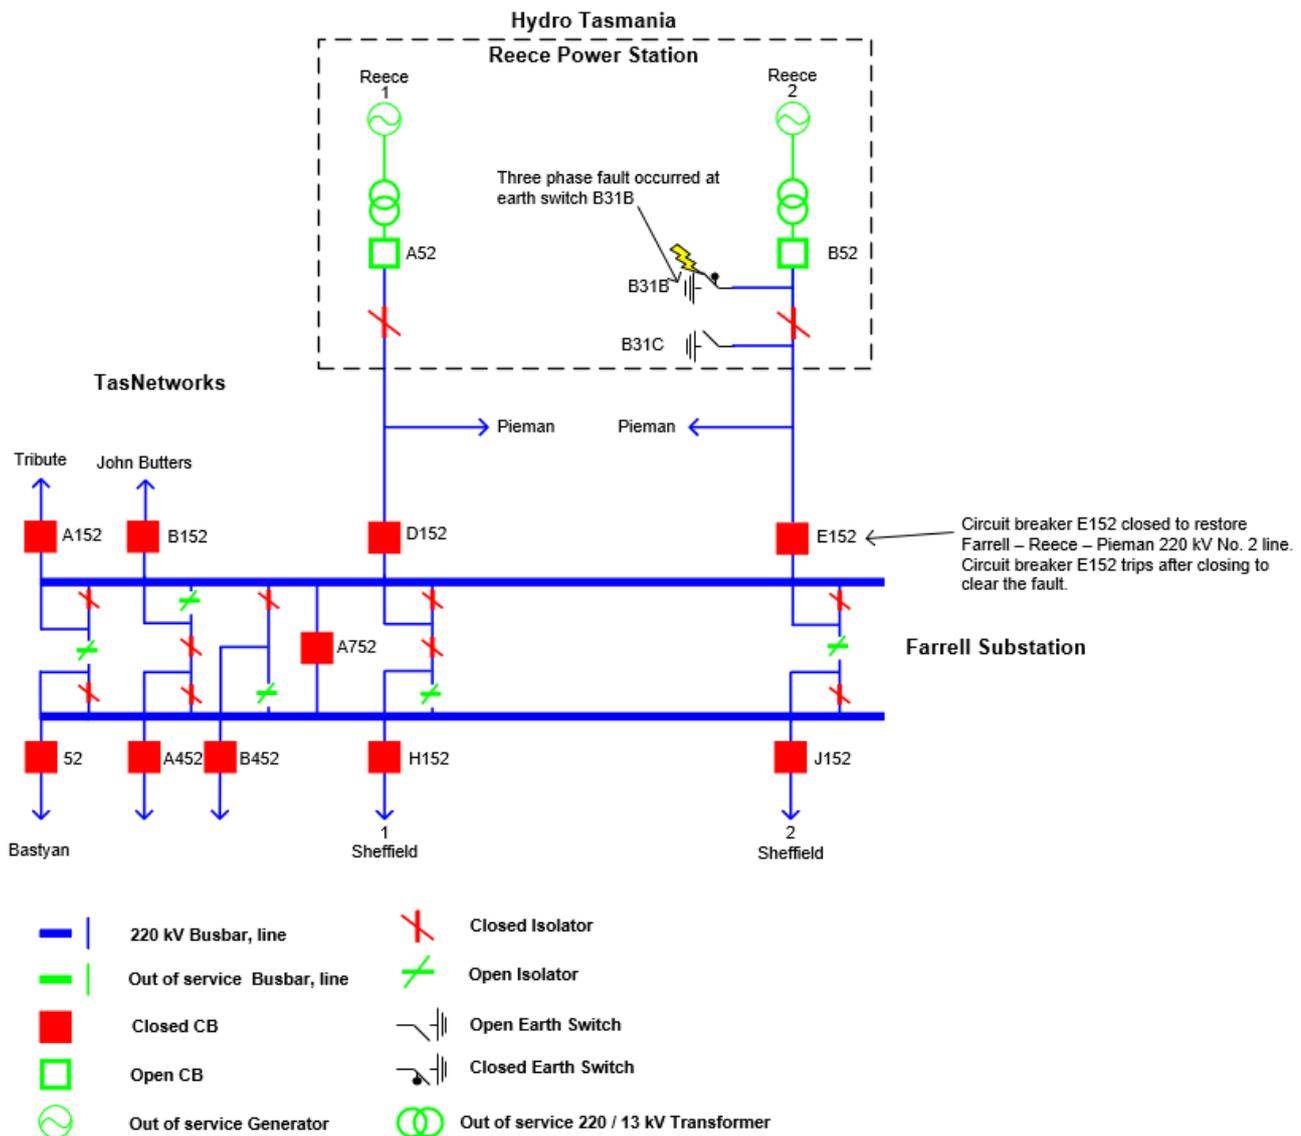
Figure 1 Incident diagram

Details	
Reviewable operating incident type	Non-credible contingency event impacting critical transmission elements.
Incident details	This report relates to a reviewable operating incident ⁵ that occurred on 23 May 2023 in Tasmania. The incident involved a three-phase fault on the Farrell – Reece – Pieman 220 kilovolt (kV) No. 2 line ⁶ .
Incident classification	Other causes – human error.
Generation impact	No generation was lost as a result of this incident.
Customer load impact	No load was lost as a result of this incident.
Pre-incident conditions	Prior to the incident, at 0927 hrs on 22 May 2023, the Farrell – Reece – Pieman 220 kV No. 2 line had been taken out of service for planned maintenance at Reece Power Station.
Incident key events	<p>The key events listed below are based on both the initial information known at the time of the incident and further details determined through post-incident investigations.</p> <ol style="list-style-type: none"> At 1128 hrs on 23 May 2023: <ul style="list-style-type: none"> The Farrell – Reece – Pieman 220 kV No. 2 line was energised by closing the E152 circuit breaker (CB) at Farrell 220 kV Substation (see 0). A three-phase fault occurred on the Farrell – Reece – Pieman 220 kV No. 2 line. The Basslink interconnector underwent commutation failure (with the interconnector recovering and remaining in service thereafter). Disconnection of approximately 3 megawatts (MW) of distributed photovoltaic (DPV) inverters was experienced in Tasmania. The E152 CB at Farrell 220 kV Substation tripped to clear the fault. Shortly after 1128 hrs on 23 May 2023, Hydro Tasmania advised TasNetworks that there was no fault, and that the trip had possibly occurred due to a locking pin⁷ that had been left in at the Reece Power Station CB. Whilst not reported at the time of the event, at 1133 hrs on 23 May 2023, Hydro Tasmania's sequence of events indicated that earth switch B31C at Reece Power Station opened. The operator advised TasNetworks that the issue was resolved (pin removed) and that the line restoration could proceed. At 1141 hrs on 23 May 2023, TasNetworks closed E152 CB at Farrell and the Farrell – Reece – Pieman 220 kV No. 2 line was successfully restored.
