# Trip of Braemar No. 4 275 kV busbar and Braemar – Western Downs 275 kV line 8820 on 29 November 2023

May 2024

Reviewable Operating Incident  
Report under the National  
Electricity Rules

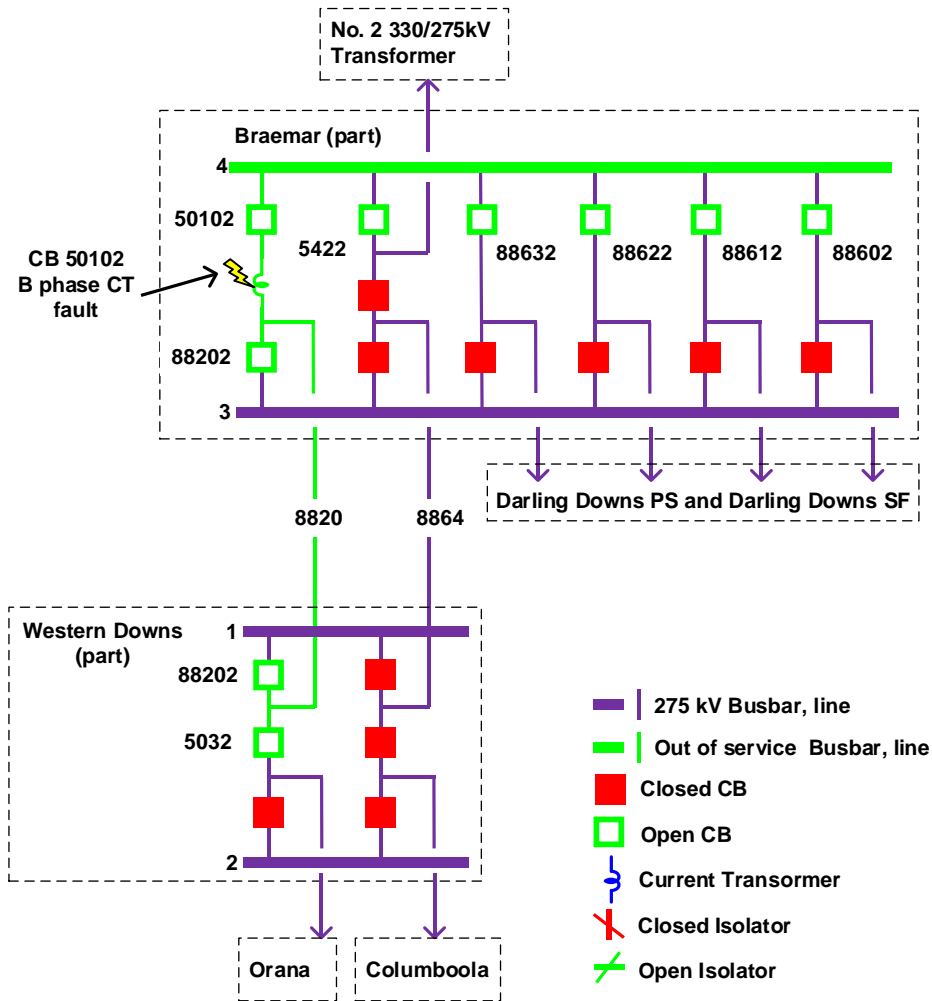
Figure 1 Incident diagram (Braemar and Western Downs substations)

| Details | |
|---|--|
| <b>Incident cause</b> | <p>Post incident investigation by Powerlink has confirmed:</p> <ul style="list-style-type: none"> <li>At 1421 hrs on 29 November 2023, the Braemar No. 4 275 kV busbar and Braemar – Western Downs 275 kV 8820 line tripped due to an internal fault in the Braemar substation B phase CT associated with CB 50102. (See Figure 1).</li> </ul> <p>In addition, post incident investigation has confirmed the following protection and CB operations were recorded during the event:</p> <p>At Braemar substation:</p> <ul style="list-style-type: none"> <li>Busbar protection operated and tripped CB 88602, CB 88612, CB 88622, CB 88632, CB 5422 and CB 50102 as expected. CB 50102 was also tripped by line protection as the CB 50102 CT fault was in the busbar and line protection zones. The busbar protection operated as expected.</li> <li>The Braemar – Western Downs 275 kV line 8820 protection operated and tripped 275 kV CB 50102 and CB 88202 B phase as expected.</li> <li>At Braemar, CB pole discrepancy tripped 275 kV CB 88202 A and C phase. This was not expected.</li> </ul> |

| Details | |
|---|--|
| <b>Conclusions</b> | <p>AEMO has concluded that:</p> <ol style="list-style-type: none"> <li>1. At 1421 hrs on 29 November 2023, the Braemar No. 4 275 kV busbar and the Braemar – Western Downs 275 kV 8802 line tripped due to an internal fault in the Braemar 275 kV CB 50102 B phase current transformer (CT).</li> <li>2. The cause of the incident has been identified as transmission equipment failure – 275 kV CT internal fault. The root cause of the CT internal fault is still under investigation by Powerlink.</li> <li>3. Powerlink are investigating the cause of the unexpected operation of the Braemar 275 kV CB 88202 pole discrepancy function.</li> <li>4. The power system remained in a secure operating state throughout this incident.</li> </ol> |

| Details | |
|--|---|
| <b>Rectification</b> | <p>Powerlink replaced the Braemar substation B phase CT on 275 kV CB 50102. On 25 January 2024 the CB was returned to service.</p> <p>Powerlink, with input from the Original Equipment Manufacturer (OEM), are investigating the cause of the CT internal fault and plan to have this completed by the end of Q3 2024.</p> |

| Details | |
|---|--|
| <b>Recommendations</b> | <ol style="list-style-type: none"> <li>1. AEMO supports Powerlink’s precautionary approach to increase the oil sampling frequency for this make and model 275 kV CT, pending the results of the investigation into the root cause of the 275 kV CT internal fault.</li> <li>2. Powerlink to share findings of the investigation of the cause of the 275 kV CT internal fault and any further recommended actions with AEMO and other TNSPs as appropriate by the end of June 2024.</li> <li>3. Powerlink to share with AEMO the results of the investigation into the unexpected operation of the Braemar 275 kV CB 88202 pole discrepancy function by the end of May 2024.</li> <li>4. AEMO has identified that the CT type which failed during this incident matches the CT type involved in recent reviewable operating incidents still under investigation involving CT failures in South Australia and is therefore engaging closely with Powerlink and ElectraNet to assess possible risks to power system security.</li> <li>5. AEMO and Powerlink plan to share the findings from this event with the Power System Security Working Group (PSSWG) by Q3 2024.</li> </ol> |
