# February 2024

# Reviewable Operating Incident Report under the National Electricity Rules

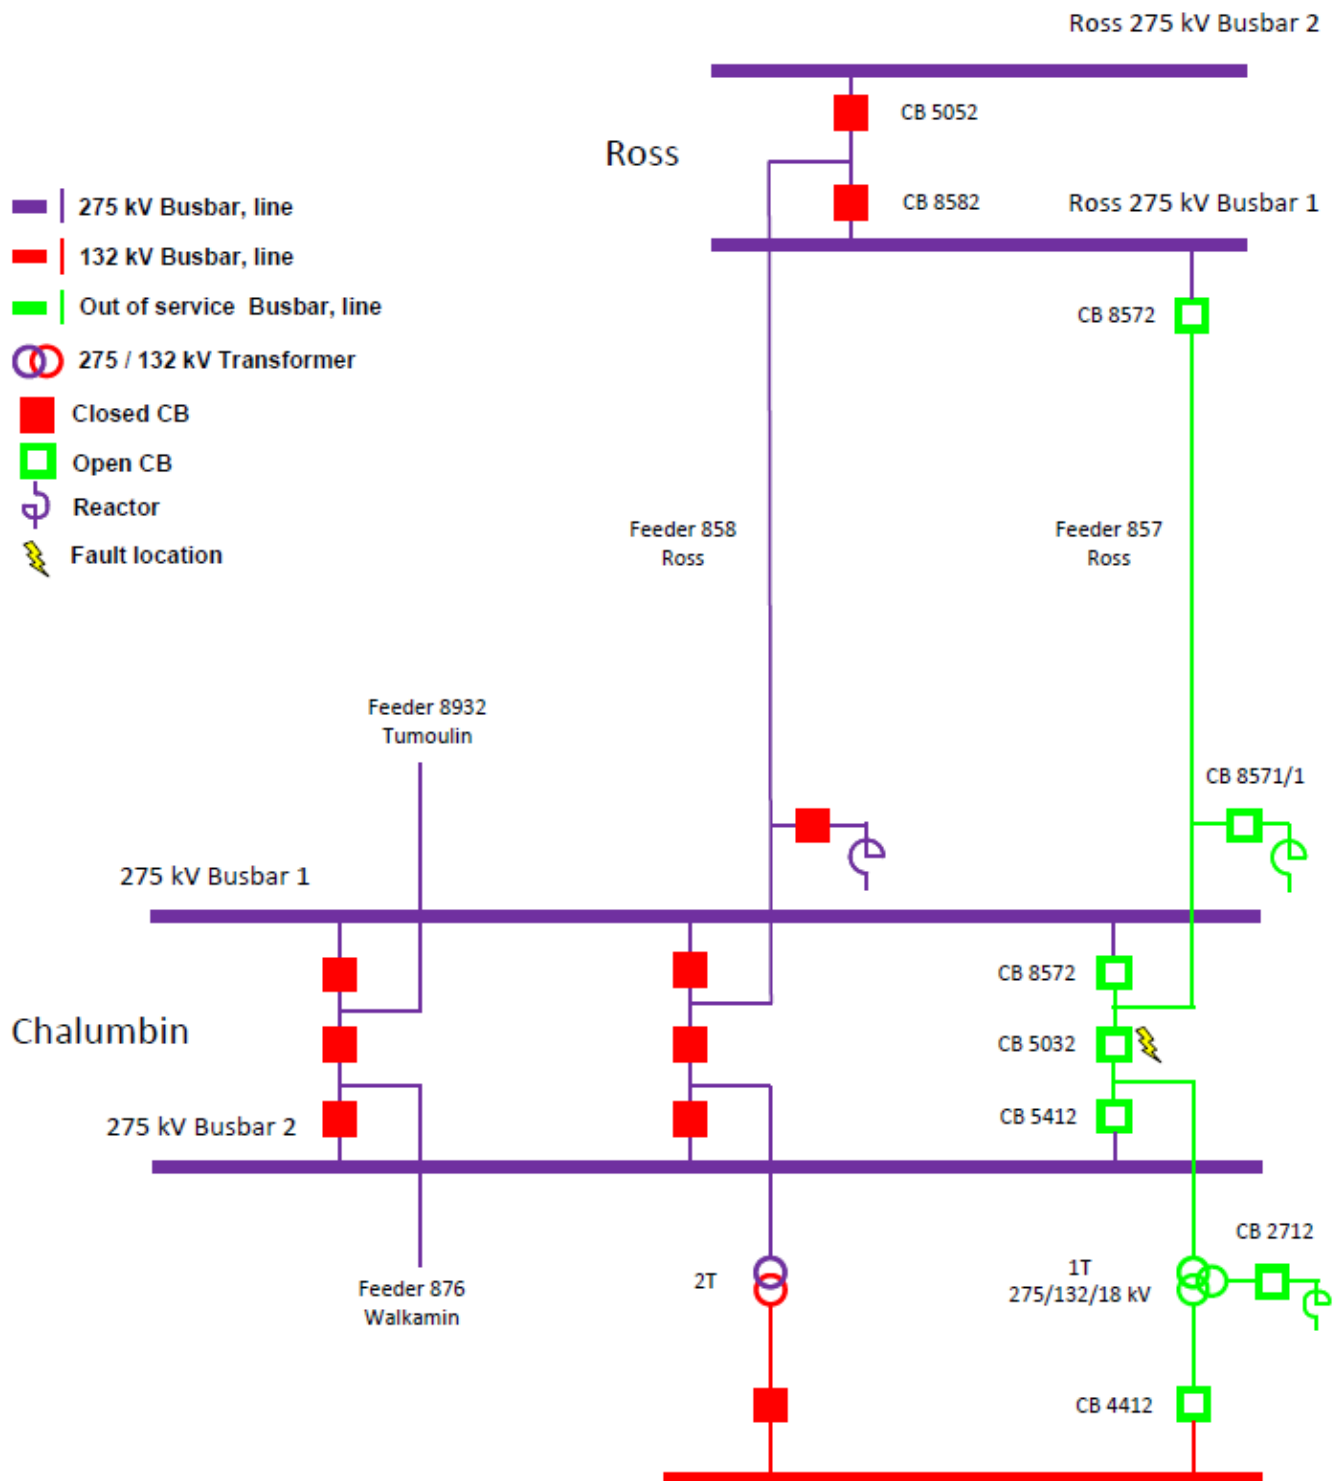
Figure 2 Post-incident diagram – Chalumbin substation

<b>Incident key events</b>	<ul style="list-style-type: none"> <li>On 30 August 2023, the following events occurred:               <ul style="list-style-type: none"> <li>At 0903 hrs, the Chalumbin – Ross 275 kV No. 857 line was switched out of service for a planned outage.</li> <li>Immediately following this, the Chalumbin 275/132 kV No. 1 transformer and Chalumbin 275 kV No. 2 reactor tripped due to the operation of their respective protection systems.</li> <li>At 1048 hrs, CB 5032 was isolated from the power system and the Chalumbin 275/132 kV No. 1 transformer was returned to service.</li> </ul> </li> <li>On 31 August 2023, at 0955 hrs, the Chalumbin – Ross 275 kV No. 857 line and the Chalumbin 275 kV No. 2 reactor were returned to service.</li> <li>Following minor repairs, CB 5032 was returned to service at 1431 hrs on 1 September 2023.</li> </ul>
<b>Incident cause</b>	<p>Powerlink's post-incident investigation has concluded that:</p> <ul style="list-style-type: none"> <li>Immediately prior to the incident at 0903.50 hrs on 30 August 2023, the Chalumbin – Ross 275 kV No. 857 line was switched out of service by opening CB 8572 and CB 5032 at Chalumbin and CB 8572 at Ross substation. This switching occurred as part of a planned outage of the Chalumbin – Ross 275 kV No. 857 line.</li> <li>An external flashover occurred across the open interrupters of A and C phases of the open CB 5032 at Chalumbin (effectively energising the Chalumbin – Ross 275 kV No. 857 line and Chalumbin 275 kV No. 2 reactor on two phases only). While CB 5032 was open, it was still energised on one side of the CB interrupters via CB 5412 and the Chalumbin 275 kV No. 2 busbar (see Figure 1).</li> <li>The protection of Chalumbin 275 kV No. 2 reactor, which was energised on A and C phase via the flashover of CB 5032, detected a negative phase sequence condition and tripped the reactor circuit breaker CB 8572/1.</li> <li>The arc on the A phase of CB 5032 evolved and contacted an adjacent earthed structure which resulted in a phase to ground fault in the Chalumbin 275/132 kV No. 1 transformer protection zone. The transformer protection operated and tripped CB 5412, CB 4412 and CB 2712 as expected and within primary protection clearing times<sup>4</sup> (see Figure 2).</li> </ul>
