# Trip of Moorabool No. 2 500 kV busbar on 19 October 2023

March 2024

Reviewable Operating Incident  
Report under the National  
Electricity Rules

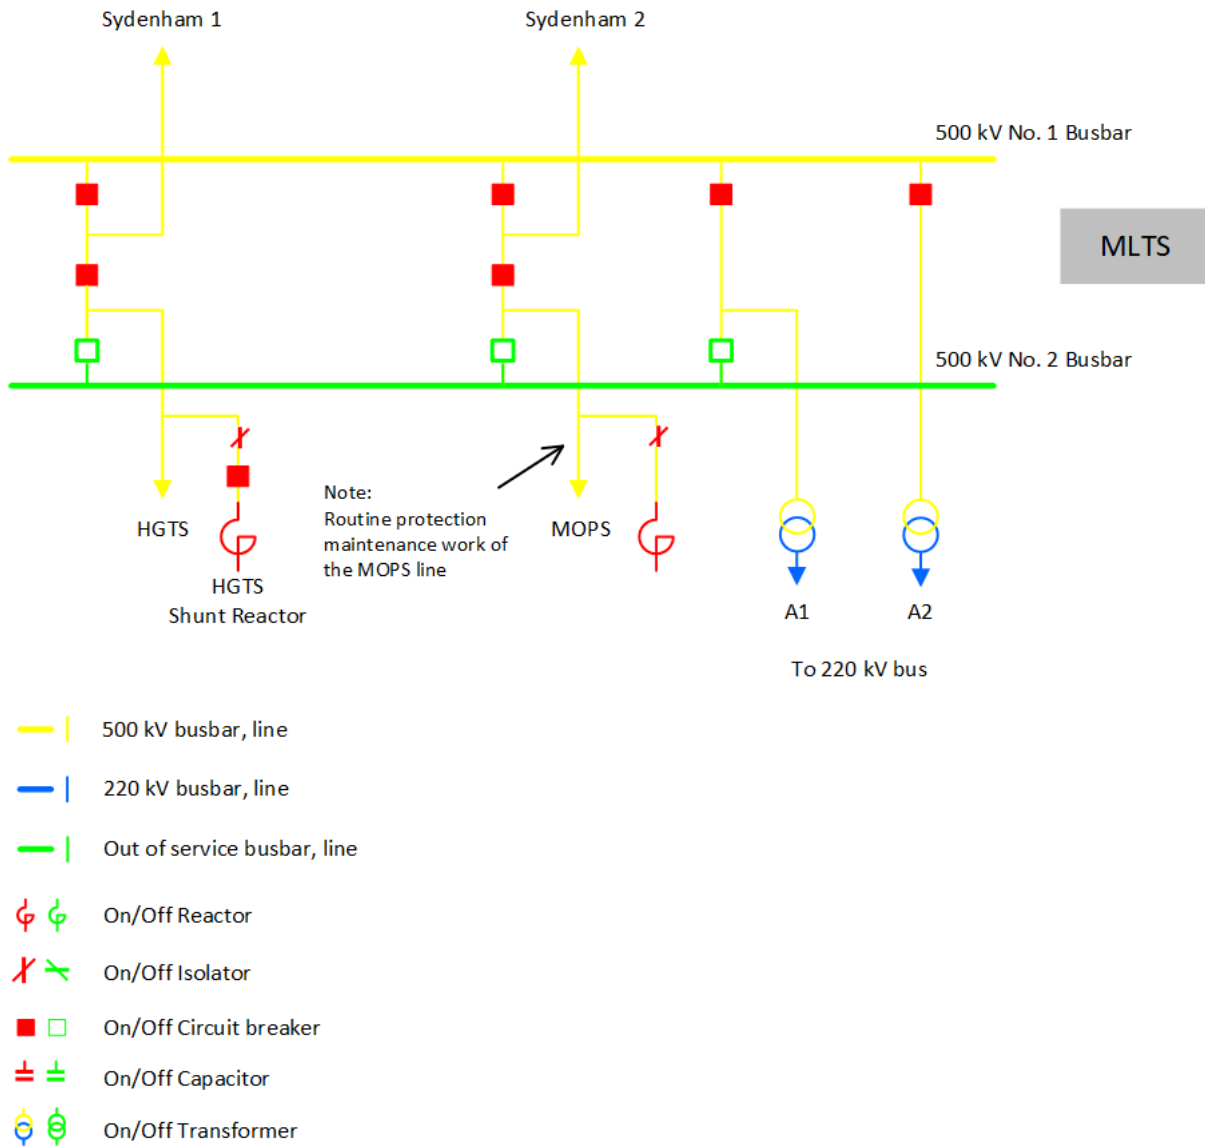
Figure 1 Post-incident diagram

Details	
<b>Reviewable operating incident type</b>	Non-credible contingency event impacting critical transmission elements.
<b>Incident details</b>	This report relates to a reviewable operating incident <sup>3</sup> that occurred on 19 October 2023 in Victoria. This incident involved the trip of the Moorabool Terminal Station (MLTS) No. 2 500 kilovolt (kV) busbar.
<b>Incident classification</b>	Other causes – Human error. Insufficient protection isolation due to: <ul style="list-style-type: none"> <li>• Outdated “As built” drawings stored in the site folder (inconsistent with AusNet procedures).</li> <li>• Failure of testing team to verify available site drawings against on site equipment.</li> </ul>
<b>Generation impact</b>	No generation was lost as a result of this incident.
<b>Customer load impact</b>	No customer load was tripped or automatically shed in response to these incidents.
<b>Previous incidents</b>	A non-credible contingency at MLTS previously occurred on 29 May 2023 <sup>4</sup> where the No. 1 220 kV busbar tripped due to a human error related to protection isolation. This busbar tripped during planned protection and control system upgrade work to the MLTS No. 1 220 kV capacitor bank. During this work, a short circuit of the two cores of a cable caused the circuit breaker fail (CBF) protection system of the MLTS No. 1 220 kV capacitor bank to operate and trip the MLTS No. 1 220 kV busbar.

<b>Pre-incident conditions</b>	Prior to the event, a secondary testing team was conducting routine protection maintenance testing on the MLTS – Mortlake Power Station (MOPS) line protection at MLTS.
<b>Incident key events</b>	On 19 October 2023, the following events occurred: <ul style="list-style-type: none"> <li>• At 1437 hrs the MLTS No. 2 500 kV busbar tripped (see Figure 1).</li> <li>• At 1447 hrs the MLTS No. 2 500 kV busbar was returned to service.</li> </ul>
<b>Incident cause</b>	Post-incident investigation by AusNet has confirmed that: <ul style="list-style-type: none"> <li>• At 1437 hrs on 19 October 2023, a secondary testing team was conducting routine protection maintenance of the MOPS 500 kV line at MLTS. During the relay testing, a CBF event initiated by MOPS line No. 2 busbar 500 kV CB caused the No. 2 500 kV busbar protection to operate and trip the MLTS No. 2 500 kV busbar.</li> <li>• It was identified that the CBF trip link of the panel under testing was not isolated and the station drawings did not reflect the actual wiring of the panel under test. Post-incident investigation confirmed that drawings used by the testing team to identify isolations for this work did not reflect the actual situation of the protection panel. The panel’s wiring had been modified in August 2023, but the station drawing folder had not been updated with the latest “as built” drawings. This was inconsistent with AusNet’s commissioning and construction requirements procedure which requires the latest “as built” drawings to be stored on site after any modifications are made.</li> <li>• In addition, AusNet’s procedures require testing teams to verify on site equipment against the available drawings before commencing the tests. AusNet’s investigation confirmed that the testing team had failed to correctly verify the site drawings prior to the works.</li> <li>• Finally, AusNet identified that the communication between the project team and the testing team before commencement of testing was not effective, as the recent onsite modifications to the panel were not discussed.</li> </ul>

Details	
<b>Power system response (facilities and services)</b>	There was no other material impact on the broader power system, load or generation.
<b>Rectification</b>	<p>Immediately after this incident, the secondary testing team informed the AusNet Control room.</p> <p>After identifying the cause of the incident, at 1447 hrs on 19 October 2023, the MLTS No. 2 500 kV busbar was returned to service.</p> <p>Following the incident, AusNet replaced the drawings in the station folder with the latest “as built” drawings.</p> <p>A toolbox meeting was held to convey the learnings from the incident.</p> <p>In addition, AusNet conducted further awareness sessions in December 2023 for the Northwest testing team members to highlight the requirement to use the latest “as built” drawings when preparing protection isolation and the requirement to conduct final checks to confirm that on site isolations/equipment match the available drawings.</p> <p>AusNet has also confirmed that its procedures for drawing management during site works require that the latest “as built” drawings reflecting the status of the wiring on site are stored in the station folders and available to other work parties.</p>
