# Trip of Mortlake Power Station – Blue Gum substation 500 kV line and operation of circuit breaker fail protection on 9 July 2023

December 2023

Reviewable Operating Incident  
Report under the National  
Electricity Rules

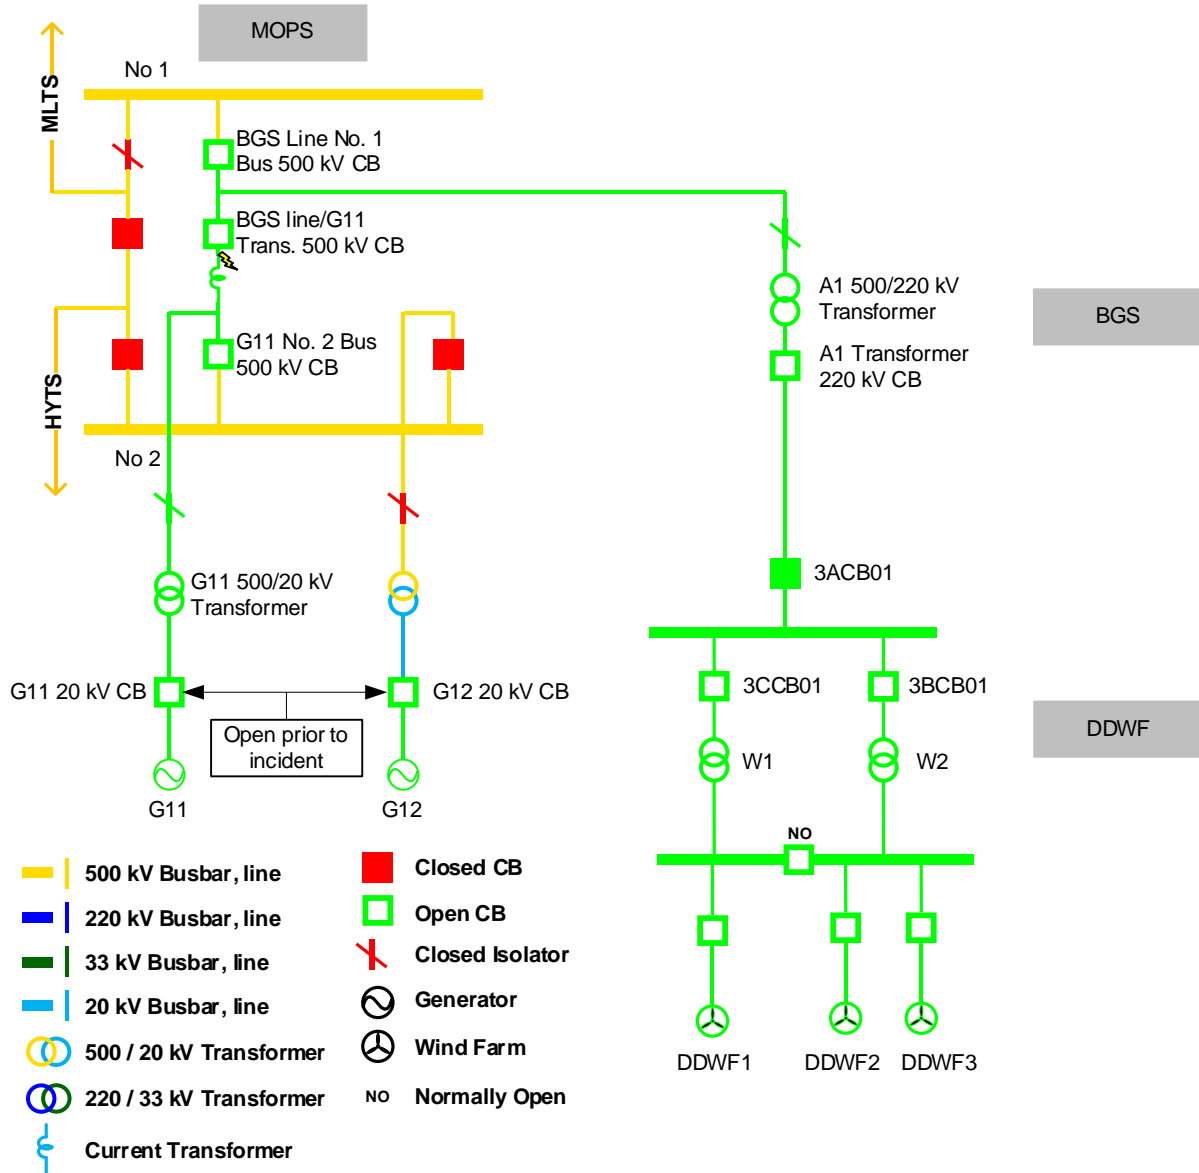
Figure 1 Post-incident diagram

Details	
<b>Reviewable operating incident type</b>	Non-credible contingency event impacting critical transmission elements.
<b>Incident details</b>	This report relates to a reviewable operating incident <sup>7</sup> that occurred on 9 July 2023 at 0653 hrs in Victoria, involving: <ul style="list-style-type: none"> <li>The trip of the Mortlake Power Station (MOPS) – Blue Gum Substation (BGS) 500 kilovolt (kV) line and BGS A1 500/220 kV transformer, resulting in islanding of Dundonnell Wind Farm (DDWF) from 254 megawatts (MW).</li> <li>Operation of circuit breaker fail (CBF) protection including the disconnection of the MOPS G11 500/20 kV transformer (see Figure 1).</li> </ul>
<b>Incident classification</b>	Transmission equipment failure - internal flashover within the blue phase current transformer (CT) housing associated with the MOPS BGS line/G11 500/20 kV transformer 500 kV circuit breaker (CB).

Details	
	<p>3. At 1458 hrs on 9 July 2023, the MOPS – BGS 500 kV line and the BGS A1 500/220 kV transformer were returned to service via the MOPS BGS Line No. 1 Bus 500 kV CB. The MOPS BGS line/G11 transformer 500 kV CB remained out of service.</p> <p>4. On 24 August 2023, following replacement of the faulty CT, the MOPS BGS line/G11 transformer 500 kV CB was returned to service.</p>
<b>Incident cause</b>	<p>AusNet Services' post-incident investigation has confirmed that:</p> <ul style="list-style-type: none"> <li>There was an internal flashover within the blue phase CT housing associated with the MOPS BGS line/G11 transformer 500 kV CB (see Figure 1).</li> <li>As the flashover occurred between the CT and the CB, the fault was within the MOPS – BGS 500 kV line protection zone and outside the MOPS G11 500/20 kV differential protection zone. The MOPS – BGS 500 kV line protection operated as expected and tripped the MOPS – BGS 500 kV line and the BGS A1 500/220 kV transformer. The fault remained uncleared as it was located outside the area disconnected by the CBs, and the MOPS – BGS 500 kV line protection continued to measure an in zone fault. As a result, the CBF protection operated and tripped the MOPS G11 No. 2 Bus 500 kV CB after 117 milliseconds (ms) (greater than the requirement of 80/100 ms for primary protection, but less than 175 ms for circuit breaker fail operation), disconnecting the MOPS G11 500/20 kV transformer.</li> <li>All protection referred to in this section operated as expected.</li> </ul>

<b>Rectification</b>	<p>The MOPS BGS line/G11 Transformer 500 kV CB was isolated until AusNet Services replaced the associated faulty CT on 24 August 2023. AusNet Services is working with the original equipment manufacturer (OEM) of the faulty CT to identify the root cause of the failure.</p> <p>AEMO and AusNet Services have shared the findings of this incident with the Power System Security Working Group (PSSWG) at the Q4 2023 meeting.</p>
<b>Power system security</b>	<p>The power system remained in a secure operating state throughout this incident and the power system frequency remained within the Frequency Operating Standard<sup>8</sup>. As shown in Figure 3, a single phase voltage dip to 0.57 p.u. was recorded by a phasor measurement unit (PMU) on the 500 kV at Moorabool Terminal Station (MLTS).</p> <p>AEMO invoked the constraint sets:</p> <ul style="list-style-type: none"> <li>V-MOPS_GT1_B2CB and V-MORTLAKE1_ZERO between 0710 hrs and 1220 hrs on 9 July 2023 to manage the disconnection of the MOPS G11 connection point.</li> <li>V-MO_CB, V-DUNDWF1_ZERO, V-DUNDWF2_ZERO and V-DUNDWF3_ZERO between 0710 hrs and 1535 hrs on 9 July 2023 to manage the disconnection of the DDWF connection point.</li> </ul> <p>AEMO's post-incident review has confirmed that constraint sets V-MOPS_GT1_B2CB and V-MO_CB were not required for this event and are only required during a single CB outage at MOPS. These constraints normally monitor DDWF output and constrain dispatch to maintain Victoria – New South Wales Interconnector (VNI) stability<sup>9</sup>, however, as DDWF was isolated from the system during this incident, these constraints could not bind and therefore could not influence power system dispatch. AEMO has updated the descriptions of V-MOPS_GT1_B2CB and V-MO_CB to clarify the applicable conditions for invoking V-MOPS_GT1_B2CB and V-MO_CB.</p>

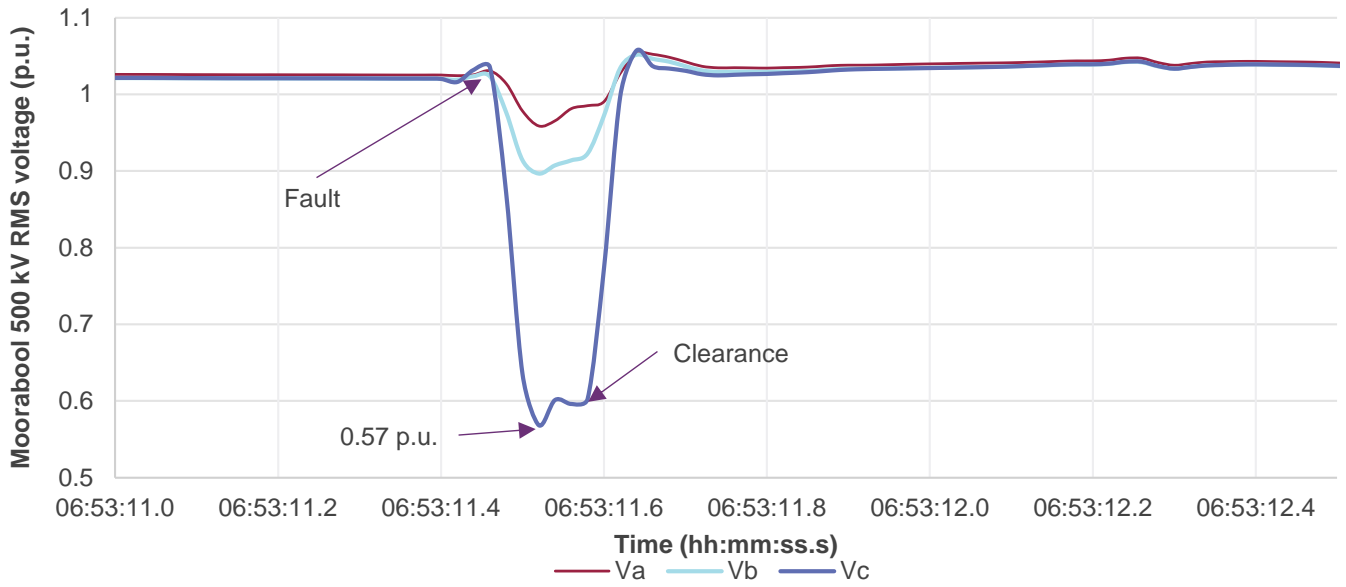
Figure 3 Voltage recorded by PMUs at MLTS 500 kV on 9 July 2023

<b>Power system response (facilities and services)</b>	<p>Following the trip of the MOPS – BGS 500 kV line and the BGS A1 500/220 kV transformer, DDWF was disconnected from the system and tripped as expected due to operation of DDWF anti-islanding protection. AEMO identified that the following generators (see Figure 2) had unexpected performance during the incident:</p> <ul style="list-style-type: none"> <li>Salt Creek WF – AEMO has confirmed that turbines at Salt Creek WF tripped due to a turbine parameter settings issue. The parameter was corrected by the proponent in consultation with AEMO on 30 August 2023.</li> <li>Mt Mercer WF – Mt Mercer Windfarm Pty Ltd has confirmed that 24 turbines at Mt Mercer WF tripped due to a converter parameter issue. AEMO is continuing to work with Mt Mercer Windfarm Pty Ltd regarding the correction of the converter parameter issue.</li> <li>Portland Cape Nelson South WF – AEMO has confirmed that 15 turbines at Portland Cape Nelson South WF tripped due to a converter timer fault. The fault was corrected by the proponent in consultation with AEMO on 1 November 2023.</li> <li>Mortlake South WF – Acciona has confirmed that the generation reduction during this event was caused by a fault ride through settings issue. AEMO is continuing to work with Acciona regarding the correction of the settings issue.</li> </ul> <p>There was no further impact on the broader power system, load or generation attributed to the response of these generators.</p> <p>The event highlights the potential for power system faults to result in unexpected response of generating facilities and the impact on overall contingency size.</p>
