Trip of Ross 275 kV No. 2 busbar on 21 October 2023

June 2024

Reviewable Operating Incident
Report under the National
Electricity Rules

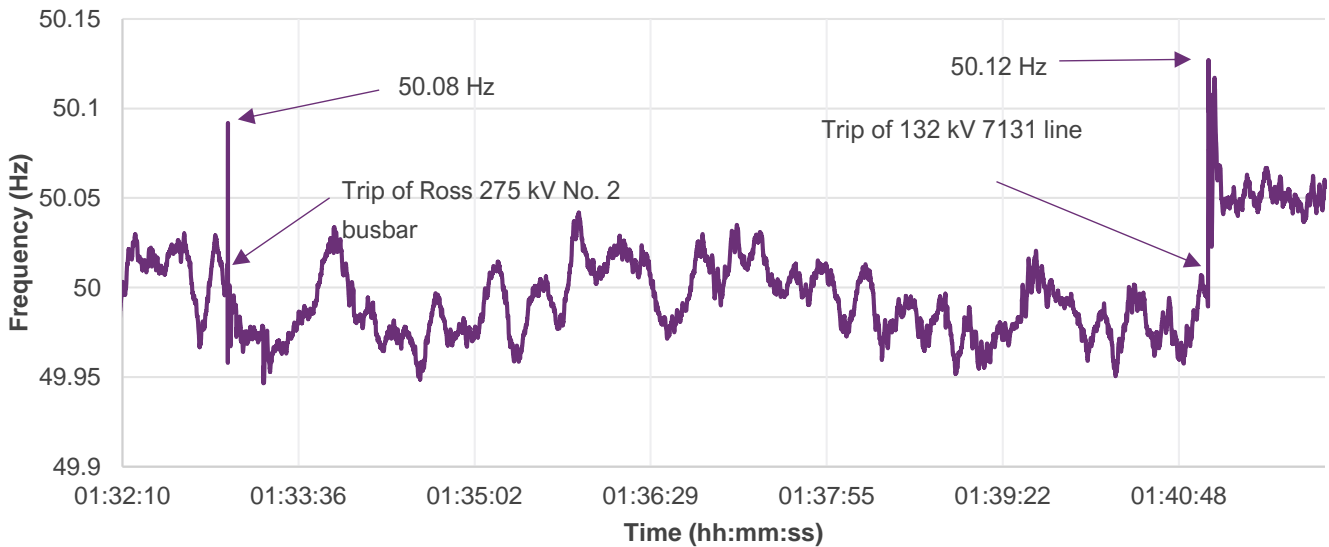
Figure 1 Power system frequency on 21 October 2023

As a result of the trip of the Ross 275 kV No. 2 busbar at 0133 hrs, the frequency reached a maximum of 50.08 Hz before immediately returning to normal levels. The trip of the 132 kV 7131 line and the loss of 213 MW of load at 0141 hrs resulted in a maximum frequency of 50.12 Hz before immediately returning to approximately 50.05 Hz.

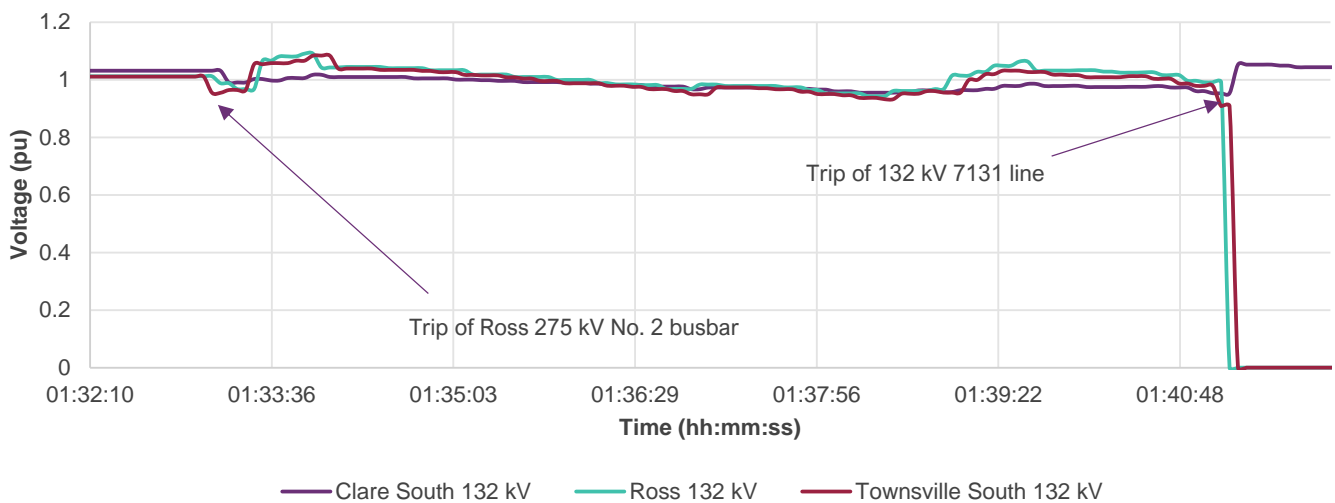
Figure 2 Voltage on 132 kV network 21 October 2023

Following the trip of Ross 275 kV No. 2 busbar at 0133 hrs, and until 0141 hrs when the 132 kV 7131 line tripped, the voltages on the 132 kV network remained within the voltage limits defined in the NER⁹ and as specified by Network Service Providers (NSPs) in limits advice to AEMO.

At 0141 hrs, the 132 kV 7131 line tripped and disconnected all load on the 132 kV network between Clare South and Tully substations.

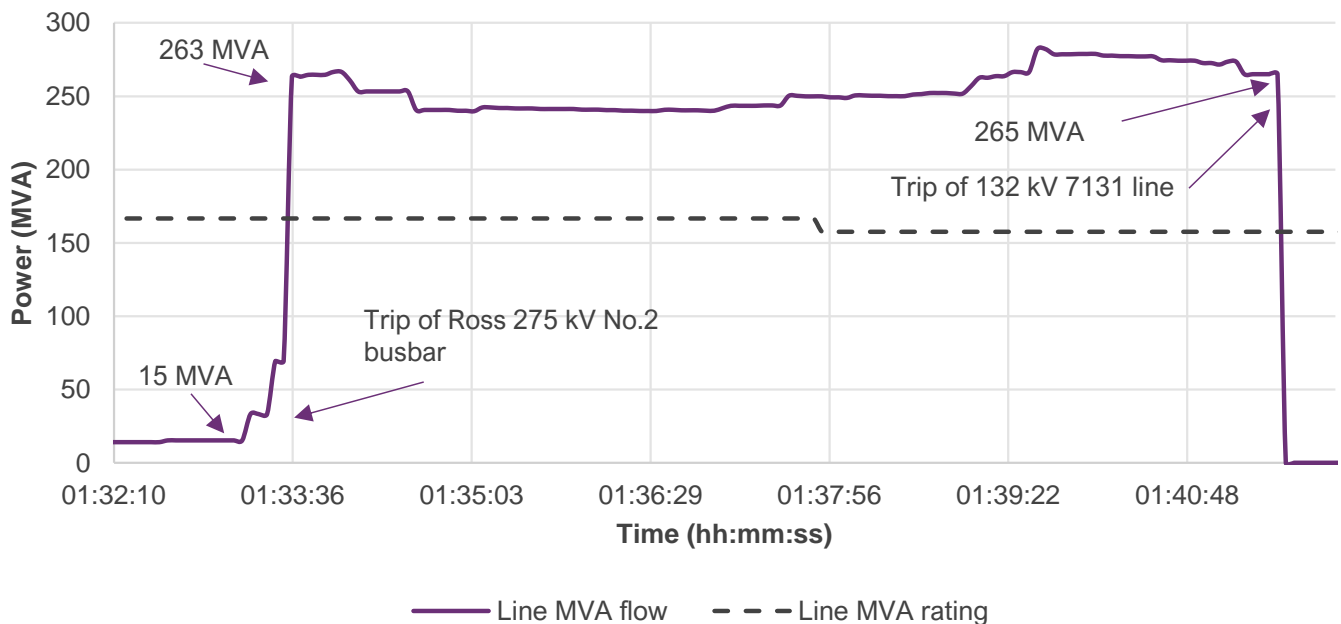
Figure 3 Load flow on 132 kV 7131 line on 21 October 2023

The applicable line rating for 132 kV 7131 line at the time was 167 MVA. The initial overload of 132 kV 7131 line was almost 60% above the dynamic line rating. The 132 kV 7131 line is protected by current differential and distance protection. Neither line protection could detect the line overloading condition. The line protection operated correctly later when a phase-to-phase fault occurred on the overhead conductors.

Immediately following the Ross 275 kV No. 2 busbar trip at 0133 hrs on 21 October 2023, the 132 kV 7131 line load flow increased from 15 MVA to 263 MVA. The initial overload of the 132 kV 7131 line was almost 60% above the line rating of 167 MVA.

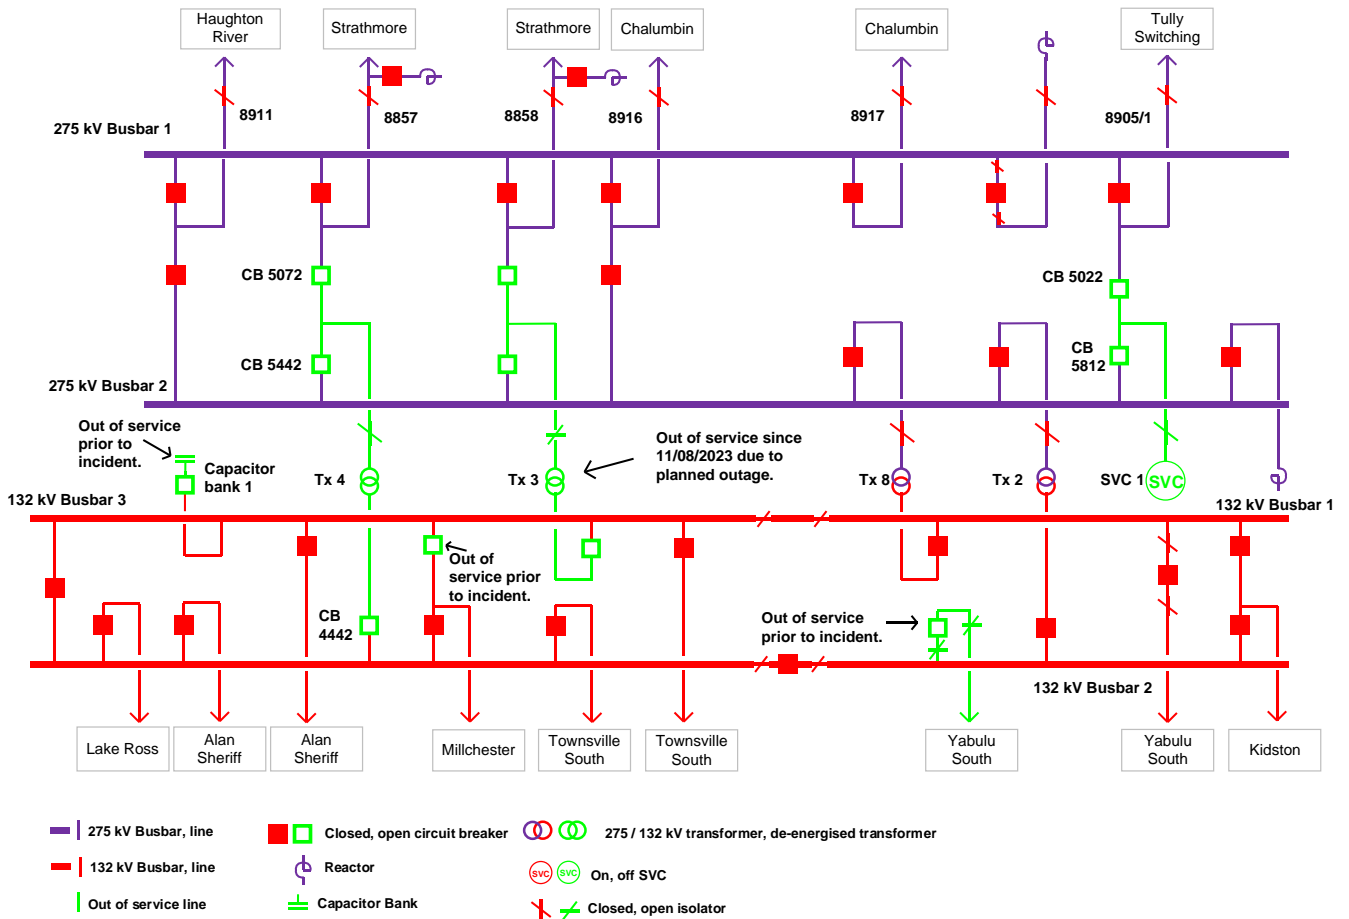
Figure 4 Ross substation at 0104 hrs on 21 October 2023, following the trip of Ross No. 4 275/132 kV transformer and 275 kV No. 1 SVC

At 0104 hrs on 21 October 2023, there was a credible trip of the Ross No. 4 275/132 kV transformer and 275 kV No. 1 SVC. This event was previously reclassified by AEMO as a credible contingency event as per MN 109794 issued at 1450 hrs on 13 September 2023. At the time of the Ross No. 4 275/132 kV transformer and 275 kV No. 1 SVC trip on 21 October 2023, the Ross No. 3 transformer was on a planned outage. The trip of No. 4 275/132 kV transformer resulted in all the Ross 132 kV load being supplied by No. 2 and No. 8 transformers which are supplied by the Ross 275 kV No. 2 busbar (see Figure 4 and Figure 5).

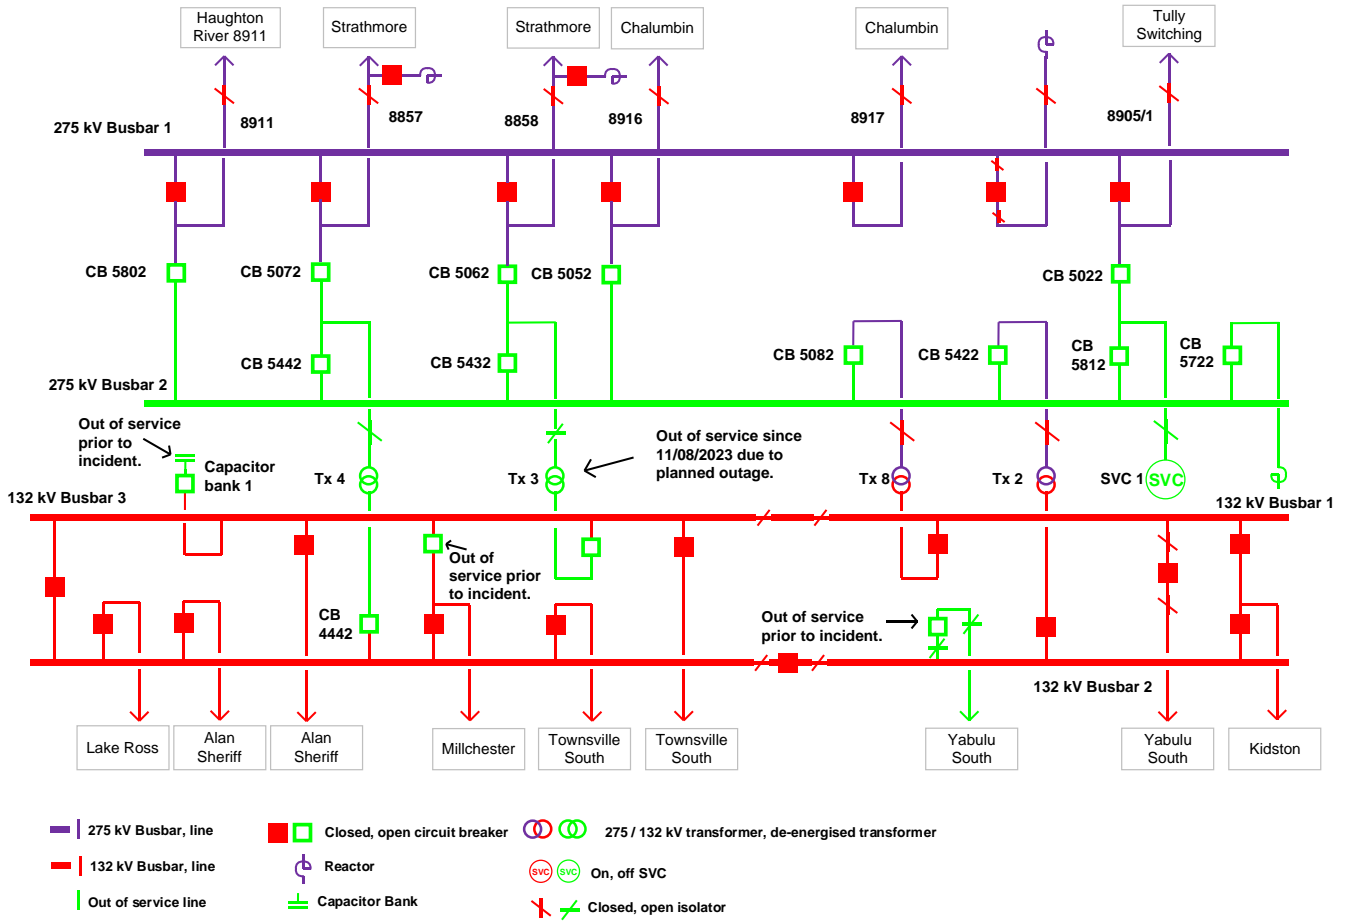
Figure 6 Ross substation at 0133 hrs on 21 October 2023, following the trip of Ross 275 kV No. 2 busbar

At 0133 hrs on 21 October 2023, the Ross 275 kV No. 2 busbar tripped when the 275 kV 5812 CB was closed during the restoration of 275 kV No. 1 SVC. The busbar trip was caused by the operation of 5812 CB CBF X protection, which was unexpected. This protection operation resulted in all the Ross 132 kV load no longer being supplied by No. 2 and No. 8 275/132 kV transformers, leaving load supplied from the Strathmore 275/132 kV substation via the 132 kV network and 132 kV 7131 line (see Figure 6 and Figure 7).

The post-incident investigation by Powerlink identified an issue with the CBF X protection relay trip output design which resulted in an un-enunciated latched trip signal that led to the operation of the CBF X protection when 275 kV 5812 CB was closed.

Powerlink informed AEMO on 4 December 2023 that the 5812 CB CBF X protection relay trip output design had been corrected on 26 October 2023.

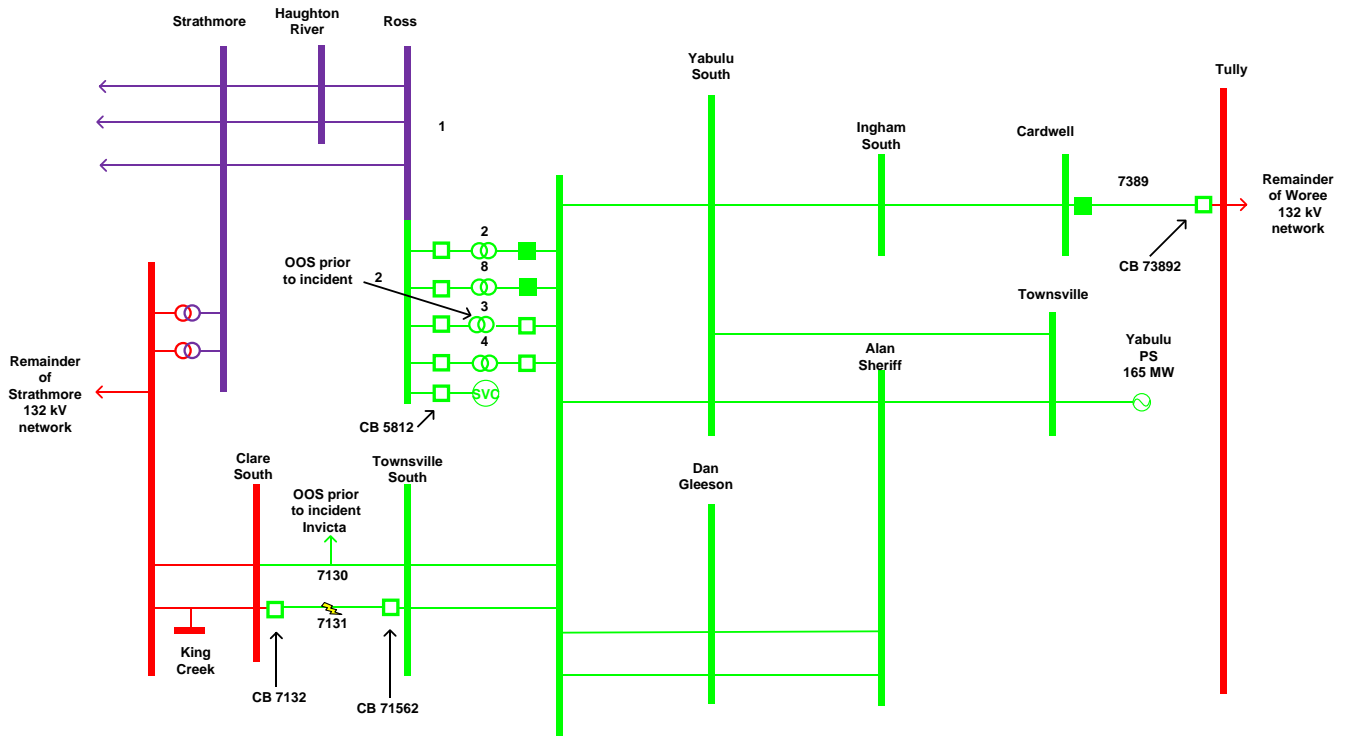
Figure 8 Ross 132 kV network at 0141 hrs on 21 October 2023, following the trip of 132 kV 7131 line

Subsequently, 132 kV 7131 line was thermally overloaded for approximately eight minutes between 0133 hrs and 0141 hrs, at which time the line tripped due to a phase-to-phase fault. This disconnected the 132 kV network between Clare South and Tully substations (see Figure 8) with the resultant loss of 213 MW of load.

At 0141 hrs on 21 October 2023, the 132 kV 7131 line tripped due to the operation of its X differential and Y distance line protection systems following an A phase – B phase HV fault on the line conductors. The line protection operated as expected. The 132 kV 7131 line fault was cleared within 66 milliseconds. Townsville South 132 kV 71312 CB successfully auto reclosed at 0141 hrs, however as the Townsville South 132 kV busbar was already de-energised from the Ross 132 kV network, auto reclose did not operate at Clare South as the line was not in an energised state, preventing any load being restored.

The trip of the 132 kV 7131 line, approximately eight minutes after the Ross 275 kV No. 2 busbar trip, resulted in the disconnection of the 132 kV network between Clare South and Tully substations and the loss of 213 MW of load interrupting the following 132 kV substations:
