# Trip of South East No. 1 and No. 2 SVC on 12 October 2023

April 2024

Reviewable Operating Incident  
Report under the National  
Electricity Rules

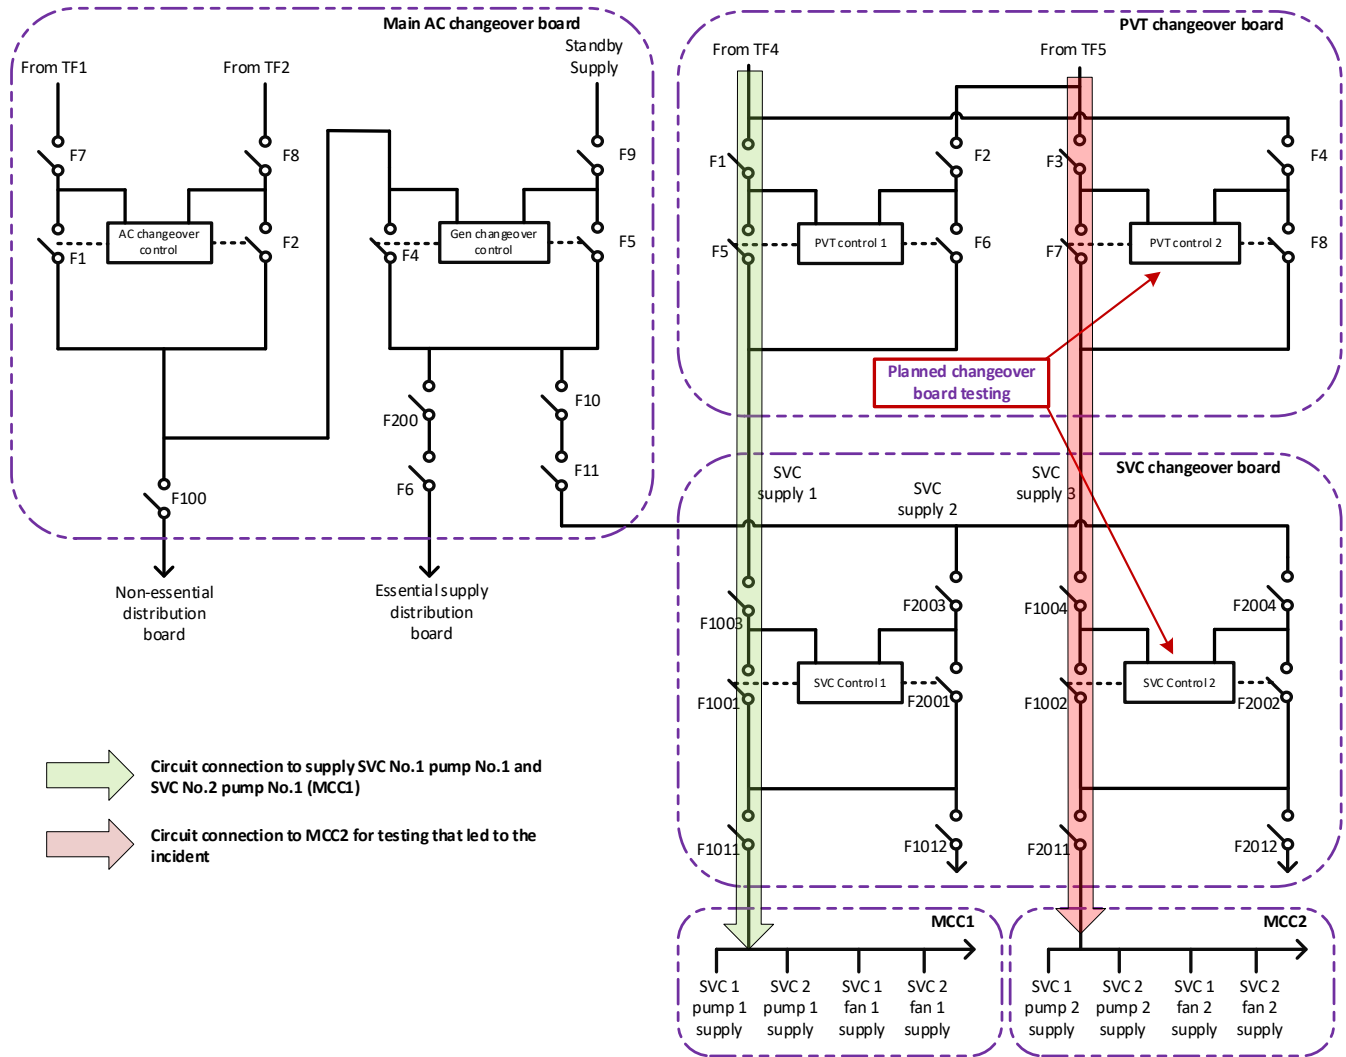
Figure 1 South East AC changeover system

<b>Pre-incident conditions</b>	<p>On 12 October 2023, ElectraNet staff were carrying out planned testing of 415 V supply changeover system at South East Substation. South East 275 kV SVC No. 1 cooling pump No. 1 and SVC No. 2 cooling pump No. 1 were in operation with power supplied from the motor control centre (MCC)1 board. This test procedure included testing of PVT control 2 changeover and SVC control 2 changeover associated with MCC2 as shown in Figure 1.</p> <p>The final test was to confirm the correct automatic switching of the SVC 415 V auxiliary supply to TF4 when the TF5 supply becomes unavailable. As per the test plan, this was to be achieved by opening isolator F3 manually. The test plan required contactor F2011 to be in open state to ensure that isolator F3 operated without any load current. Testing affected 415 V supply to MCC2 only. Furthermore, as South East 275 kV SVC No. 1 cooling pump No. 2 and SVC No. 2 cooling pump No. 2 were not in service, ElectraNet was not expecting that making changes to the 415 V supply of MCC2 would interrupt the operation of the SVCs.</p>

Details	
<b>Rectification</b>	<ul style="list-style-type: none"> <li>To reduce the risk of a re-occurrence of this incident during future planned maintenance works, ElectraNet have updated their testing procedure to account for the 'supply fail latching' signal associated with the South East SVC 415 V MCC boards.</li> <li>ElectraNet have advised that this incident could re-occur if, following an MCC1 or MCC2 supply failure, and prior to the 'supply fail latching' signal being reset, the remaining in-service MCC supply fails. This risk will remain until the SVC control system is replaced. ElectraNet has confirmed that the SVC control system is due for replacement and regulatory investment test for transmission has been issued (although the replacement works have not yet been approved). To address this risk, ElectraNet plans to review all alarm signals associated with South East 275 kV SVC No. 1 and No. 2 auxiliary supplies to ensure that the alarm text displayed in their EMS matches the functionality. As part of this work ElectraNet will also update the relevant operating procedures. These EMS updates will allow ElectraNet to quickly identify that an MCC1 or MCC2 415 V supply failure has occurred and take appropriate action, reducing the risk that a subsequent MCC 415 V supply failure causes both South East SVCs to trip.</li> <li>ElectraNet has updated the signage on the South East 275 kV SVC No. 1 and No. 2 415 V auxiliary supply changeover system to improve clarity for on site staff.</li> <li>The operating time and the timer setting of all South East SVC 415 V auxiliary supply changeover circuits were tested and it was identified that the timer setting<sup>8</sup> of the SVC PVT control 2 changeover and SVC control 2 changeover were inconsistent, with overall supply fail time delays approaching 5 s. ElectraNet has confirmed that for correct operation, these fail times should be set to less than 2 s as the 'Cooling System Fail Trip' protection is set to operate if the SVC 415 V auxiliary supply is lost for more than 5 s. ElectraNet has corrected the timer setting of all changeover circuits of South East SVC 415 V auxiliary supply changeover system including PVT control 2 changeover and SVC control 2 changeover and has confirmed that the 415 V auxiliary supply changeover system operates after a maximum supply fail time of 1.5 s.</li> </ul>

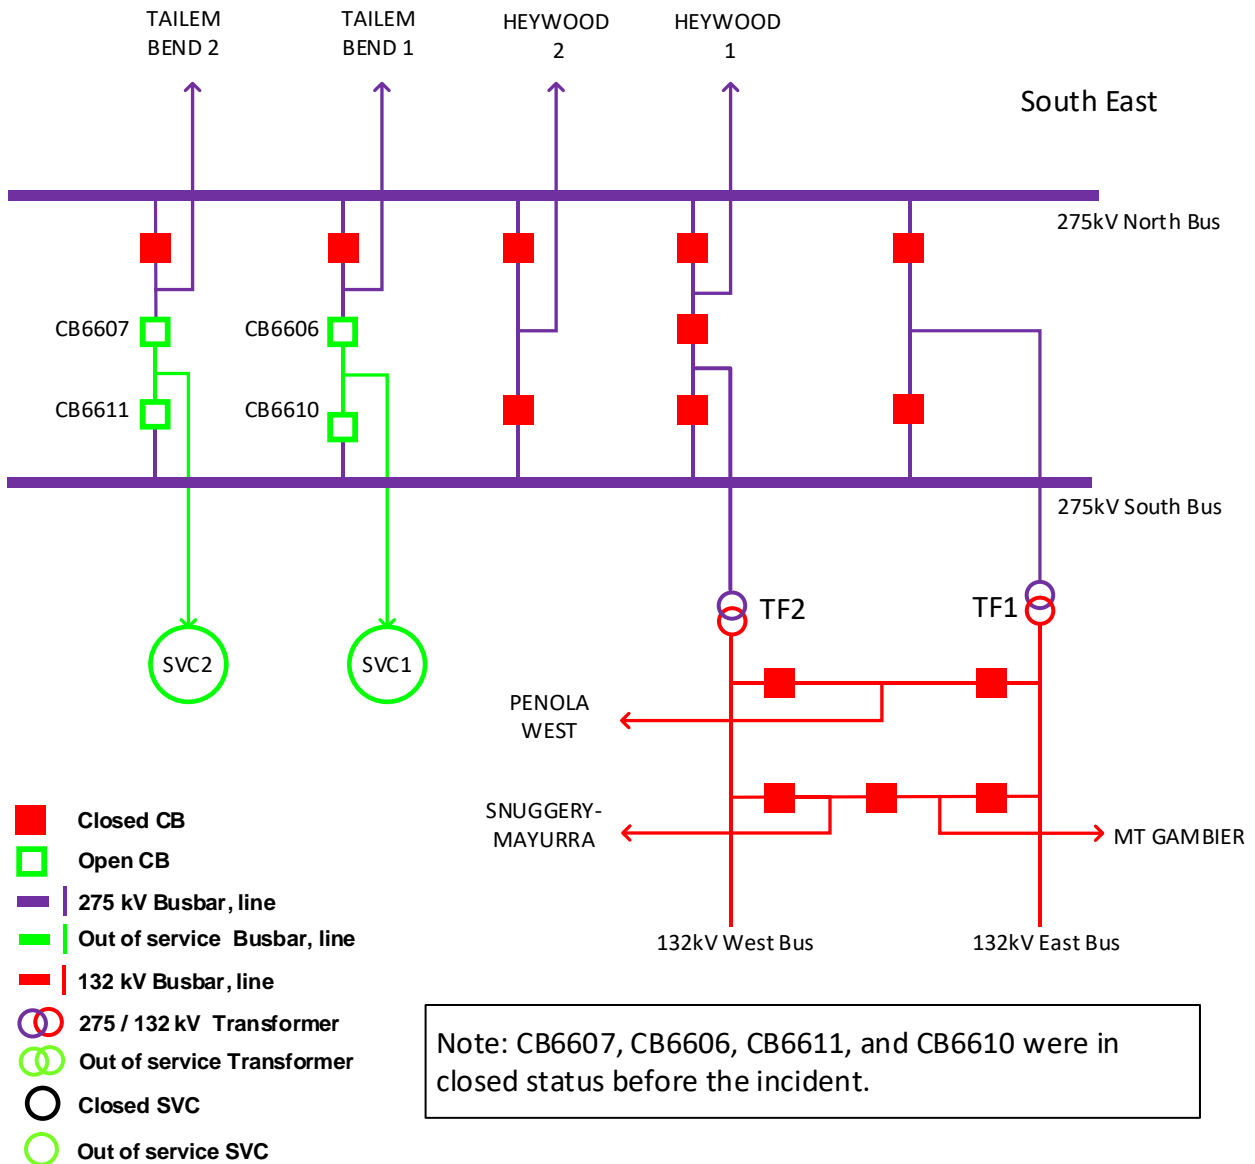
Figure 2 Incident diagram – Network representation immediately after the incident

<b>Incident key events</b>	<ol style="list-style-type: none"> <li>1. At 1524 hrs on 12 October 2023, South East 275 kV SVC No. 1 and No. 2 tripped.</li> <li>2. At 1607 hrs on 12 October 2023, South East 275 kV SVC No. 1 was returned to service.</li> <li>3. At 1609 hrs on 12 October 2023, South East 275 kV SVC No. 2 was returned to service.</li> </ol>
<b>Incident cause</b>	<p>ElectraNet’s post-incident investigation has confirmed that:</p> <ul style="list-style-type: none"> <li>• When contactor F2011 was opened, it caused MCC2 to be de-energised as expected. However, it also caused South East 275 kV SVC No. 1 and No. 2 ‘Cooling System Fail Trip’ protection to operate, opening circuit breaker (CB) 6610, CB 6606, CB 6607, and CB 6611 (see Figure 2). Therefore, at 1524 hrs on 12 October 2023, the 415 V auxiliary supplies to the South East SVC No. 1 and No. 2 cooling systems were interrupted and South East SVC No. 1 and No. 2 tripped after approximately 7 s. The cooling system protection operated in line with expected performance. Following the trip, all testing was abandoned, and the 415 V SVC auxiliary supply system was returned to its normal position with TF4 supplying MCC1 and TF5 supplying MCC2.</li> <li>• ElectraNet did not expect the SVC ‘Cooling System fail Trip’ to operate during the planned testing as ElectraNet was unaware of a ‘supply fail latching’ signal associated with the SVC 415 V MCC boards. During its investigation ElectraNet identified that a latching signal would become active in the SVC control system if the MCC board lost supply for more than 5 s. Furthermore, the latching signal would remain active even after the affected MCC 415 V supply was restored. ElectraNet also identified that once activated the latching signal associated with MCC remains active until it is reset from the SVC human machine interface (HMI). This signal is an input to an AND gate and if the other MCC fails then that will also send high latching signal through the AND gate, causing the ‘Cooling System Fail Trip’ protection to operate, irrespective of whether the SVC cooling system remains in service. ElectraNet has identified the root cause of the incident as a design error in the South East 275 kV SVC No. 1 and No. 2 controller, as the ‘supply fail latching’ signal is not required/desirable for the correct controller operation and could trip the SVC unnecessarily if the latched signal was not reset.</li> <li>• The onsite labelling of the South East 275 kV SVC No. 1 and No. 2 415 V auxiliary supply changeover system were ambiguous in relation to the site drawings. The equipment labels on the SSD were also incomplete and ElectraNet’s EMS alarm system did not display clear alarms for a South East SVC MCC1 or South East SVC MCC2 supply fail. ElectraNet has confirmed that this increased the complexity of the work being completed by the test team on 12 October 2023 and contributed to the incident.</li> </ul>
