Trip of Tungkillo East 275 kV Busbar on 4 September 2023

January 2024

Reviewable Operating Incident
Report under the National
Electricity Rules

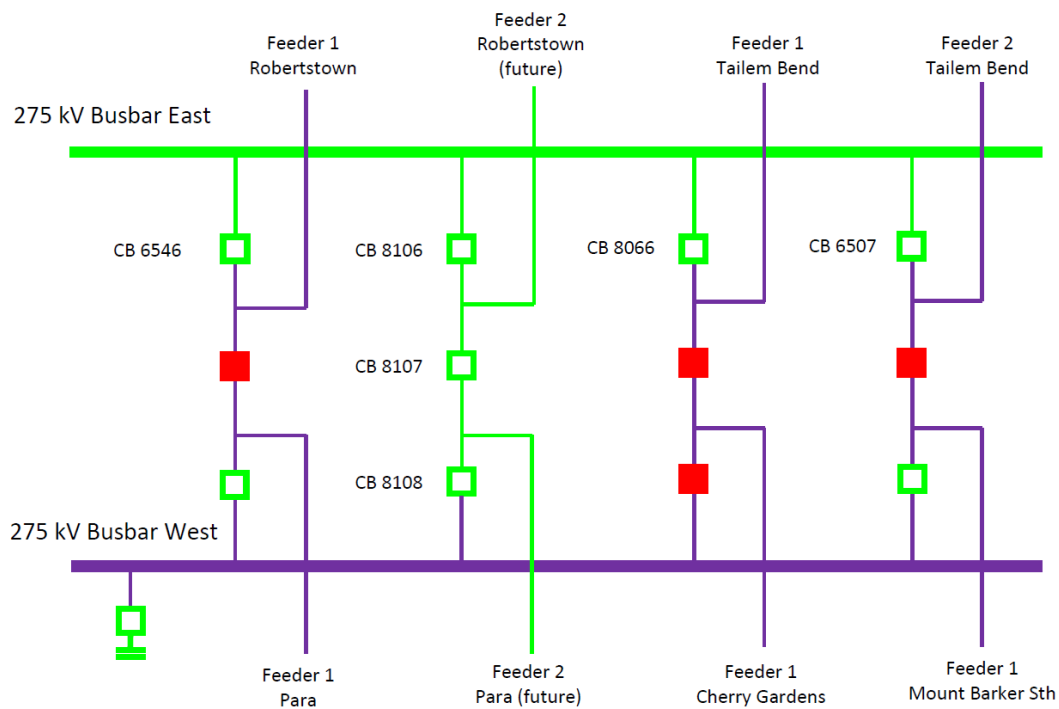
Figure 2 Post-incident diagram – Tungkillo substation

Details	
Reviewable operating incident type	Non-credible contingency event impacting critical transmission elements.
Incident details	This report relates to a reviewable operating incident ³ that occurred on 4 September 2023 in South Australia. The incident involved the trip of the Tungkillo East 275 kilovolt (kV) busbar.
Incident classification	Other causes – Human error. Bypass of secondary isolation when fitting test wiring.
Generation impact	No generation was lost as a result of this incident.
Customer load impact	No load was lost as a result of this incident.
Pre-incident conditions	Prior to the event, ElectraNet contractors were undertaking protection testing works related to the future Tungkillo – Robertstown 275 kV No. 2 and Tungkillo – Para 275 kV No. 2 lines. Figure 1 illustrates the pre-incident network configuration.
Incident key events	<ol style="list-style-type: none"> At 1252 hrs on 4 September 2023, the Tungkillo 275 kV East busbar zone protection operated and circuit breaker (CB) 6546, CB 8066 and CB 6507 opened to de-energise the Tungkillo East 275 kV busbar. At 1340 hrs on 4 September 2023, Tungkillo 275 kV East busbar was returned to service.
