POWER SYSTEM OPERATING INCIDENT REPORT TRIP OF TULLY NO.2 132 KV BUSBAR AND TULLY — INGHAM SOUTH TEE CARDWELL 132 KV LINE ON 9 MAY 2011

PREPARED BY:	Electricity System Operations Planning and Performance
VERSION:	1.0
DATE:	9 September 2011
FINAL

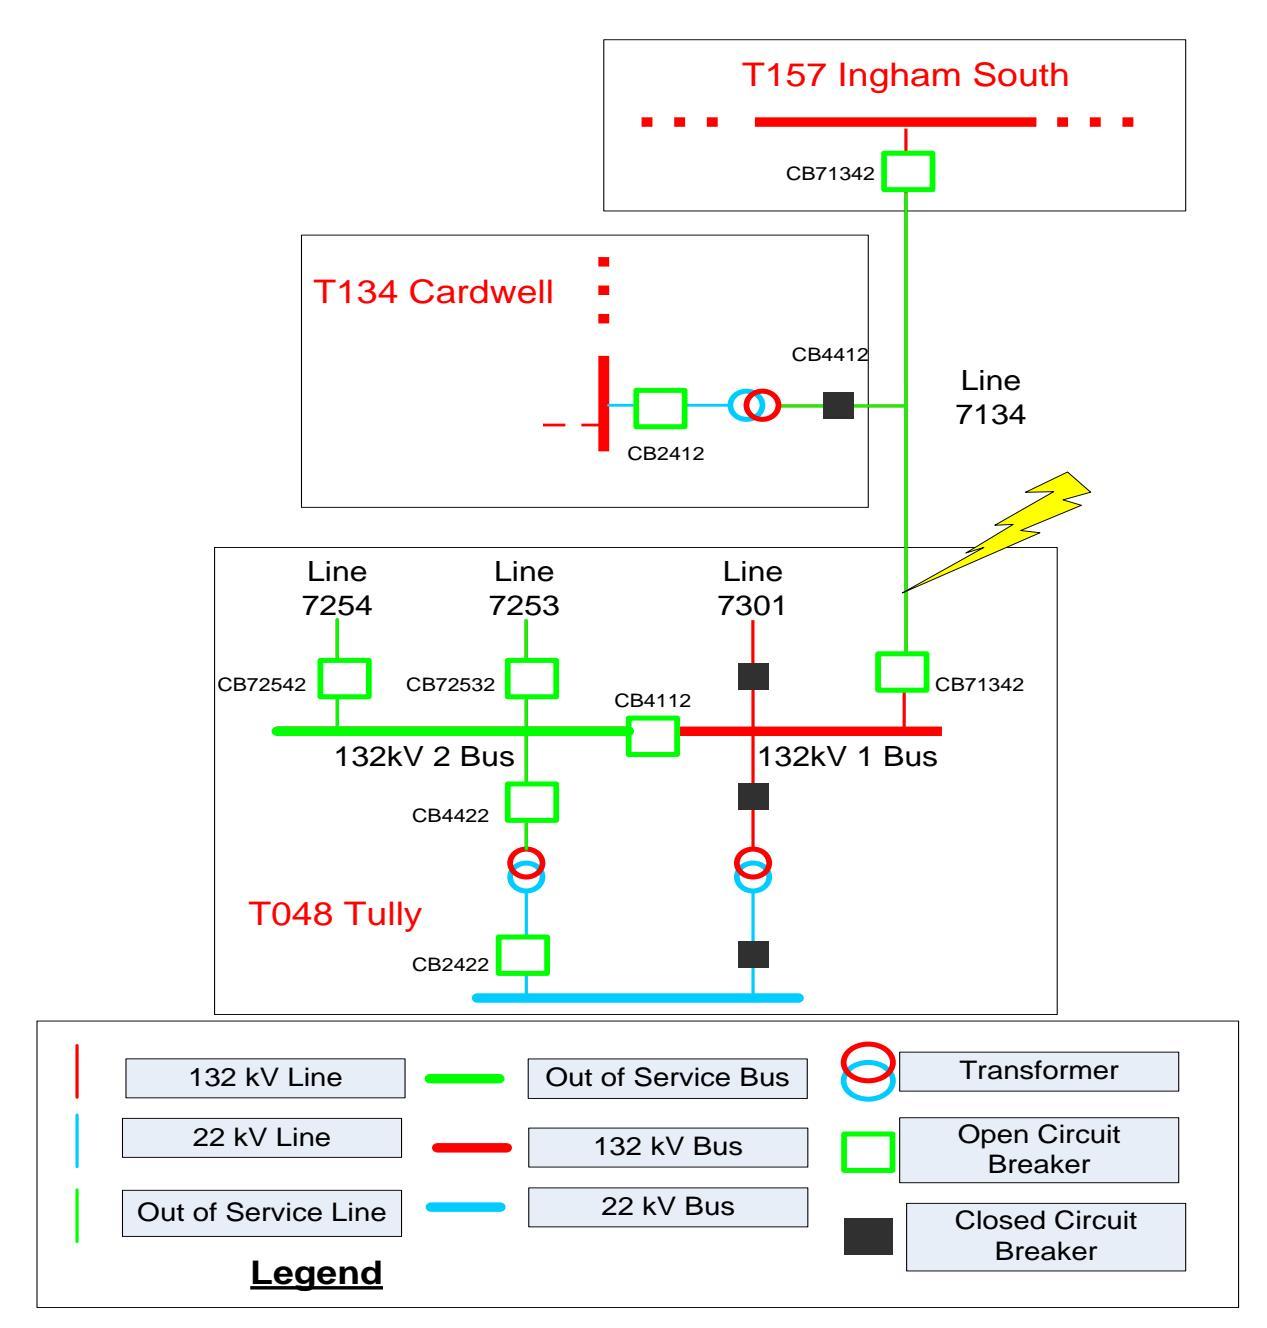
Figure 2: Status of power system immediately after the tripping of 7134 line and the Tully No.2 busbar

At approximately 2329 hrs on 9 May 2011, the 7134 Tully — Ingham South tee Cardwell 132 kV line tripped. Figure 2 below shows the status of the power system immediately after the line trip. The trip was caused by one phase to ground fault on 7134 line. The high voltage fault was cleared and the line was auto-reclosed within five seconds.

The No.2 132 kV busbar at Tully substation tripped immediately following the high voltage fault on 7134 line. This was due to the operation of circuit breaker fail protection associated with the bus section CB 4112. The busbar trip resulted in the off-loading of transmission lines connected to the No.2 busbar and No. 2 transformer. Figure 2 below shows the status of power system immediately after the busbar trip. Figure 3 shows the status of the power system after 7134 line was successfully auto-reclosed. The operation of the circuit breaker fail protection was not expected.

A line patrol of 7134 line that was carried out did not find evidence of a fault. Following the trip of No. 2 132 kV Tully busbar, Powerlink investigated the cause of the trip. This investigation revealed that the circuit breaker fail protection associated with Tully 132 kV bus section CB 4112 operated unexpectedly due to an issue with its settings. Powerlink implemented the correct setting and the relay was returned to service shortly after the event.

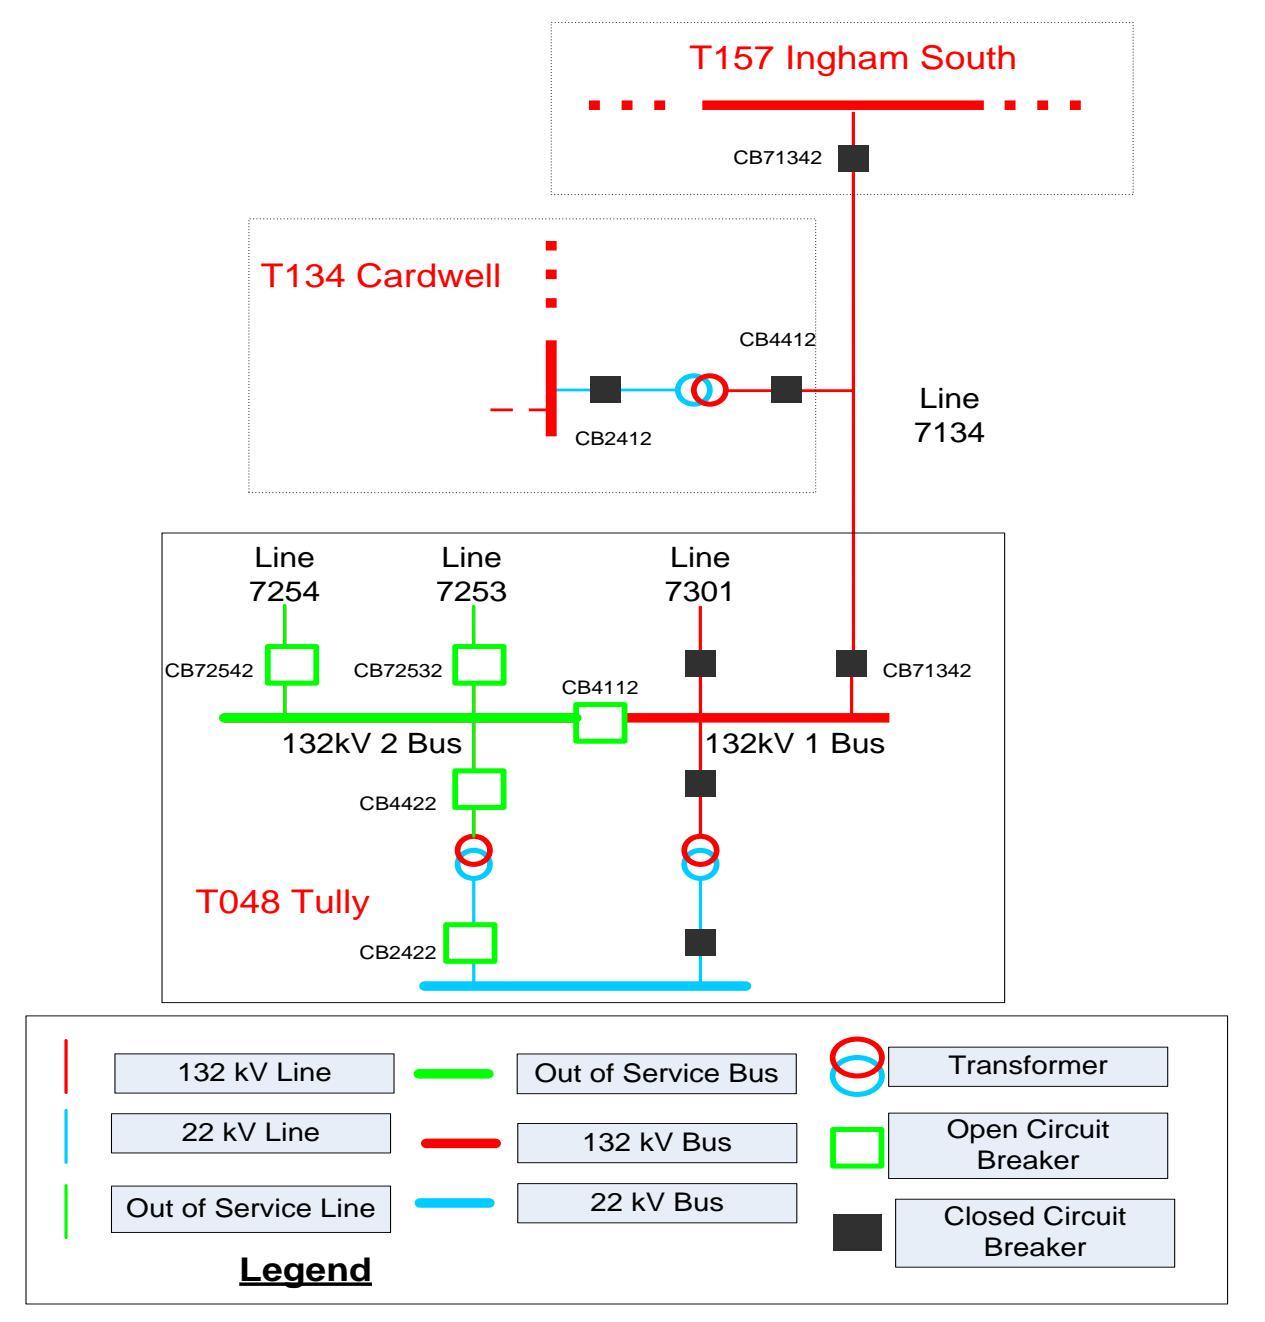
Figure 3: Status of the power system after auto-reclosing of the 7134 line

At 2352 hrs, the No.2 busbar at Tully substation was returned to service. The 132/22 kV No.2 transformer at Tully substation was returned to service at 2355 hrs. There was no load interruption or disconnection of generation as a result of this system incident.
