POWER SYSTEM OPERATING INCIDENT REPORT – SIMULTANEOUS TRIP OF 97G MURRAY - GUTHEGA 132 KV LINE AND MURRAY TIE TRANSFORMERS 330/132 KV ON 14 FEBRUARY 2013

PREPARED BY: System Performance and Commercial

DATE: 16 May 2013

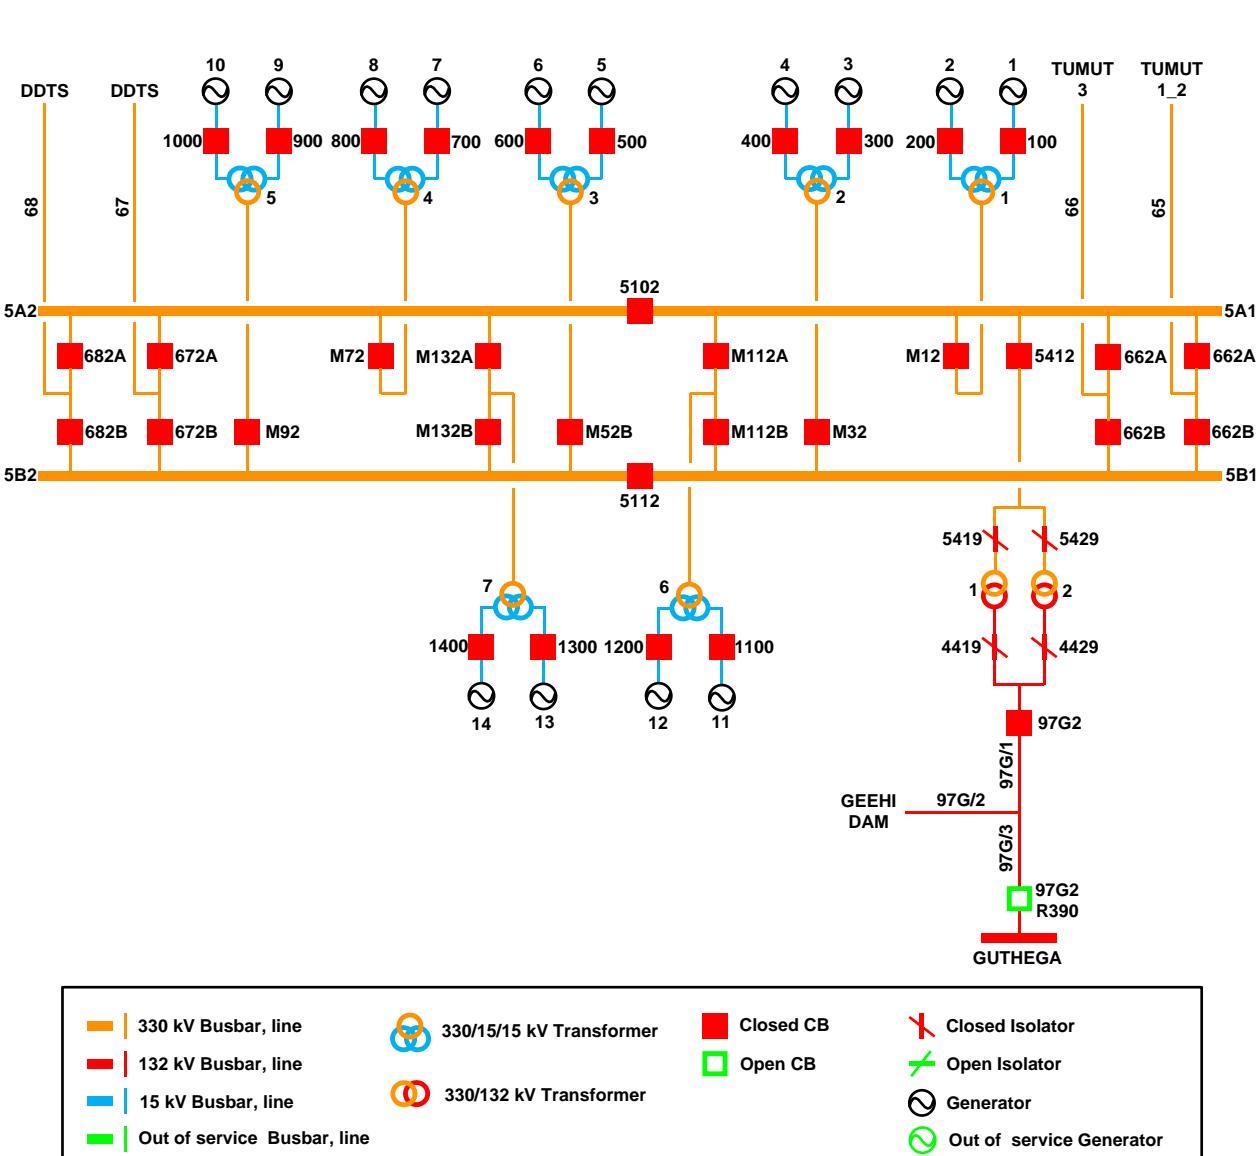
The 97G Murray – Guthega 132 kV Transmission Line and the Murray 1 and 2 330/132 kV Tie Transformers were energised but deloaded at the time of the event because the 97G Murray – Guthega 132 kV Transmission Line was open at the Guthega Power Station¹.

The status of the power system prior to the incident is shown in Figure 1.

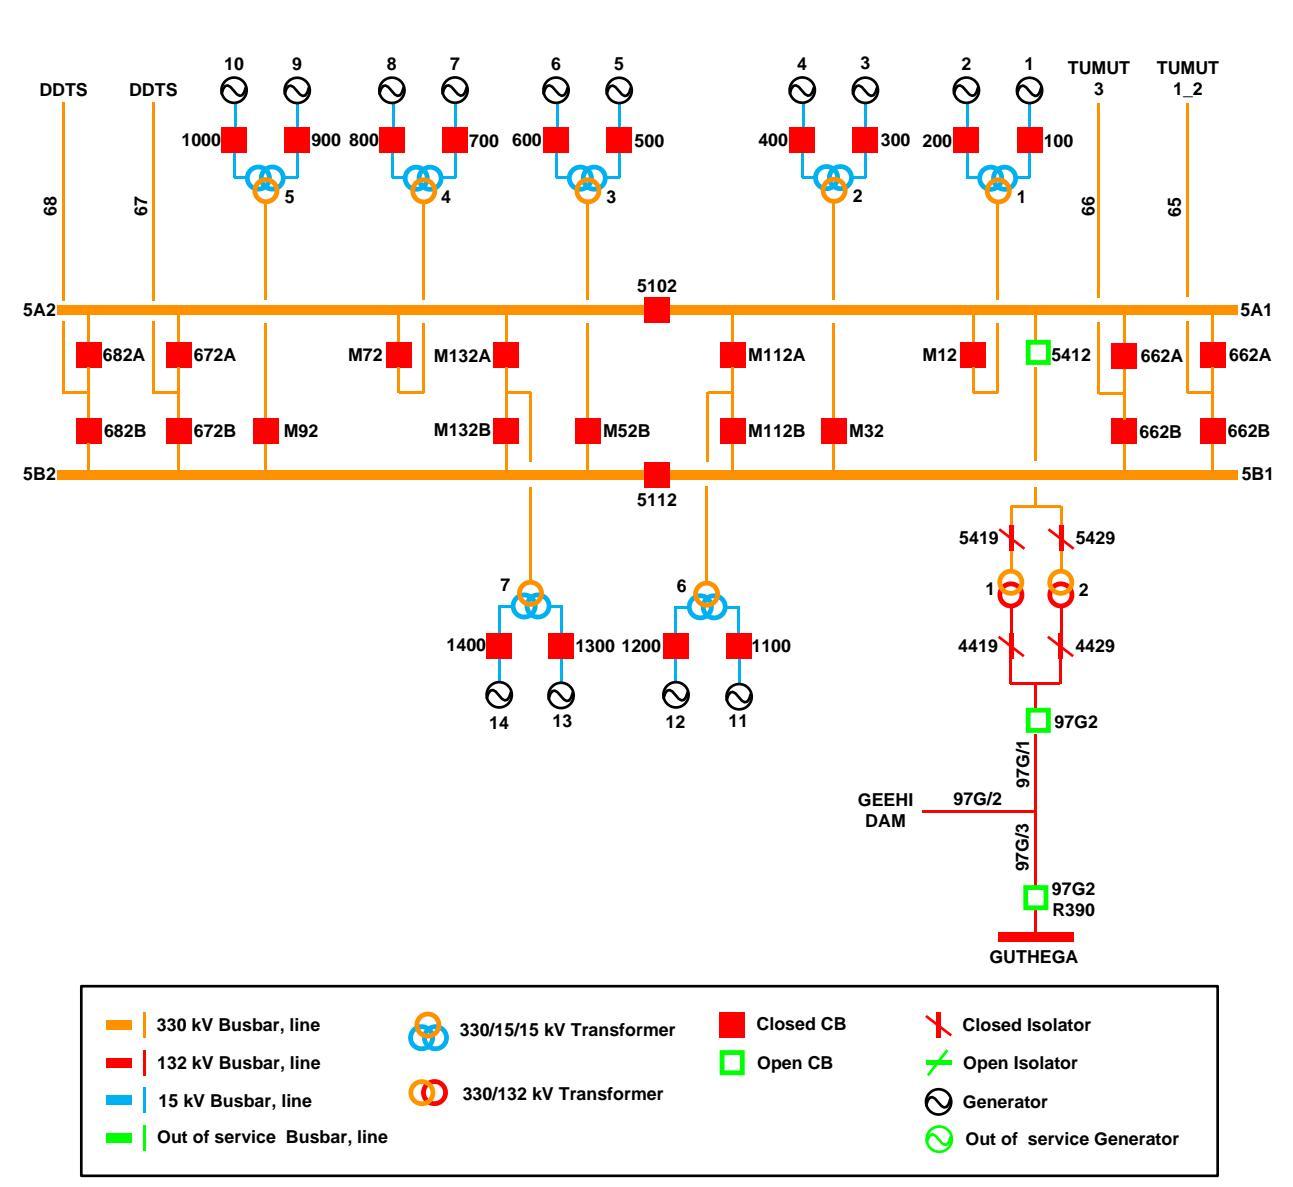
On 14 February 2013 at 13:11 hrs the 97G Murray – Guthega 132 kV Transmission Line and the Murray 1 and 2 330/132KV Tie Transformers tripped simultaneously. Lightning was present in the vicinity of the line at the time. Transgrid advised that the trip of the Murray 1 and 2 330/132 kV Tie Transformers was unexpected and likely due to either slow circuit breaker operation or maloperation of the local back-up protection, but this has not been confirmed.

The status of the power system immediately after the incident is shown in Figure 2.

Transgrid to complete protection and circuit breaker testing and advise AEMO of the outcomes by 30 June 2013.
