Simultaneous trip of Cherry Gardens – Tailem Bend 275 kV and Mobilong – Tailem Bend 132 kV lines on 20 September 2020

July 2021

Reviewable Operating Incident Report under the National Electricity Rules

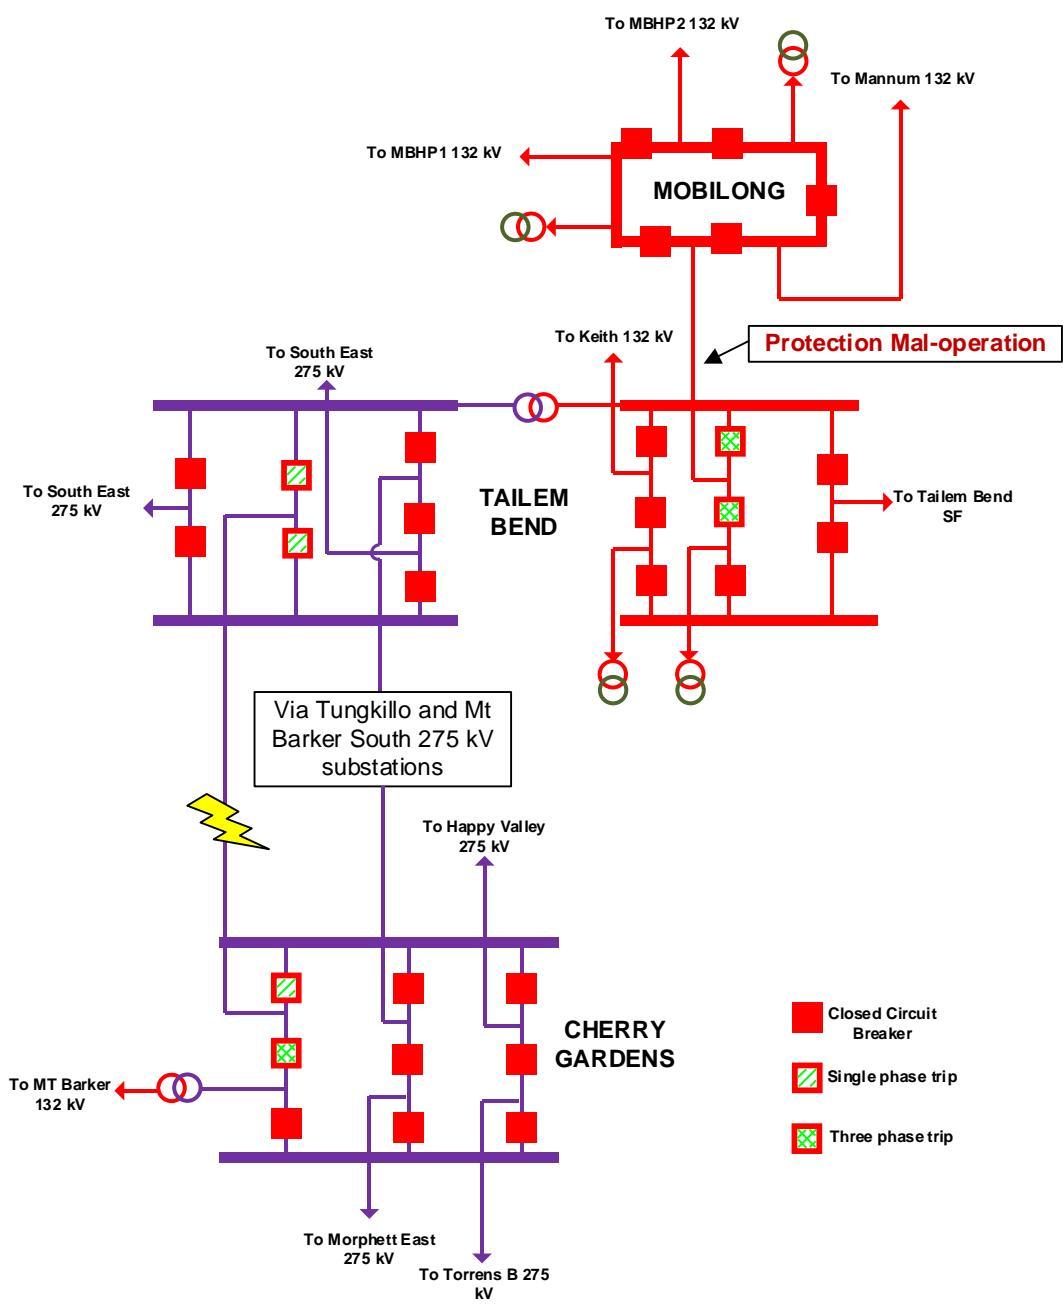
Incident cause	Post-incident analysis has concluded that at 1736 hrs on 20 September 2020 a lightning strike caused a single phase to ground fault on the CHG-TBE 275 kV transmission line. This caused the CHG-TBE 275 kV line to trip and auto-reclose and the unexpected simultaneous trip and auto-reclose of the MOB-TBE 132 kV transmission line.
Power system response (facilities and services)	The lightning strike caused the CHG-TBE 275 kV line to trip and auto-reclose. Coincident with this 275 kV fault, the MOB-TBE 132 kV line Set 2 protection operated unexpectedly at Tailem Bend 132 kV substation, tripping and reclosing the MOB-TBE 132 kV circuit breakers at Tailem Bend 132 kV substation. The CHG-TBE 275 kV circuit breakers and protection systems operated correctly. The MOB-TBE 132 kV circuit breakers and protection systems mal-operated. The MOB-TBE line should not have tripped due to the 275 kV lightning fault. The Set 2 earth fault protection system on the MOB-TBE 132 kV line operated unexpectedly. The earth fault protection mal- operated as it was unable to identify the fault as out of zone due to the applied settings. Please see Figure 1 for a simplified single line diagram of the network around Tailem Bend 275 kV substation.
