Eraring 500 kV Main Busbar trip on 31 August 2021

November 2021

Reviewable Operating Incident Report under the National Electricity Rules

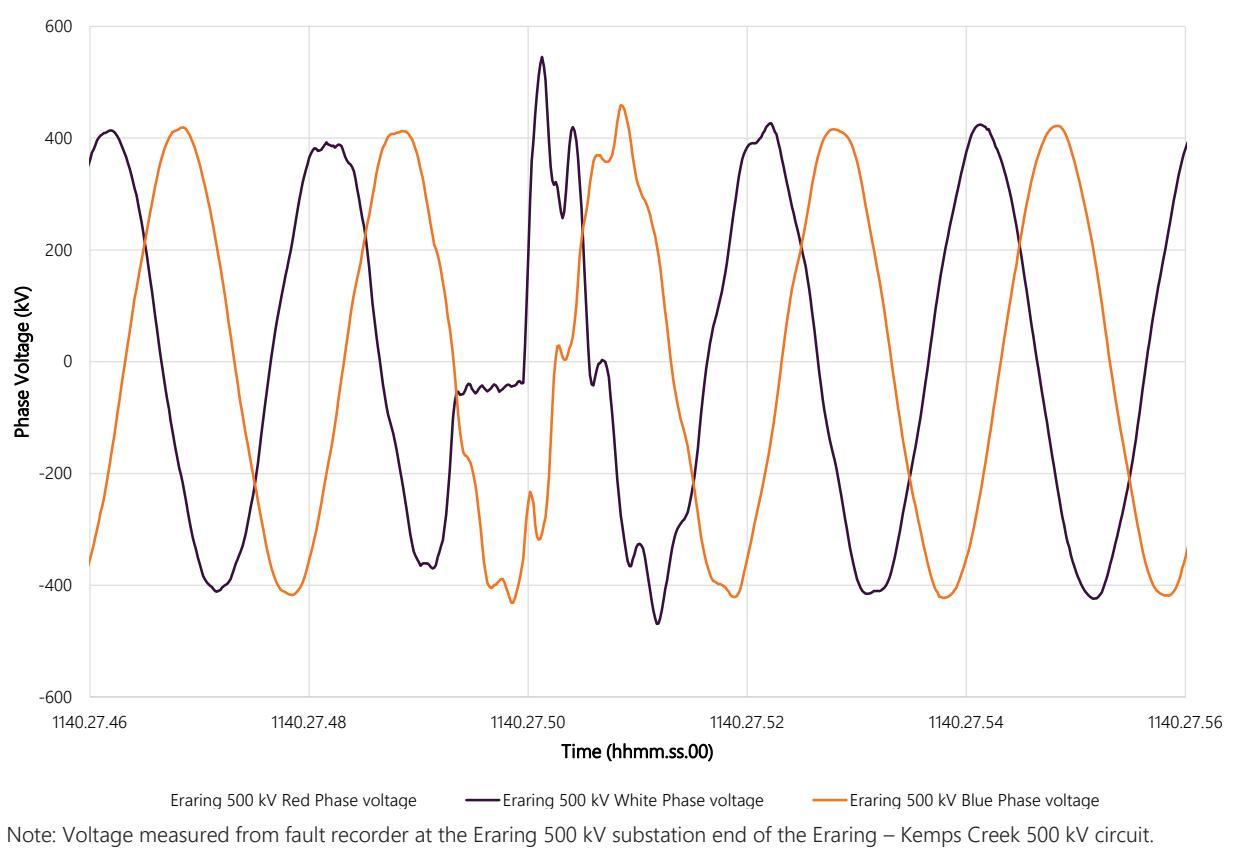
Power system response (facilities and services)	 Transgrid has confirmed that: Prior to the fault, voltages at Eraring 500 kV substation were within normal levels (see Figure 1). The surge arrestor suffered an internal failure. The reason for this failure is still to be confirmed, however, it is presumed to be the result of moisture ingress, and possibly related to the age of the surge arrestor, which is estimated to be 40 years. The White phase to ground fault was identified and cleared by the Eraring 500 kV Main Busbar No. 1 and No. 2 protections, tripping the Main Busbar. Both of these protections operated as per their design. Due to the circuit breaker and a half configuration at Eraring 500 kV substation, the busbar trip did not cause any other equipment to trip/disconnect from the system (see Figure 2).
Rectification	The faulty surge arrestor was isolated at 1647 hrs, prior to the Eraring 500 kV Main Busbar being returned to service.

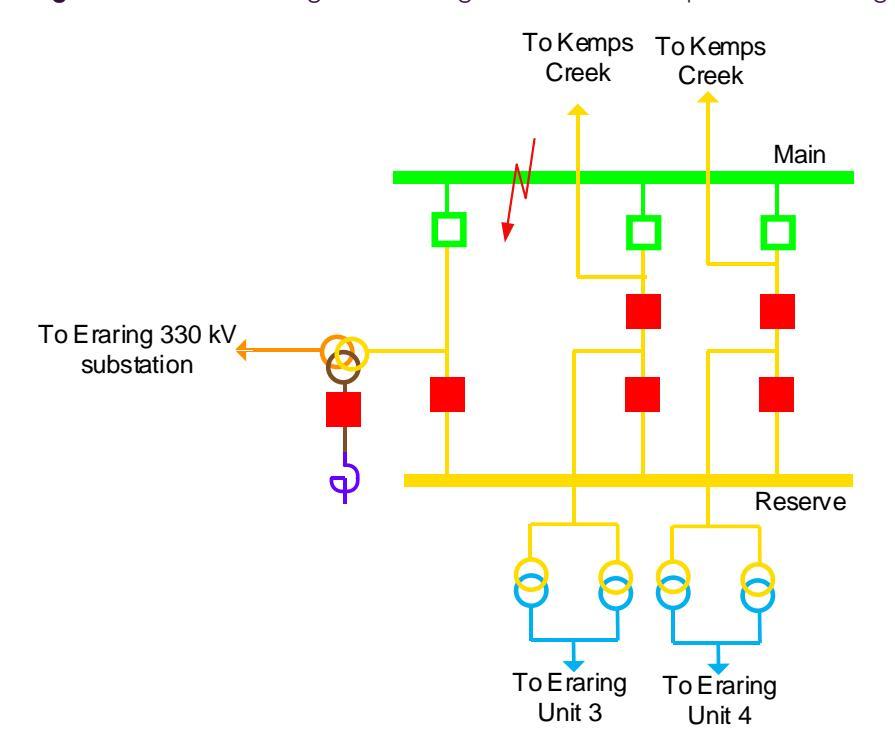
Figure 2 Incident diagram – Eraring 500 kV substation post incident single line diagram

1. An internal fault in a surge arrestor connected to the Eraring 500 kV Main Busbar caused a White phase to ground fault.
	2. This White phase to ground fault was cleared by the Eraring 500 kV Main Busbar protection as per its design. No other equipment tripped as a result of this protection operation.
