Trip of Liddell – Tomago 330 kV line and the Tamworth SVC on 7 April 2023 September 2023

Reviewable Operating Incident Report under the National Electricity Rules

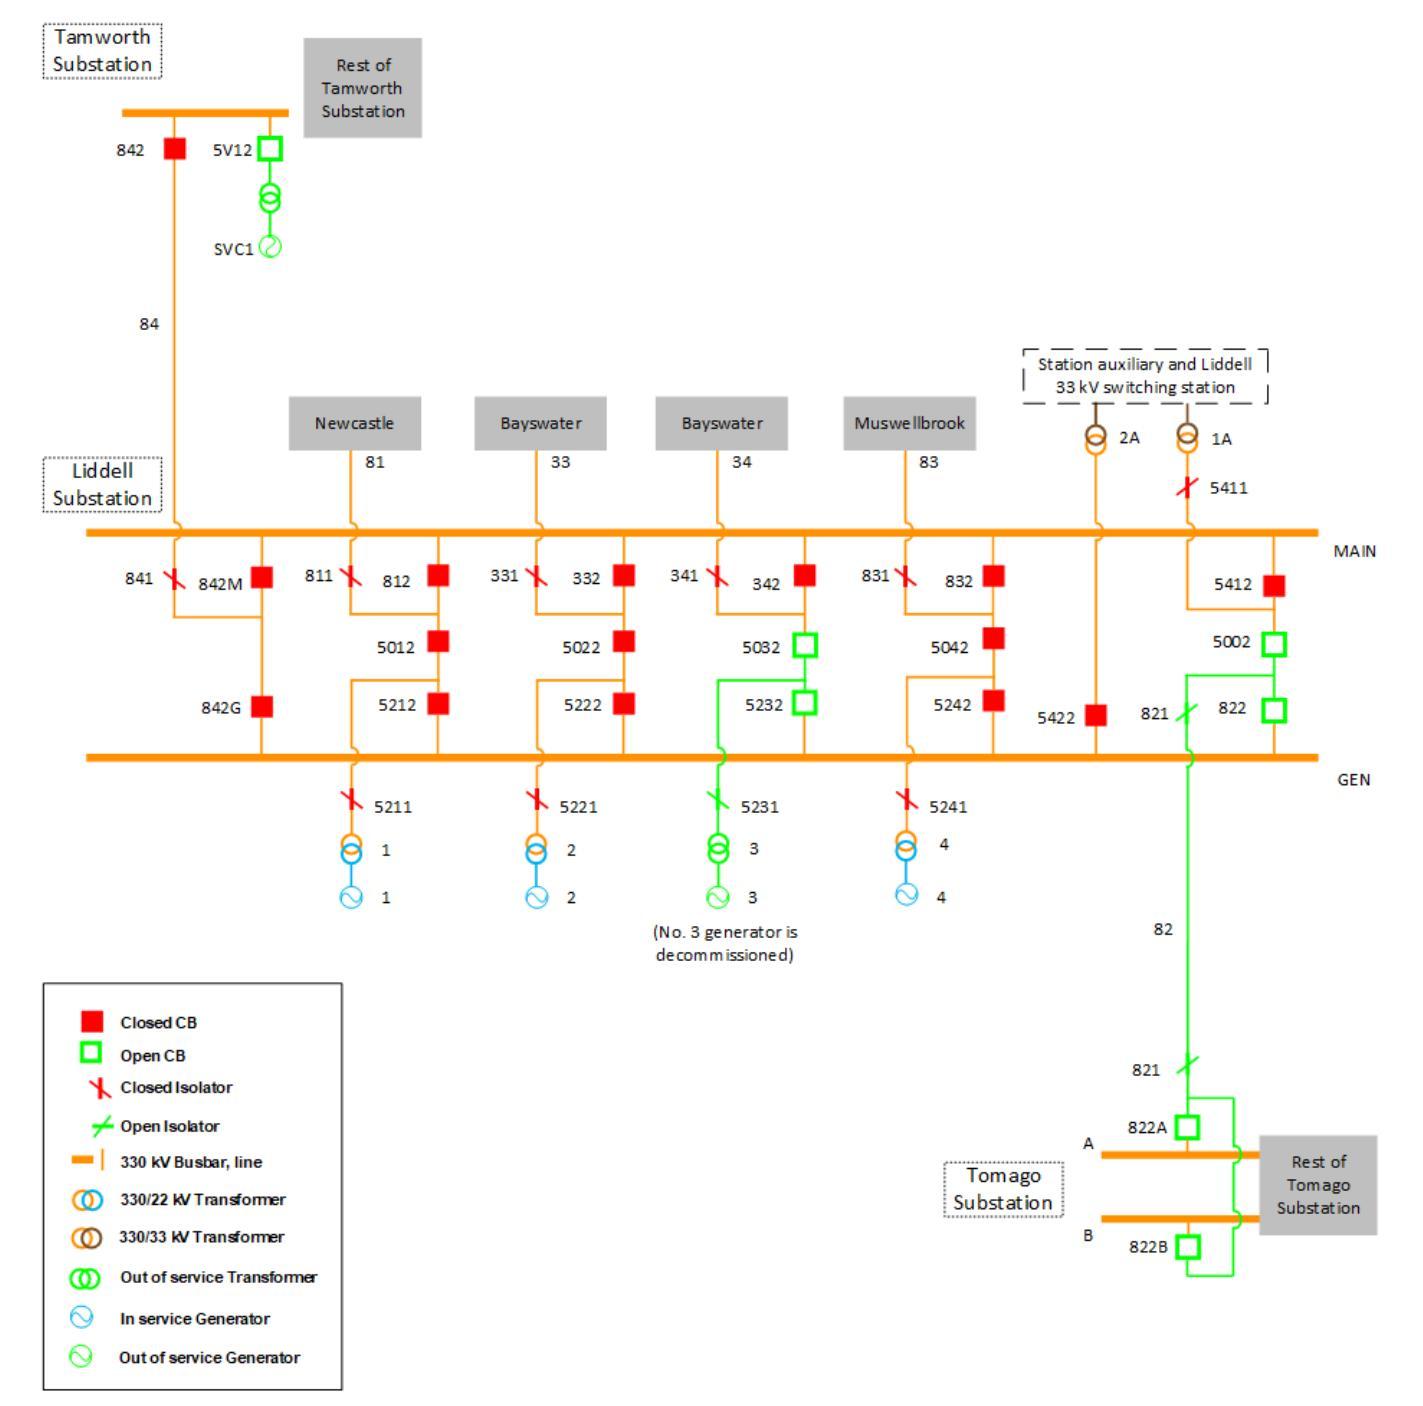
Figure 1 Post-incident diagram – Trip of Liddell – Tomago No. 82 Line and Tamworth 1 330 kV SVC
