220 kV Busbar Trip at Eildon Power Station on 19th February 2017

REVIEWABLE OPERATING INCIDENT REPORT UNDER THE NATIONAL ELECTRICITY RULES

Published: 25 May 2017

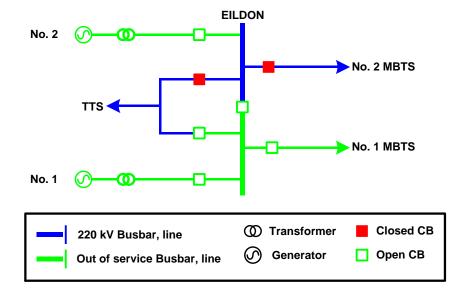
APPENDIX A - POWER SYSTEM DIAGRAM

The diagram below shows the status at Eildon Power Station immediately after the event.

On Sunday 19 February 2017 at 0754 hrs, while synchronising the Eildon Power Station No1 generating unit, the No. 2 220 kV busbar at EPS tripped resulting in offloading of the Eildon – Mount Beauty No1 220 kV transmission line (MBTS 1 line). Refer to Appendix A for a diagram of EPS immediately after the event.
