Trip of Liddell – Tomago 330 kV line and Liddell 330/33 kV transformer on 8 June 2023

November 2023

Reviewable Operating Incident
Report under the National
Electricity Rules

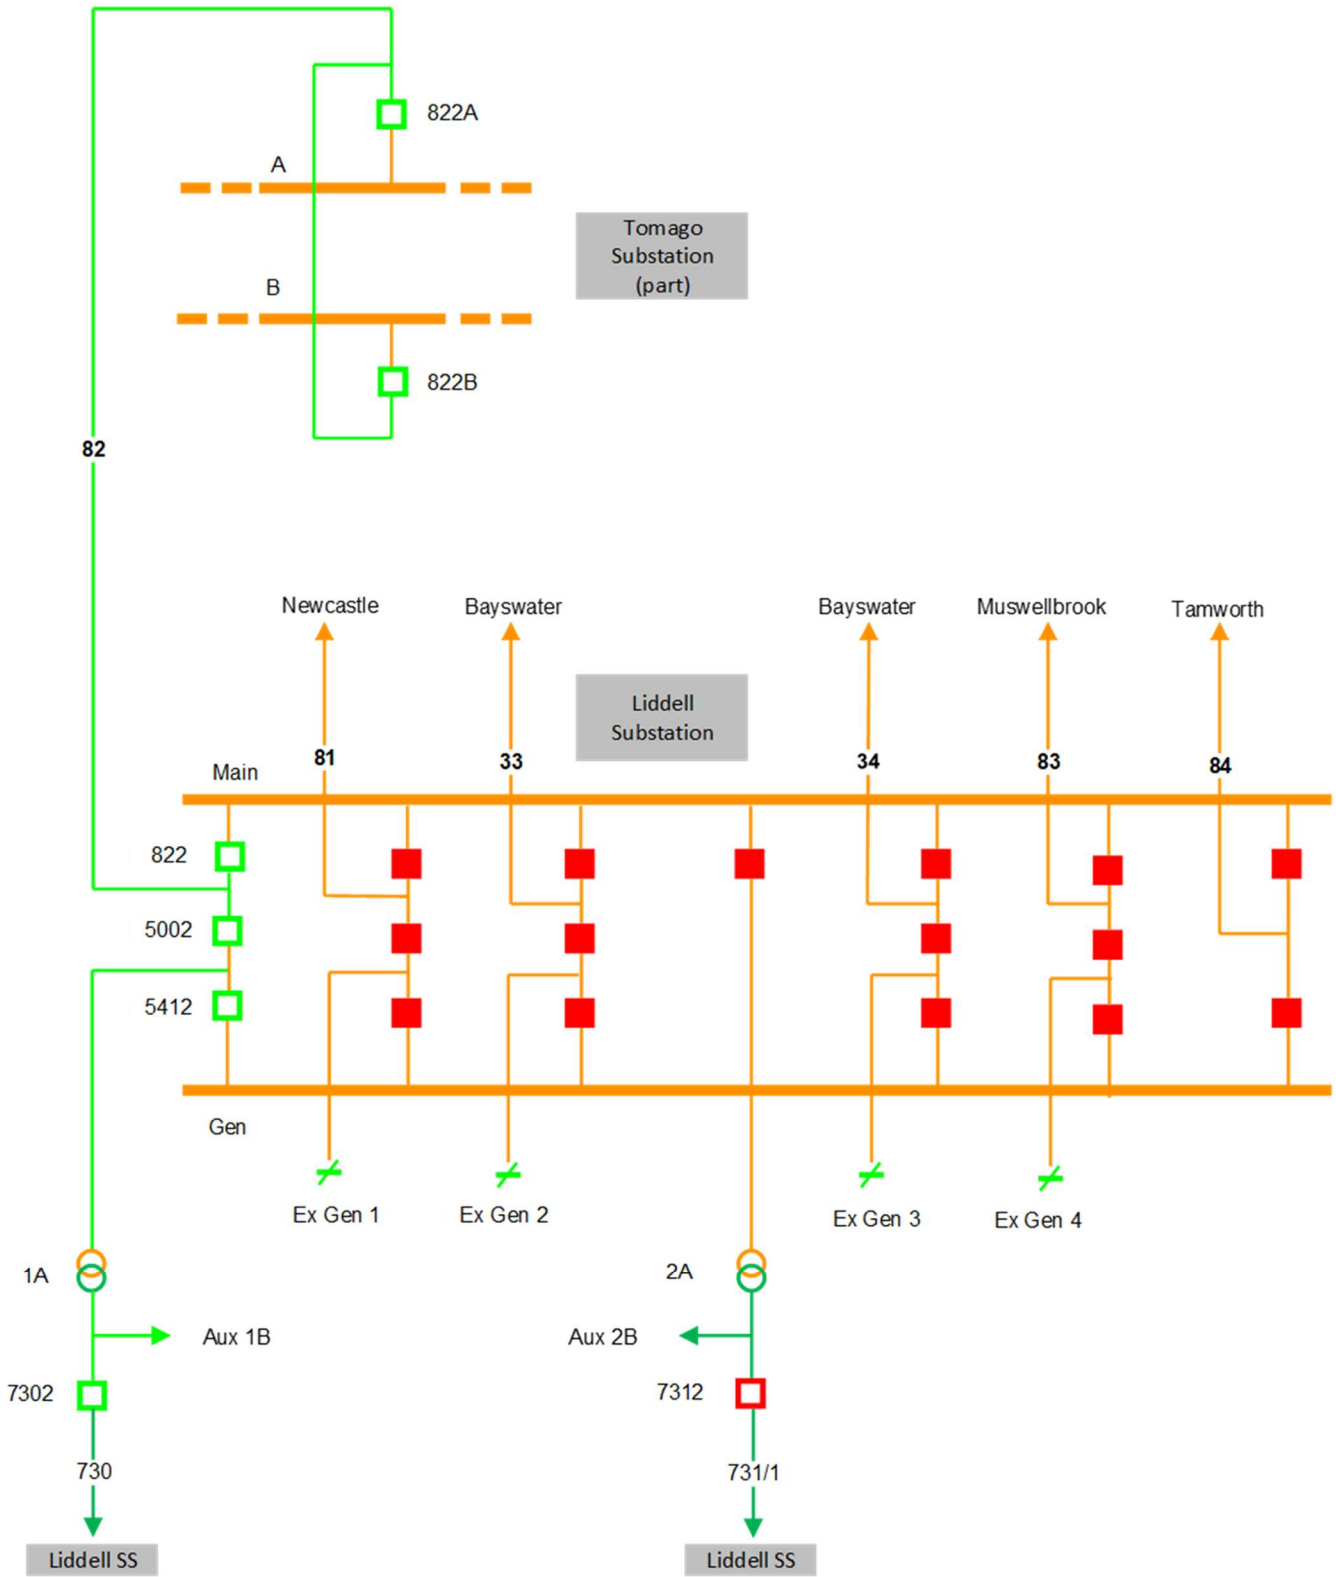
Figure 1 Post-incident diagram Liddell – Tomago 330 kV 82 line and 1A 330/33 kV transformer trip

Incident key events	On 8 June 2023, the following events occurred: <ul style="list-style-type: none"> At 1433 hrs the Liddell – Tomago 330 kV 82 line and the Liddell 330/33 kV 1A transformer tripped (see Figure 1). At 1521 hrs the Liddell – Tomago 330 kV 82 line was returned to service. At 1710 hrs the Liddell 330/33 kV 1A transformer was returned to service.
Incident cause	Post incident investigation by Transgrid has confirmed that: <ul style="list-style-type: none"> At 1433 hrs on 8 June 2023, the Liddell – Tomago 330 kV 82 line and the Liddell 330/33 kV 1A transformer tripped. The incident occurred when a contractor at Liddell was undertaking secondary cable continuity testing of newly installed cables near the No. 1 protection equipment of the Liddell – Tomago 330 kV 82 line. There were two control cables with identical core numbers where the testing was taking place; one cable was in service the other was a new cable. The contractor did not verify which cable was in service and incorrectly applied an earth to an in-service cable core. This caused the CB 5002 circuit breaker failure (CBF) protection to initiate from the Liddell – Tomago 330 kV 82 line No. 1 protection system. Once triggered, the CBF protection operated and tripped the Liddell – Tomago 330 kV 82 line and the Liddell 1A transformer as expected.

Power system response (facilities and services)	There was no other material impact on the broader power system, load or generation.
Rectification	Immediately following the trip of the Liddell – Tomago 330 kV 82 line and 1A transformer, all secondary testing works ceased. The Transgrid project team, including the contractor, held a toolbox meeting in the following days, where the need to ensure the positive identification of a cable prior to testing and to follow existing work procedures was reinforced before secondary testing works were resumed.
